Rail Accident Investigation Branch

Rail Accident Report

**Fatal accident at Waterloo Underground station,
London
26 May 2020**

Report 05/2021
September 2021

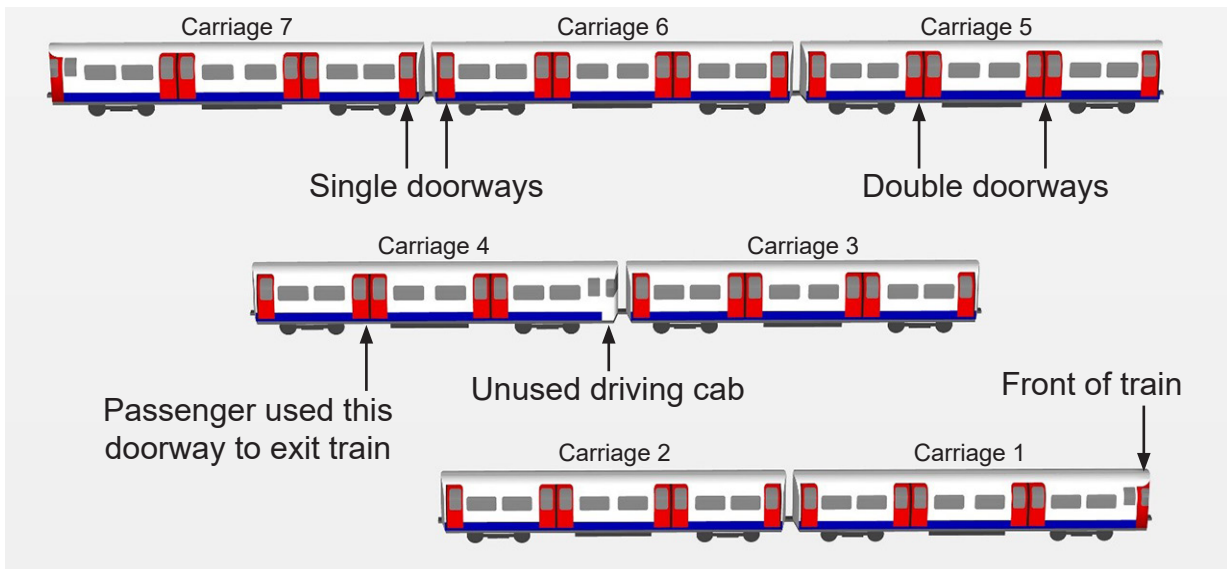
Figure 4: Arrangement of passenger saloon doors on 1972 tube stock trains

- 23 It has not been possible to determine if this announcement was made before the passenger alighted and, if so, whether it prompted him to get off the train. However, 176 seconds after the train had stopped, the passenger left the train from the rear set of double doors of carriage 4 (the fourth carriage from the front of the train, figure 4). After taking two steps on the platform, moving away from the train, the station CCTV shows the passenger becoming unsteady on his feet, stumbling backwards, and falling into the gap between the platform edge and the mid-point of carriage 4. He fell entirely below the level of the platform at a position where the curvature of the platform is particularly tight and so the gap between the platform and the side of the train was particularly wide (paragraph 6).
