Report on the investigation of
the grounding of the chemical tanker

Key Bora

in the approaches to Kyleakin pier, Isle of Skye, Scotland
on 28 March 2020

REPORT NO 15/2021

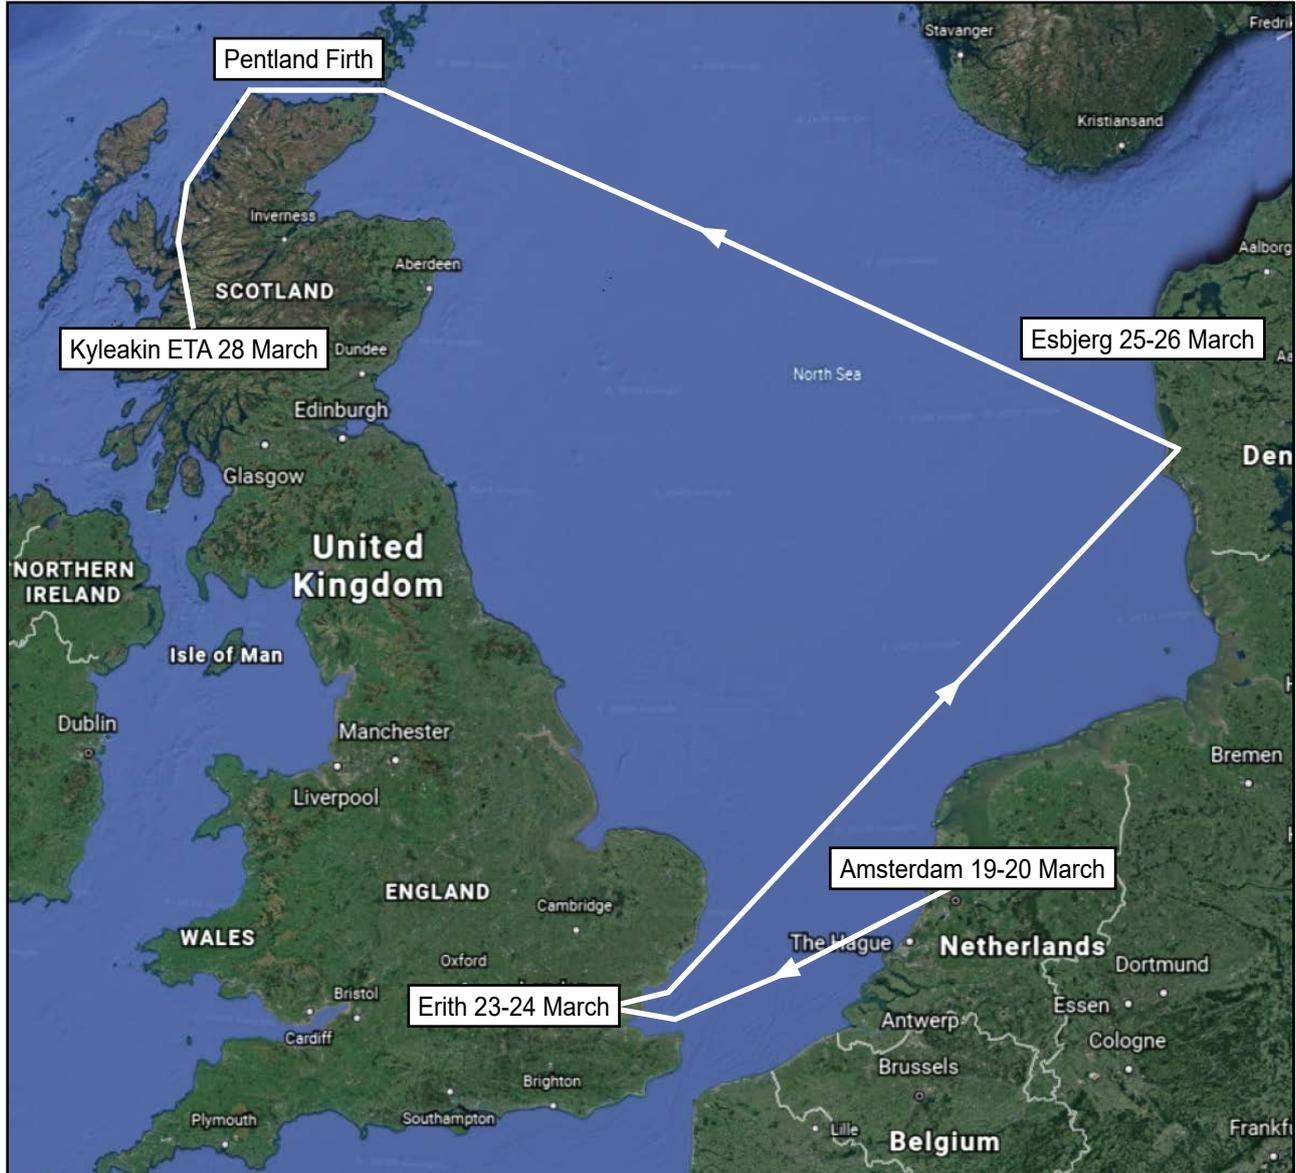
Figure 1: *Key Bora*'s voyage

Key Bora sailed from Esbjerg, Denmark, on 26 March 2020 laden with a liquid chemical cargo bound for Kyleakin, Isle of Skye, Scotland (**Figure 1**). During the morning of 28 March 2020, the master notified the agent that the arrival time would be 1500 that afternoon, planned to coincide with low water when slack tidal stream was anticipated. The master also informed the agent that the vessel's arrival draughts would be 5.4 metres (m) forward and 6.2m aft.

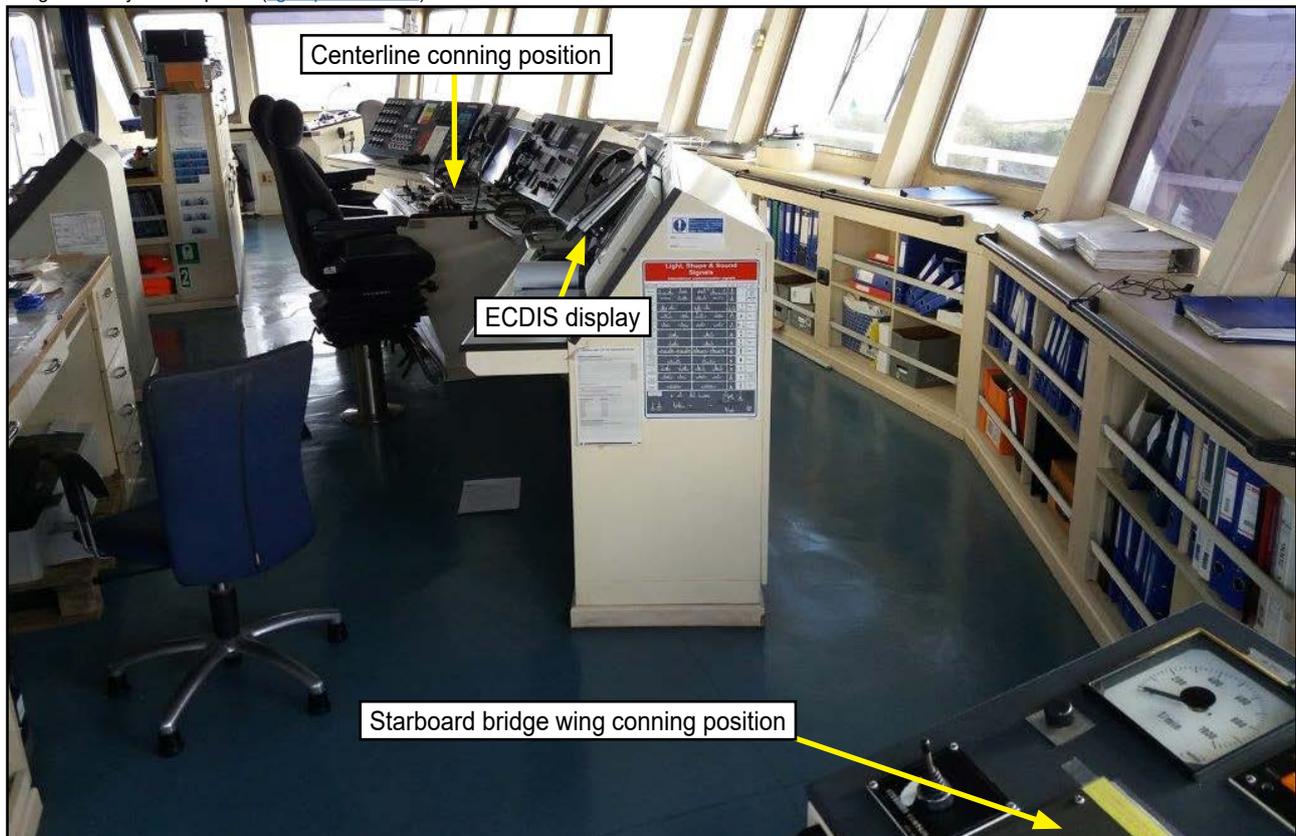
Figure 6: *Key Bora's* bridge viewed from starboard bridge wing conning position

Key Bora's bridge (**Figure 6**) had a centreline console that comprised of engine, rudder and bow thruster controls, flanked by two radar displays and the ECDIS display. There was also a conning control console on each of the enclosed bridge wings.

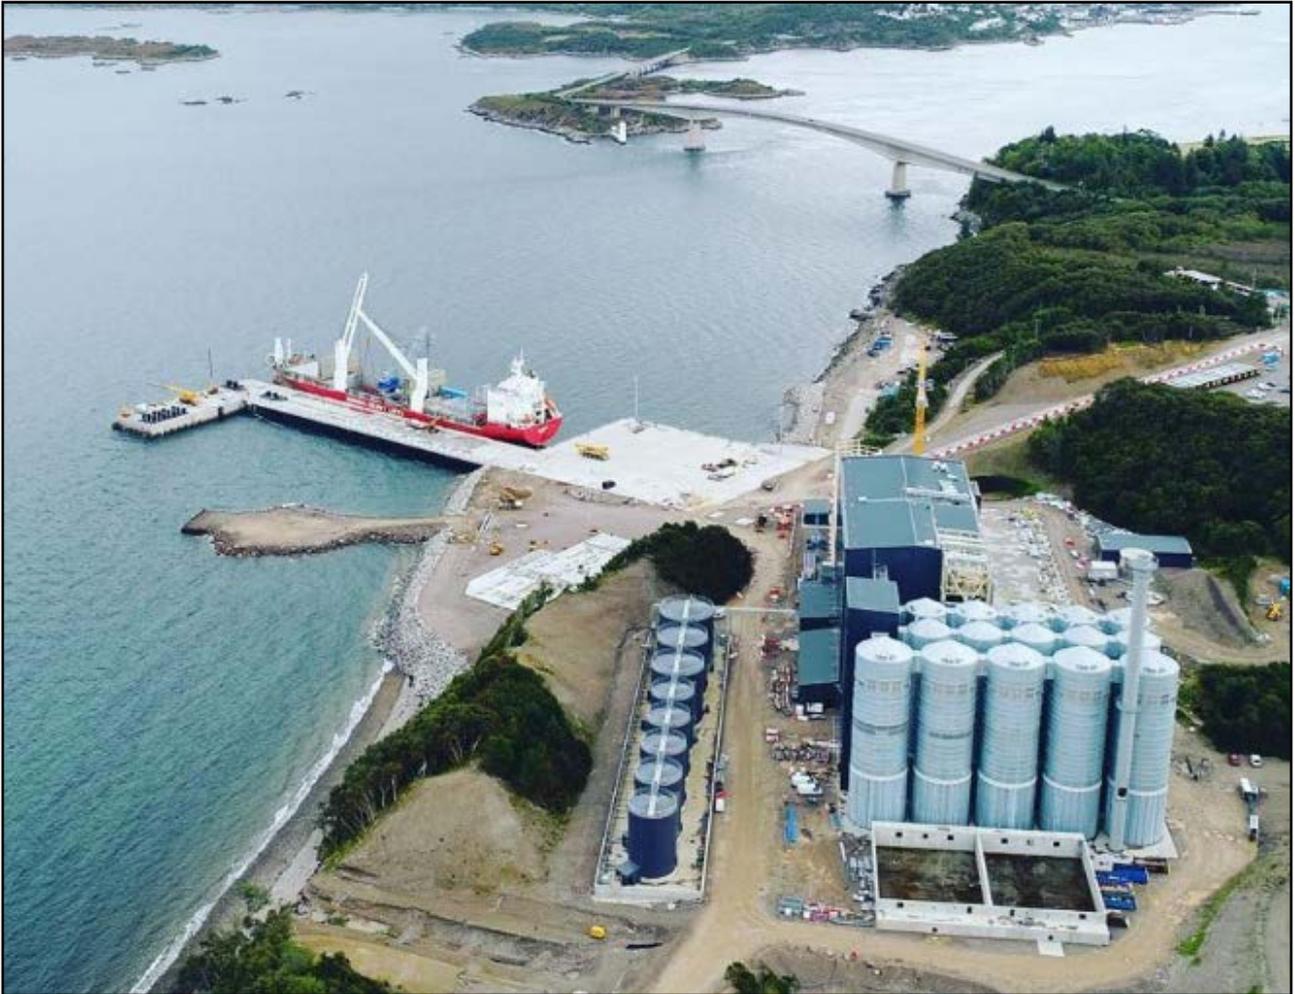
Figure 10: Aerial view of the Kyleakin Feed Mill and pier

The Kyleakin Feed Mill Pier (**Figure 10**) was a major infrastructure development by the aquaculture company Mowi. Employing over 12,000 staff globally, Mowi managed operations in 25 countries and was the world's largest producer of Atlantic salmon with an annual turnover of 3.8 billion euros. The Kyleakin factory manufactured fish feed and the pier facilitated the inward supply of raw materials, and the outward distribution of the manufactured fish feed to aquaculture sites in Scotland.
