Report on the investigation of  
a subsea explosion  
resulting in crew injuries and vessel damage  
to the crab potting vessel

***Galwad-Y-Mor (BRD 116)***

22 nautical miles north of Cromer, England  
on 15 December 2020

REPORT NO 1/2022

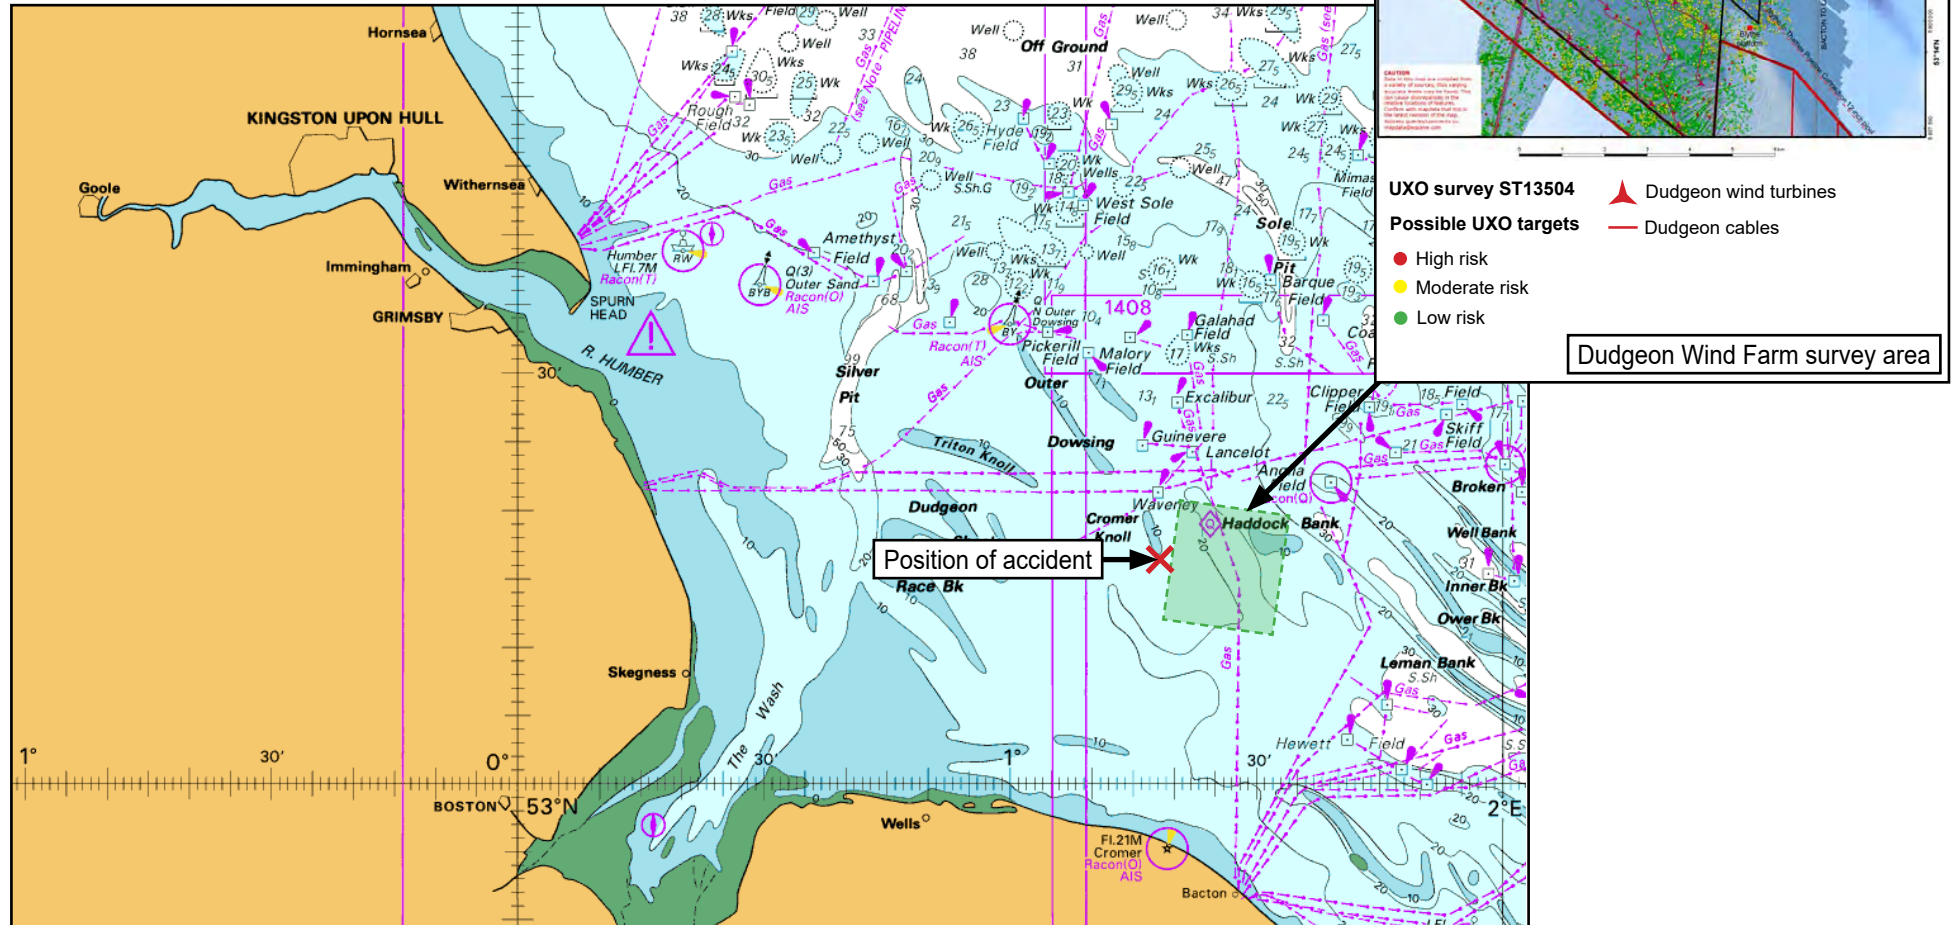
Figure 12: Possible UXO in Dudgeon Wind Farm survey area

A pre-installation seabed survey of the Dudgeon Offshore Wind Farm site, which was 1.5nm to the east of the *Galwad-Y-Mor* accident, covered a 90 square nautical mile survey area (**Figure 12**). It identified numerous potential UXO targets, of which 244 were classed as high risk to the wind farm's installation and operation. EOD specialists cleared several UXO, including German SC bombs, using controlled explosion methods and post detonation fragment collection (**Figure 13**).
