## Accident

<b>Aircraft Type and Registration:</b>	Amateur-built balloon (DB-6R), G-CMFS	
<b>No &amp; Type of Engines:</b>	1 Ultra Magic Mk 21 LPG twin burner	
<b>Year of Manufacture:</b>	2022	
<b>Date &amp; Time (UTC):</b>	25 June 2023 at 0519 hrs	
<b>Location:</b>	Ombersley Court, Worcestershire	
<b>Type of Flight:</b>	Private	
<b>Persons on Board:</b>	Crew - 1	Passengers - None
<b>Injuries:</b>	Crew - 1 (Fatal)	Passengers - N/A
<b>Nature of Damage:</b>	Balloon destroyed	
<b>Commander's Licence:</b>	Commercial Pilot's Licence (Balloon)	
<b>Commander's Age:</b>	25 years	
<b>Commander's Flying Experience:</b>	569 hours (of which 33 were on type) Last 90 days - 10 hours Last 28 days - 3 hours	
<b>Information Source:</b>	AAIB Field Investigation

## Synopsis

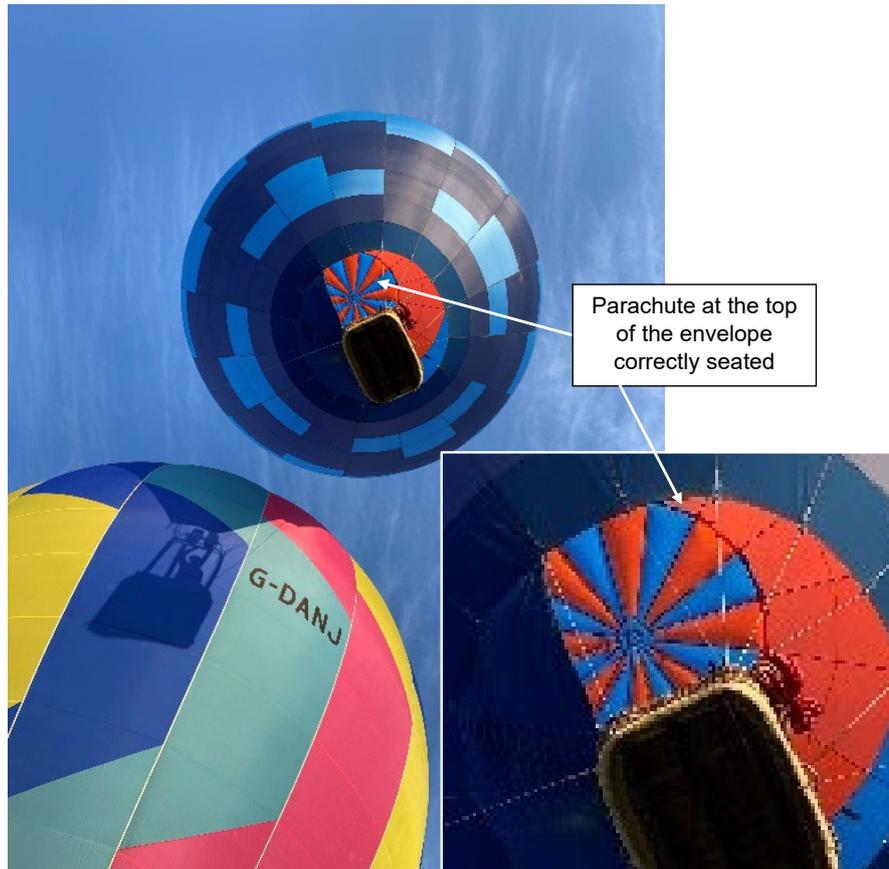
**Figure 4**

G-CMFS launched at 0506 hrs and Figure 4 shows it just after launch (the balloon parachute can be seen correctly seated at the top of the envelope<sup>2</sup>). The three ground-crew that helped launch G-CMFS reported the launch was normal and that all pre-flight checks were completed successfully. They reported that everything looked fine during the launch.

G-CMFS just after launch showing the parachute correctly seated

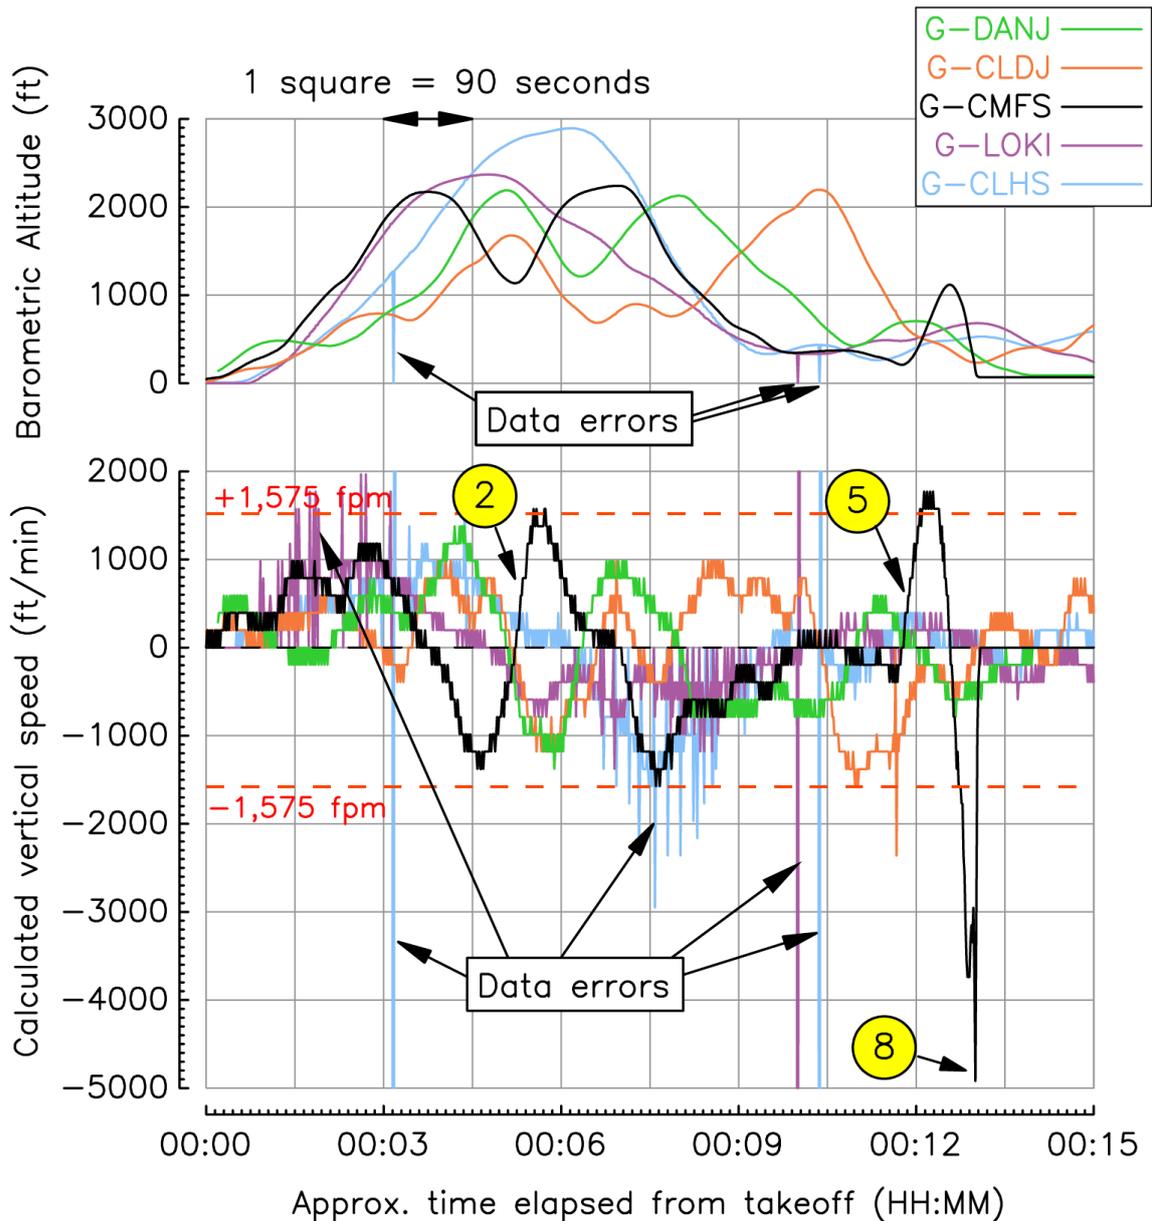
**Figure 17**

The AAIB obtained data from the other competitors' balloon sensors, which had been streamed to the cloud. Their height and calculated vertical speed data was compared against that from G-CMFS by aligning the data at their approximate takeoff times<sup>8</sup>, illustrated by Figure 17. Some data exhibited errors for undetermined reasons.

Comparison of altitude and vertical speed for each competitor.
