Rail Accident Report

Runaway and derailment of wagons at Toton, Nottinghamshire 17 January 2021

Report 09/2021
December 2021

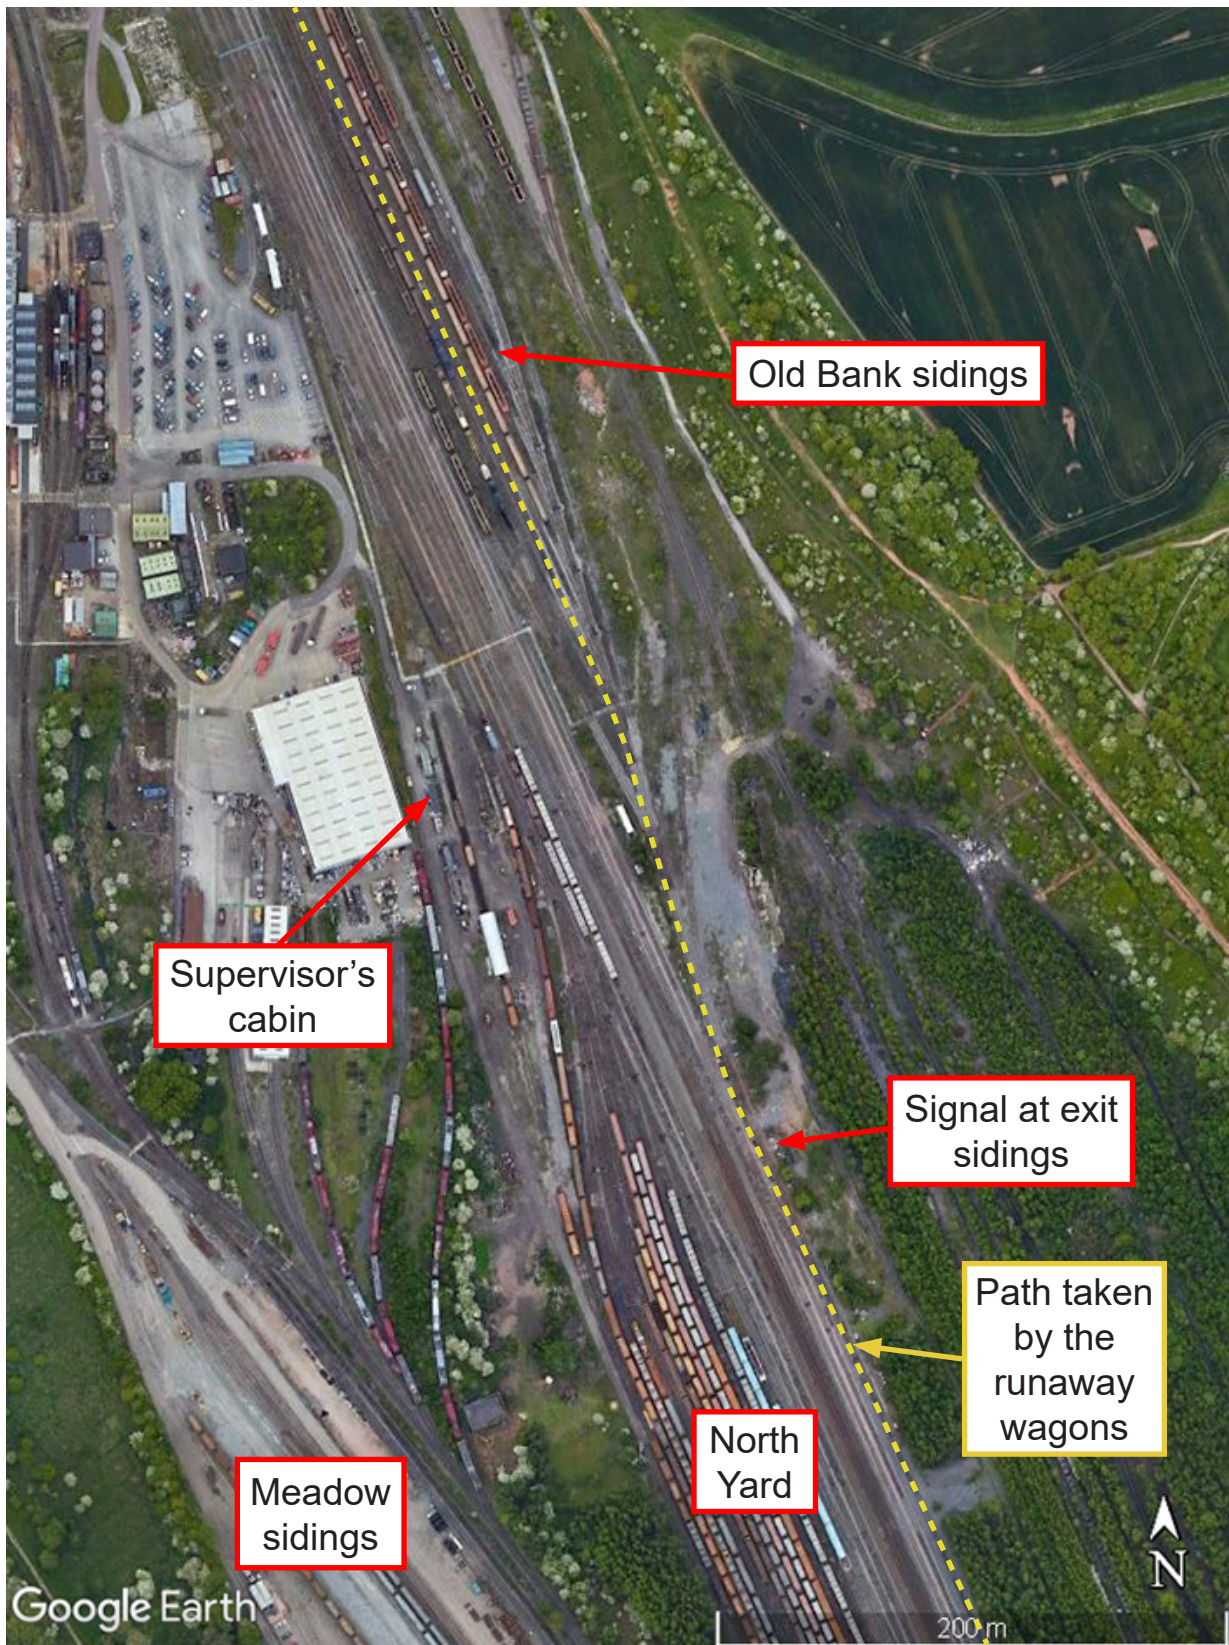
Figure 2: Google Earth view of the path taken by the runaway wagons out of Old Bank sidings

- 4 After exiting Old Bank sidings, the rake passed a signal displaying a red aspect, which generated an alarm on a signaller's workstation.¹ This alerted the signaller, who could see that track sections² along the line leading away from the sidings were being occupied (figure 2).
- 5 The rake then passed a second signal displaying a red aspect and, a short distance later, the leading four wagons derailed at the end of the run-out rails associated with a set of trap points. The trap points worked as intended to derail the unauthorised movement (figure 3). The leading two derailed wagons stopped foul of the adjacent running line (figure 4), although no trains were nearby when the derailment occurred. The rake of wagons travelled a total distance of about 0.6 miles (1.0 km) during the runaway.

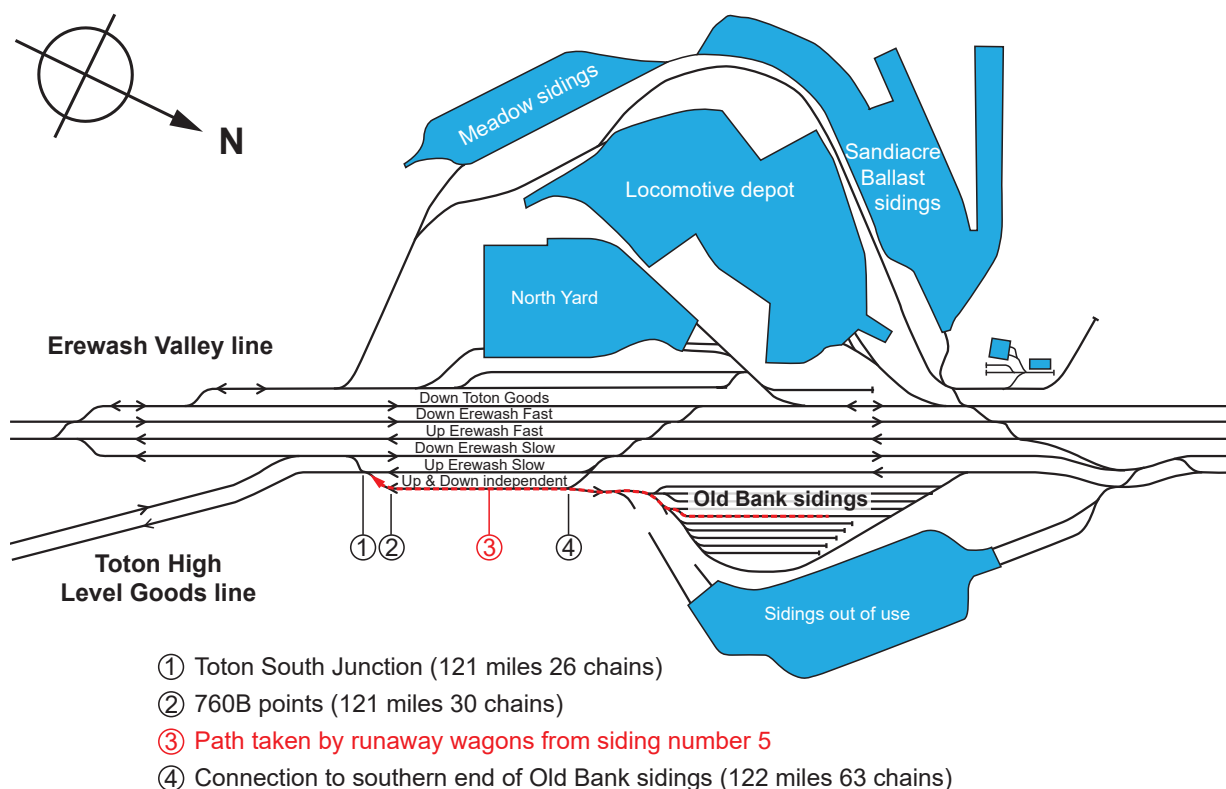
Figure 6: Track layout at Toton

- 8 The southern end of Old Bank sidings joins the up and down independent line at 122 miles 63 chains⁵ (from a zero reference at London St Pancras), at the boundary where ownership of the infrastructure changes from DB Cargo to Network Rail. At 121 miles 30 chains, the up and down independent line joins the up Erewash slow line at Toton South Junction. The trap points that derailed the wagons, reference number 760B, were located here (figure 6).

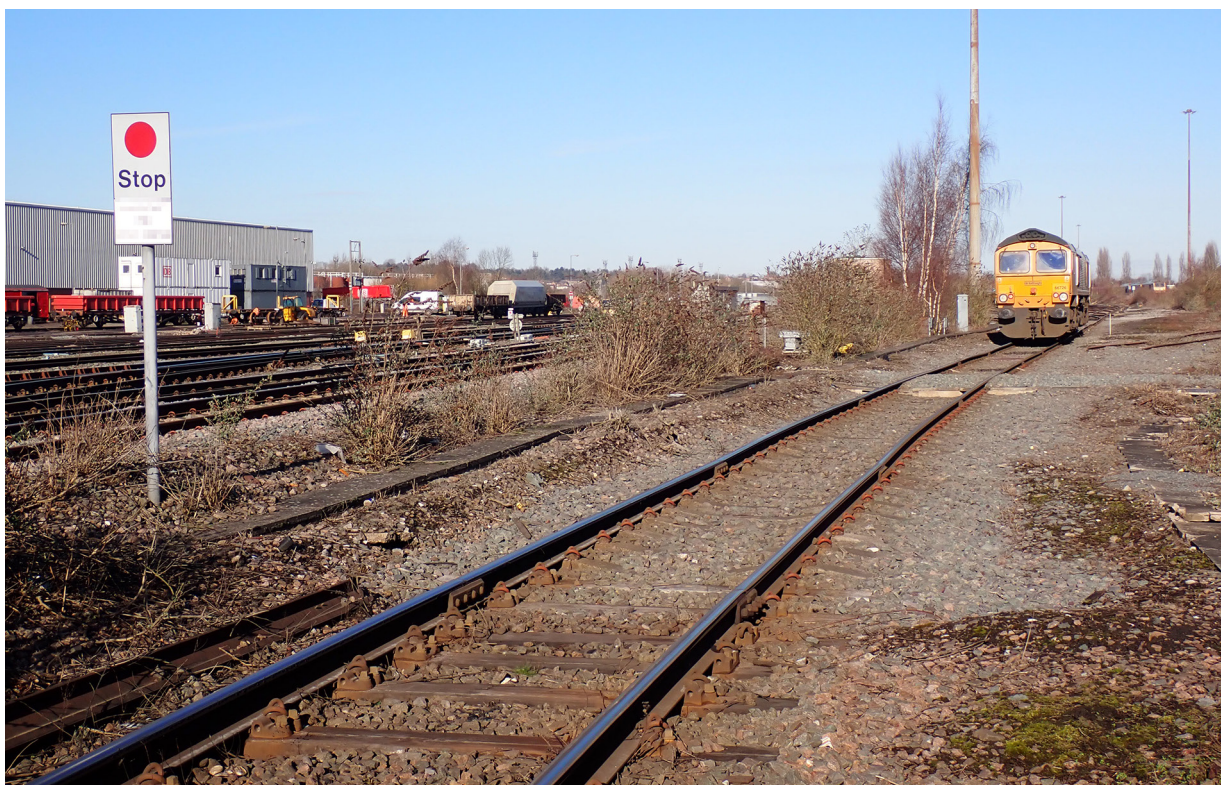
Figure 9: The stop board at the southern entrance to Old Bank sidings

- 49 When a train that was destined for Old Bank sidings was approaching Toton, the signaller at EMCC would call the PIC to obtain permission to route the train up to the stop board at the entrance to the sidings (figure 9).
