## Fatal man overboard from the fishing vessel *Reul A Chuain* (OB915) in the Sound of Rùm, Scotland on 24 June 2021

### SUMMARY

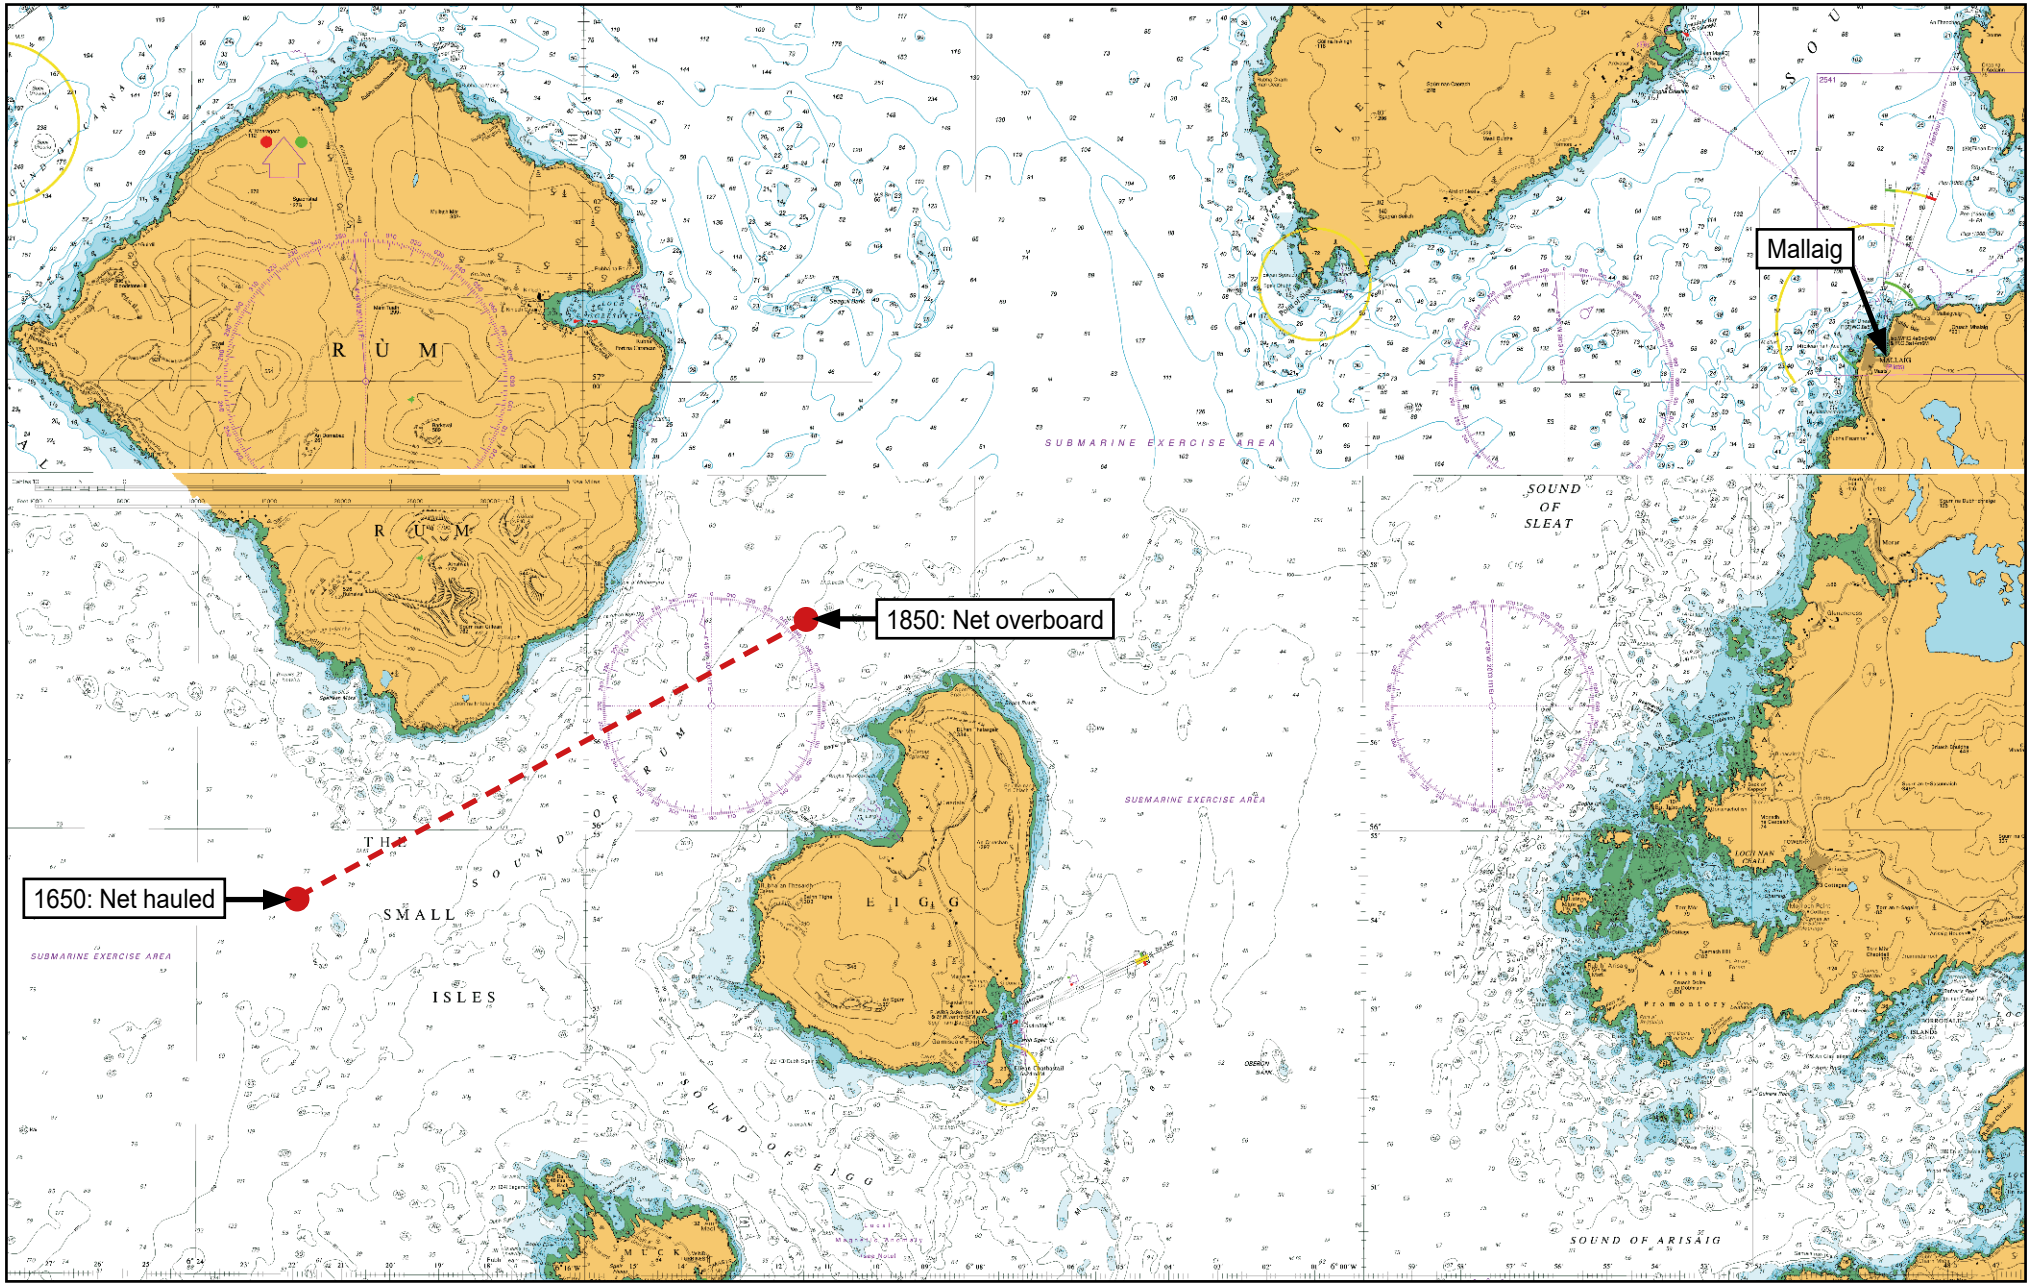
Figure 1: Extract from UKHO chart showing Mallaig (port of departure/destination), point of last net haul, and accident position (net overboard)
