ACCIDENT

Aircraft Type and Registration:	Flight Design CT2K, G-CBDJ	
No & Type of Engines:	1 Rotax 912ULS piston engine	
Year of Manufacture:	2001 (Serial no: 7850)	
Date & Time (UTC):	24 March 2022 at 1400 hrs	
Location:	Beccles Aerodrome, Suffolk	
Type of Flight:	Private	
Persons on Board:	Crew - 1	Passengers - None
Injuries:	Crew - 1 (Fatal)	Passengers - N/A
Nature of Damage:	Aircraft destroyed	
Commander's Licence:	Private Pilot's Licence	
Commander's Age:	87 years	
Commander's Flying Experience:	2,677 hours (of which 1,621 were on type) Last 90 days - 20 hours Last 28 days - 9 hours	
Information Source:	AAIB Field Investigation

Synopsis

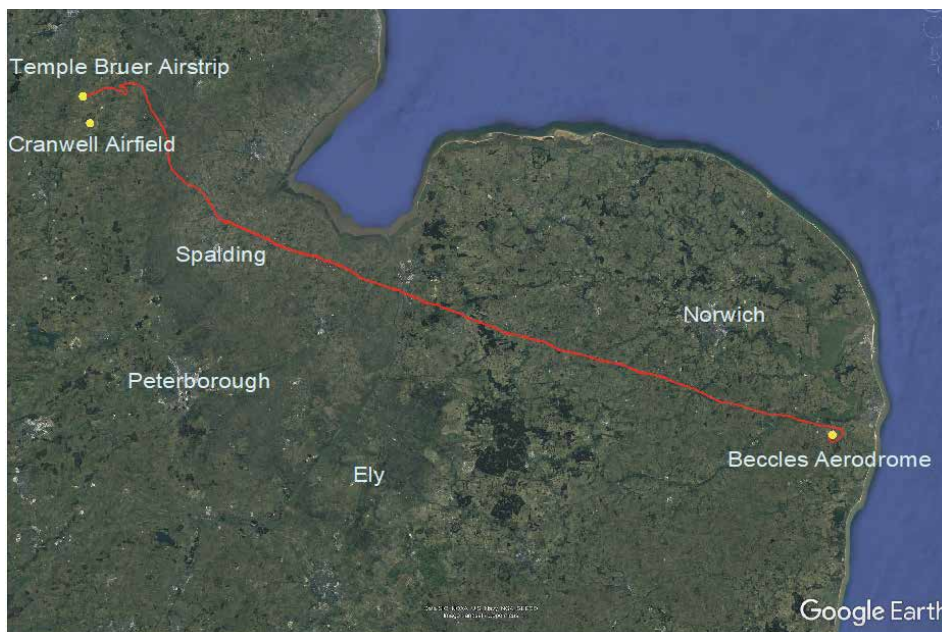
Figure 2

The pilot of G-CBDJ made initial radio contact at 1244 hrs with Cranwell Zone ATC to request permission to depart from Temple Bruer into the Military Air Traffic Zone (MATZ), for a flight to Beccles (Figure 2). The pilot was cleared for departure, with the aircraft subsequently taking off from Runway 08 at 1246 hrs before then turning onto a south-easterly heading. However, at 1249 hrs, the pilot reported to ATC that he had a “SLIGHT PROBLEM” and was returning to Temple Bruer, with the aircraft making a left turn back towards the airstrip. ATC inquired if they could further assist the pilot, who responded by advising “NO, NO I’M, I’M FINE THANK YOU, IT’S JUST SOMETHING HASN’T FIRED UP AS IT SHOULD HAVE DONE”. About one minute later, at 1250:54 hrs, the pilot

Aircraft track from Temple Bruer to Beccles Aerodrome
© 2022 Google, Image © Landsat / Copernicus

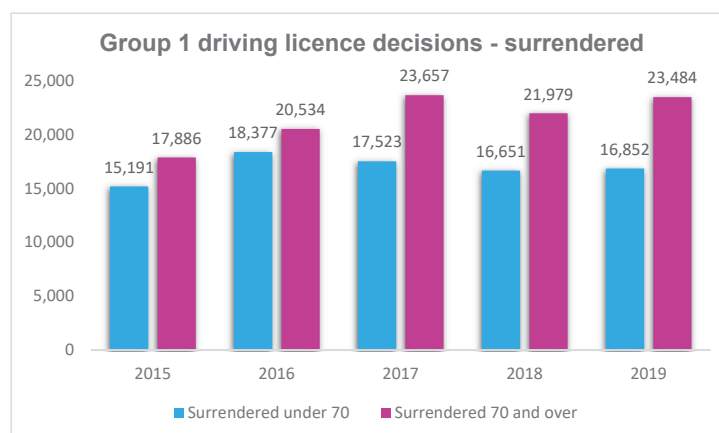
Figure 4
Driving licences surrendered

The total numbers of licences surrendered in each cohort indicates a measure of compliance with the medical standards for driving (Figure 4).

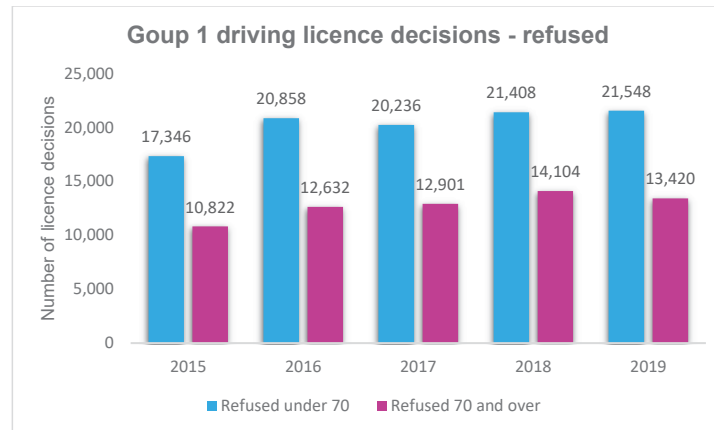
Figure 5
Driving licences refused

The total numbers of licences refused and revoked (Figures 5 and 6) indicate a measure of intervention made by the DVLA to withhold or withdraw a driving entitlement from individuals who do not meet the medical standard to hold a Group 1 licence.

For the five years of data, the trend is for an increasing number of licenses to be refused, revoked, and surrendered in both age cohorts. Also of note is that the number of surrendered licences is broadly similar to the number of licences subject to enforcement action (revoked + refused).

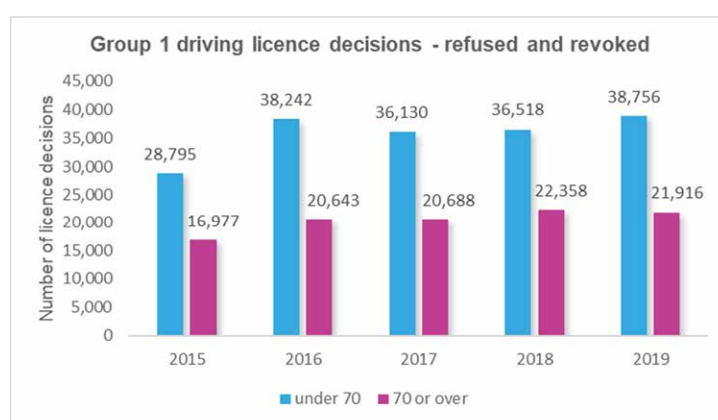
The DVLA has established a process by which drivers, doctors and other healthcare professionals are provided with comprehensive guidance on the medical requirements to hold a driving licence. The DVLA also has a mechanism by which driving licences can be refused or revoked based on the medical history of the licence holder. The CAA does not revoke flying licences for medical reasons, but places an obligation on GA pilots to withdraw their PMD and cease flying if they have reason to believe they no longer meet the medical standard for a Group 1 driving licence. However, should a GA pilot misunderstand this requirement, or choose not to comply, there is no means by which these individuals are visible to the CAA and they might continue to fly.

Figure 7 shows the total number of driving licences that were subject to enforcement action (refused and revoked) for medical reasons by the DVLA for the years 2015 to 2019.

Driving licences refused plus revoked
