Accident

Aircraft Type and Registration:	Extra NG, G-MIIL
No & Type of Engines:	1 Lycoming AEIO-580-B1A piston engine
Year of Manufacture:	2021 (Serial no: NG028)
Date & Time (UTC):	2 April 2022 at 1059 hrs
Location:	Upper Heyford, Oxfordshire
Type of Flight:	Private
Persons on Board:	Crew – 1 Passengers – None
Injuries:	Crew – 1 (Serious) Passengers – N/A
Nature of Damage:	Aircraft destroyed
Commander's Licence:	Private pilot's licence
Commander's Age:	62 years
Commander's Flying Experience:	593 hours (of which 28 were on type) Last 90 days – 7 hours Last 28 days – 4 hours
Information Source:	AAIB Field Investigation

Synopsis

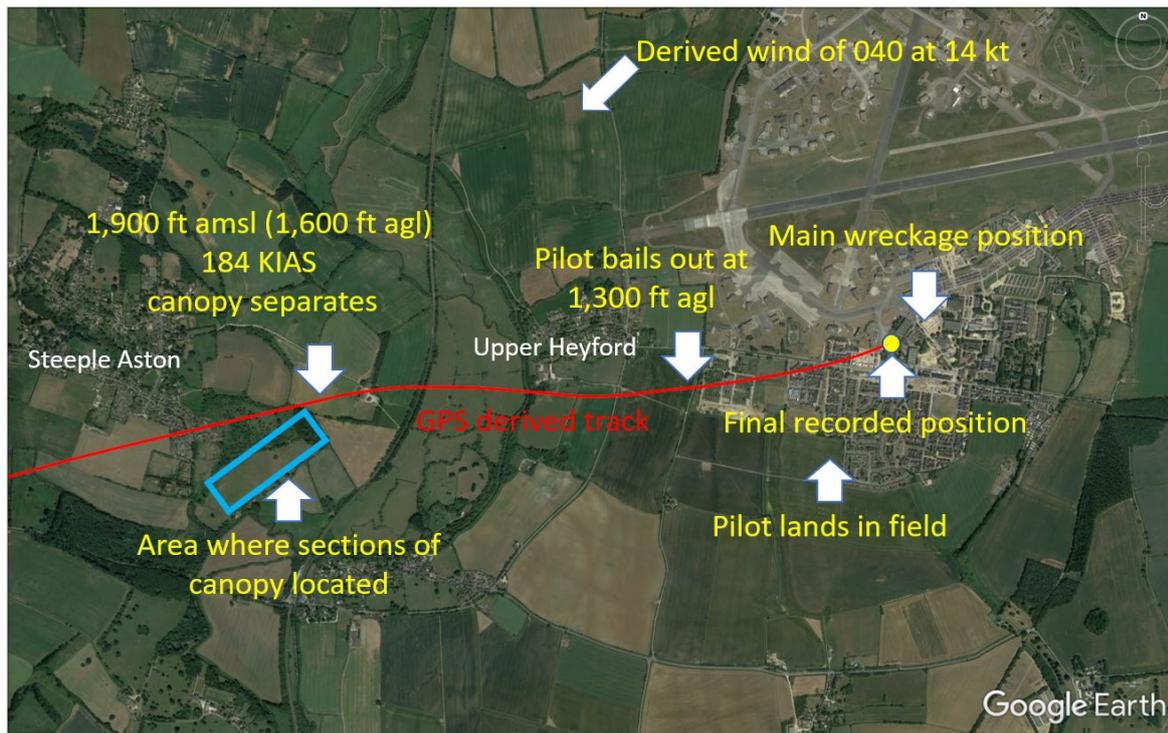
Figure 3

The position where the sections of the canopy were found, in combination with the aircraft's flightpath, wind direction and speed, indicated that the canopy had most likely separated from the aircraft at about 1057:59 hrs. At this time, the aircraft was at an altitude of 1,900 ft amsl (1,600 ft agl) and its airspeed was 184 KIAS (Figure 3). This also coincided with the start of erratic changes in both pitch and roll.

Aircraft track and probable position of canopy separation

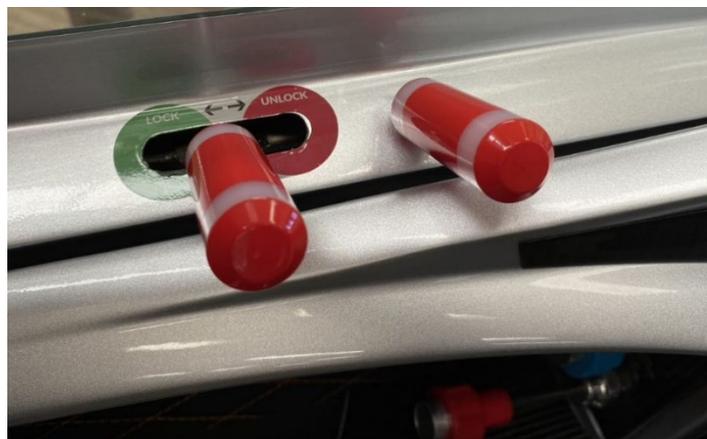
Figure 5

With the canopy closed and the handle released, the handle will travel under spring pressure towards the locked position, stopping just as it enters the green LOCK area. This is a partially locked condition and the distance between the handle centres in this condition is 60 mm (Figure 5).

Canopy handle partly locked position when under spring pressure alone

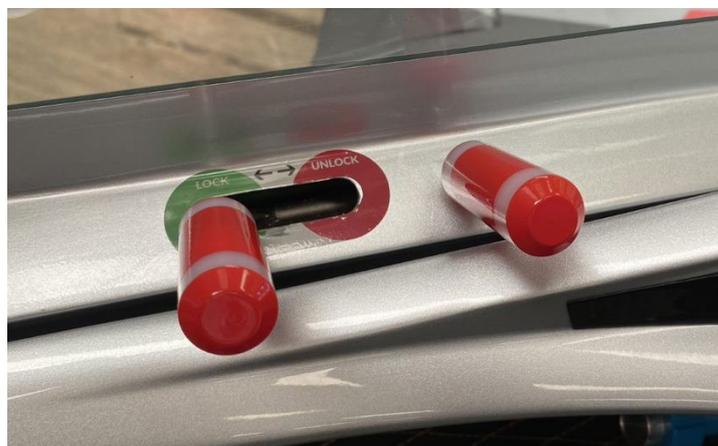
Figure 6

To fully lock the canopy the handle must then be manually pulled rearwards into the fully locked position (Figure 6).

Shoot bolt handles (canopy in the closed and locked position)

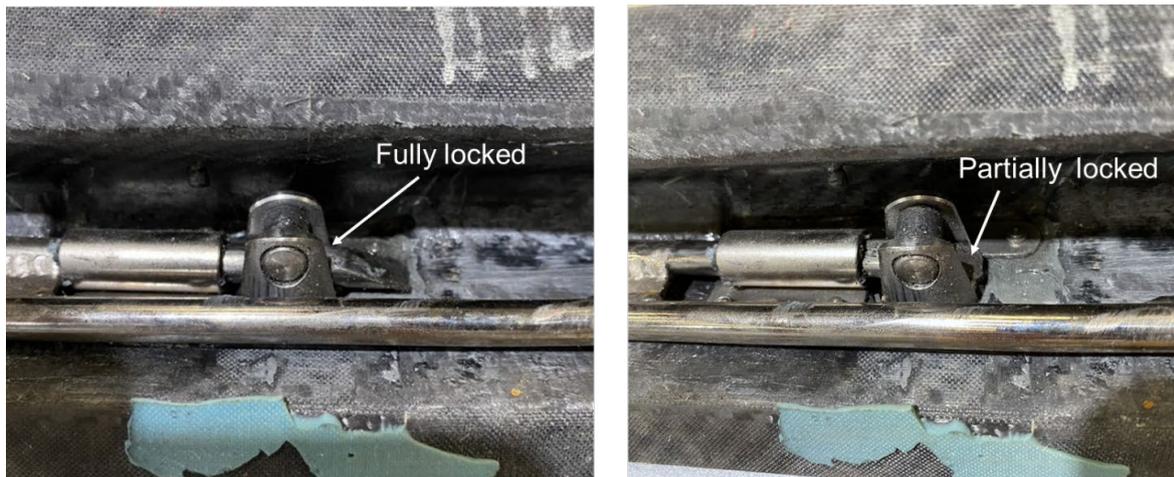
Figure 7 shows the extent of the shoot bolt engagement within the latch when the handles are in the fully locked and partially locked condition. The photographs were taken without the canopy outer frame skin in position. In normal circumstances these components are completely hidden from view.

Shoot bolt and latch engagement conditions

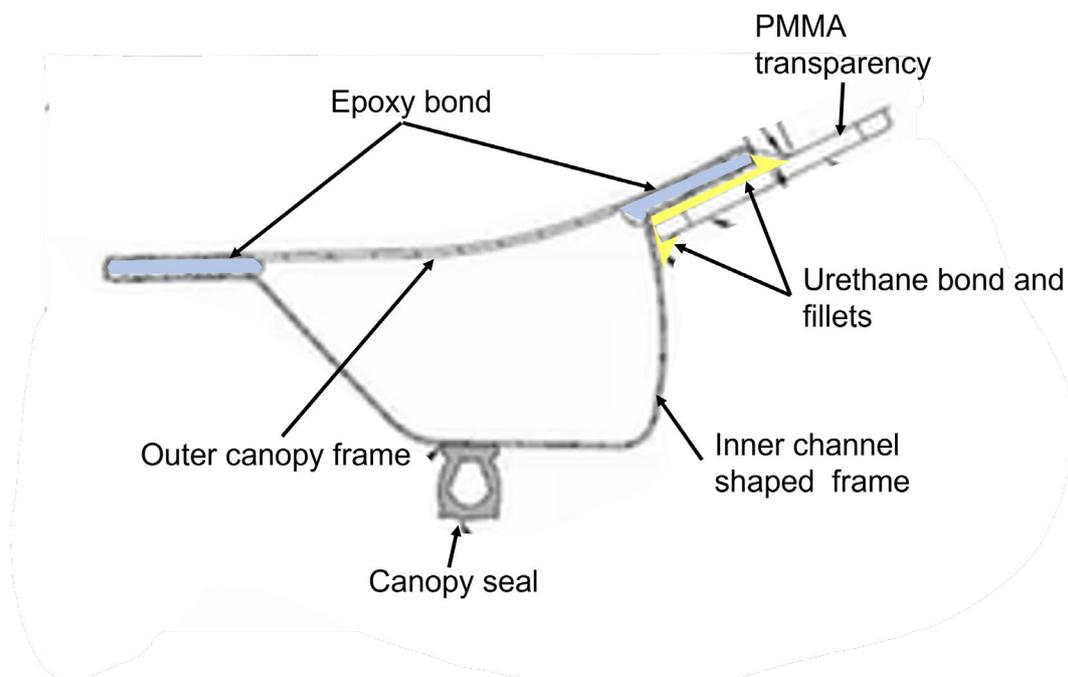
Figure 13

A schematic cross section of the front of the canopy frame assembly from the manufacturer's assembly diagram in this area is shown in Figure 13.

Schematic cross section of the front of the canopy frame assembly

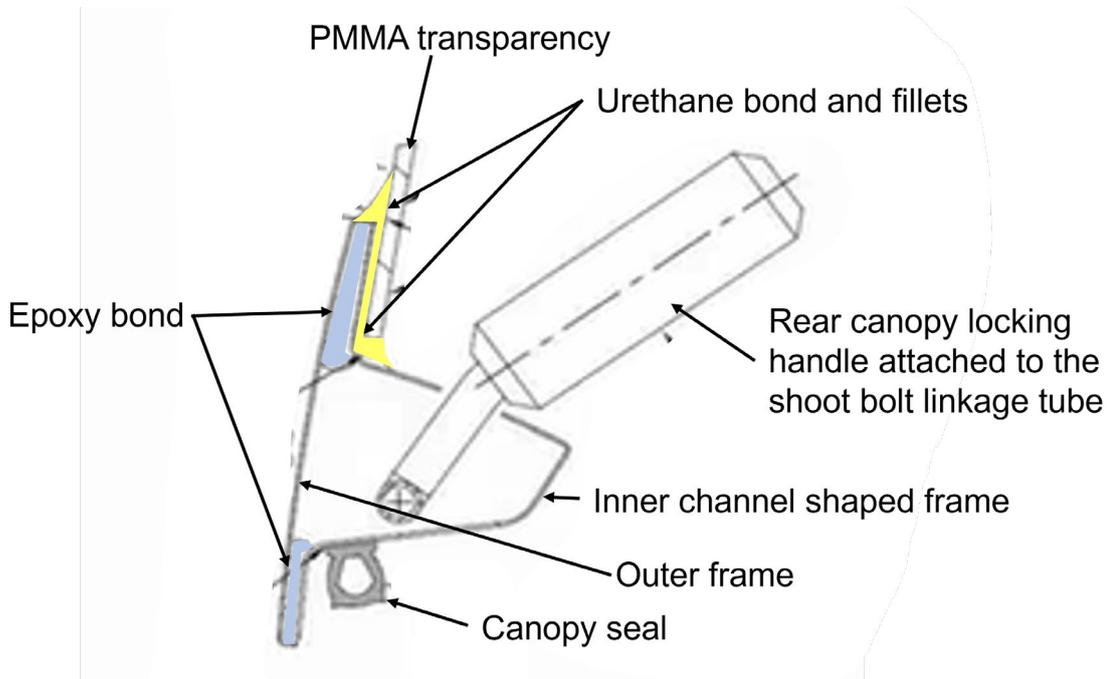
Figure 19

One area of the outer frame covering the shoot bolt mechanism had not been attached to the left channel of the canopy frame (Figure 17). The bead of bond material at the top of this piece of the structure was inconsistent and narrow and had not been fully applied over the peel ply area. In one small area, about 50 mm in length, it had not made contact with the inner frame at all (Figure 18).

A schematic cross section of this area of the frame showing the extent of the epoxy bond that should have been applied is at Figure 19. A schematic of the same section as found is shown in Figure 20.

Manufacturer's canopy frame assembly schematic with the epoxy bond area highlighted (left side looking towards the front of the aircraft)
