## **Wrong side signalling failure and derailment at Dalwhinnie, Badenoch and Strathspey 10 April 2021**

Report 11/2022  
September 2022

# Wrong side signalling failure and derailment at Dalwhinnie, Badenoch and Strathspey, 10 April 2021

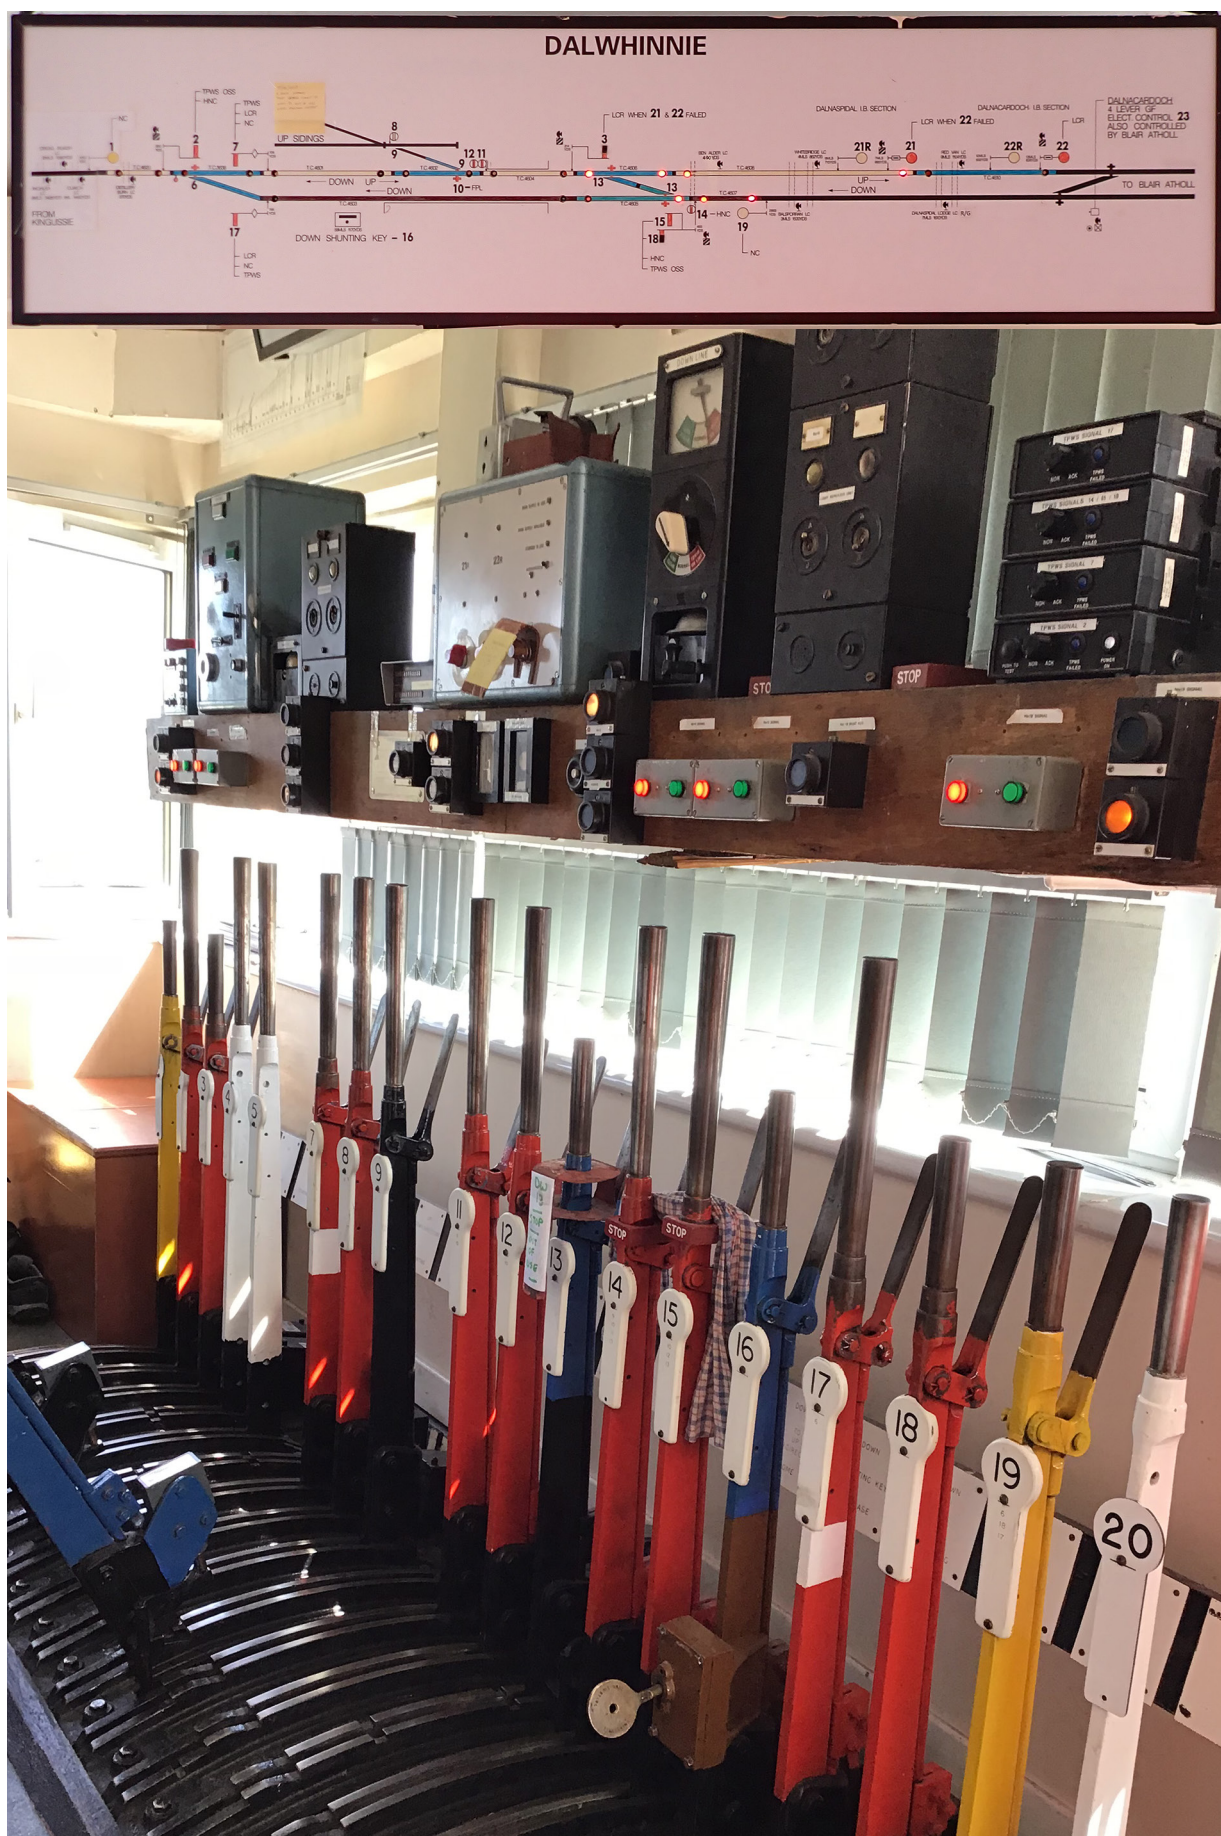
Figure 4: Signalling controls in Dalwhinnie signal box (main photograph courtesy of Network Rail)

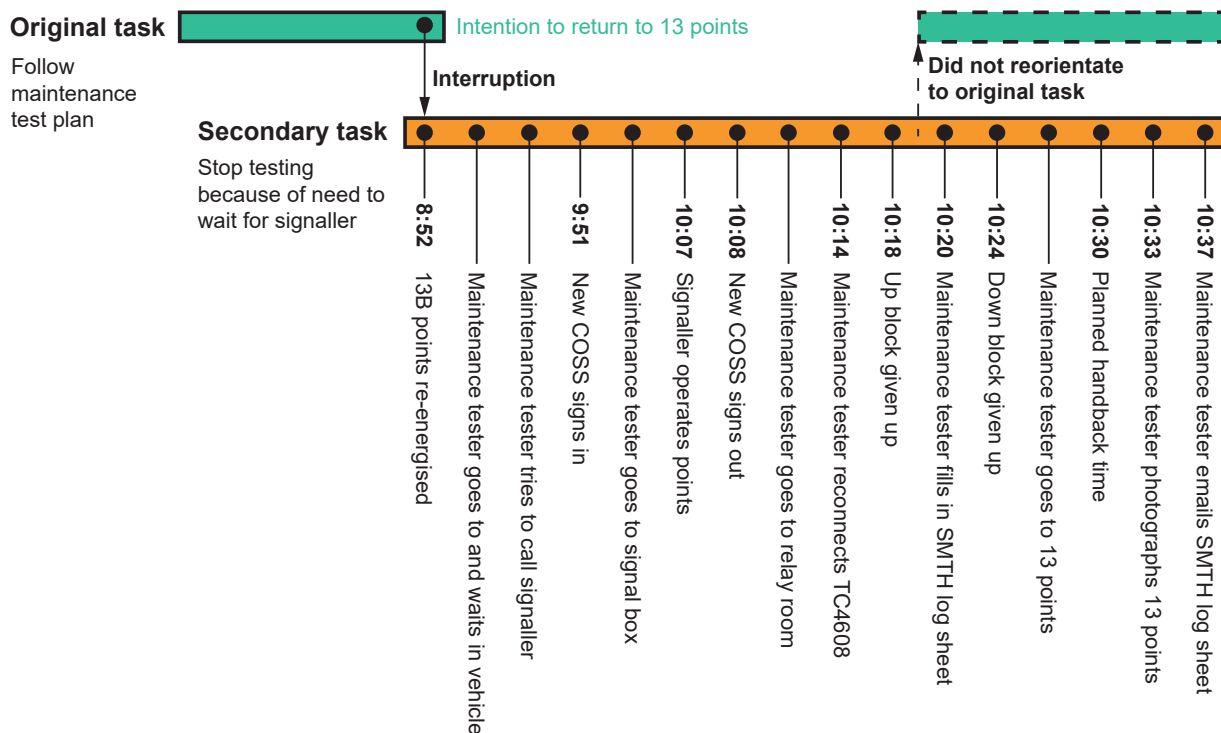
RAIB found a variety of evidence supporting that the interruption had likely captured the maintenance tester's attention and reasons for him not re-orientating correctly (see paragraphs 142 to 150). Figure 15 shows a timeline which summarises the relevant actions, and how they relate.

Figure 15: Timeline of events relating to the renewal of the 13B point machine and the interruption resulting from the need to wait for the signaller to book on duty

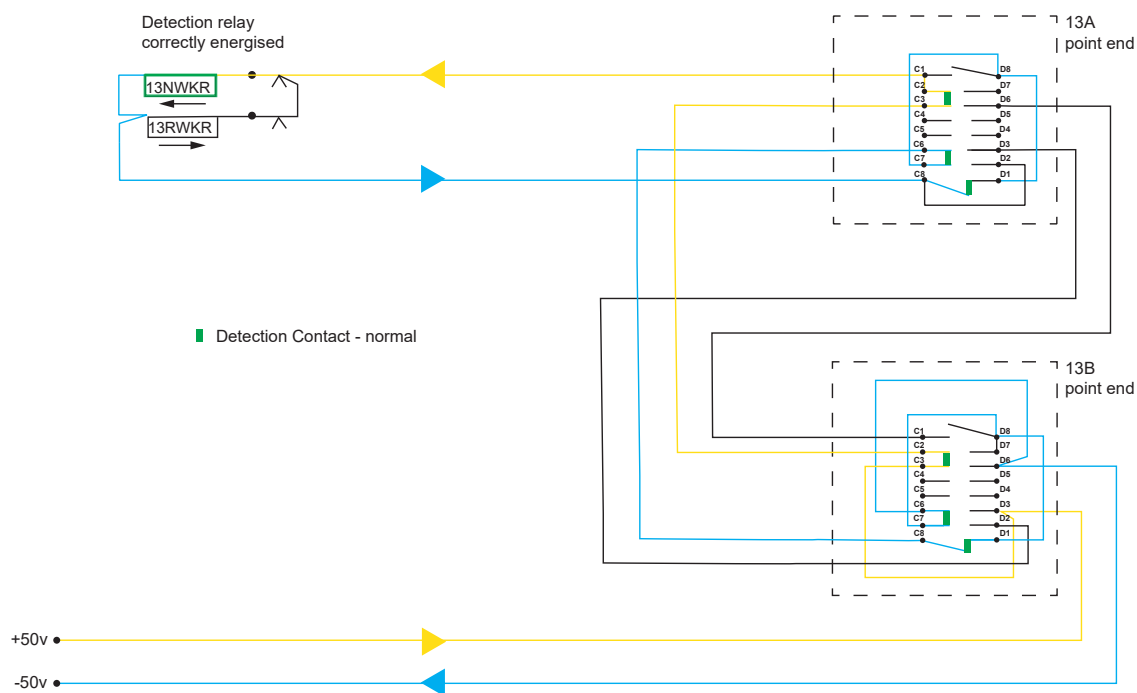
- B5 Figure B1 shows a simplified diagram of the detection circuit associated with 13 points. The detection contacts are contained inside the point machines and are wired in series between each point end. The detection contacts need to be made, in either the normal or reverse position, in both point machines for the appropriate detection relay (13NWKR or 13RWKR) to energise. This should only occur when the associated switch rails are in the correct position.

Figure B1: Simplified diagram of the detection circuit associated with 13 points as designed (showing switch rails detected in normal position at both point ends)

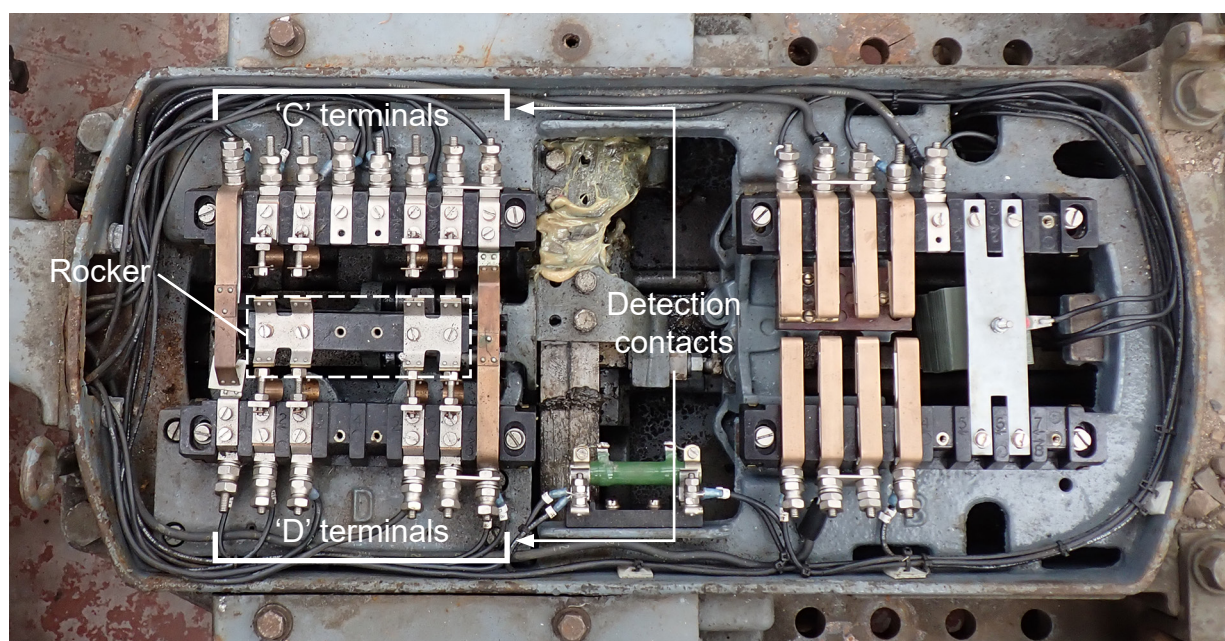
B6 On a GRS 5E type point machine, detection contacts comprise two metal H-shaped pieces which are attached to a rocker. The rocker moves from one side to the other side depending on the position of the switch rails. For 13 points, when detection is obtained in the normal position, the H-shaped pieces are in contact with fixed springs connected to the terminals designated by prefix 'C'; for detection in the reverse position, they are in contact with springs connected to terminals designated by prefix 'D' (figure B2). If detection is lost, a back contact of the appropriate detection relay energises the respective points calling relays (13ANWR and 13BNWR, or 13ARWR and 13BRWR) to command the points to move back to the required position, in an attempt to regain detection.

Figure B2: GRS 5E type point machine detection contacts
