Rail Accident Investigation Branch

Rail Accident Report

Near miss with track workers at Bookham Tunnel, Surrey 29 April 2025

Report 07/2026
June 2026

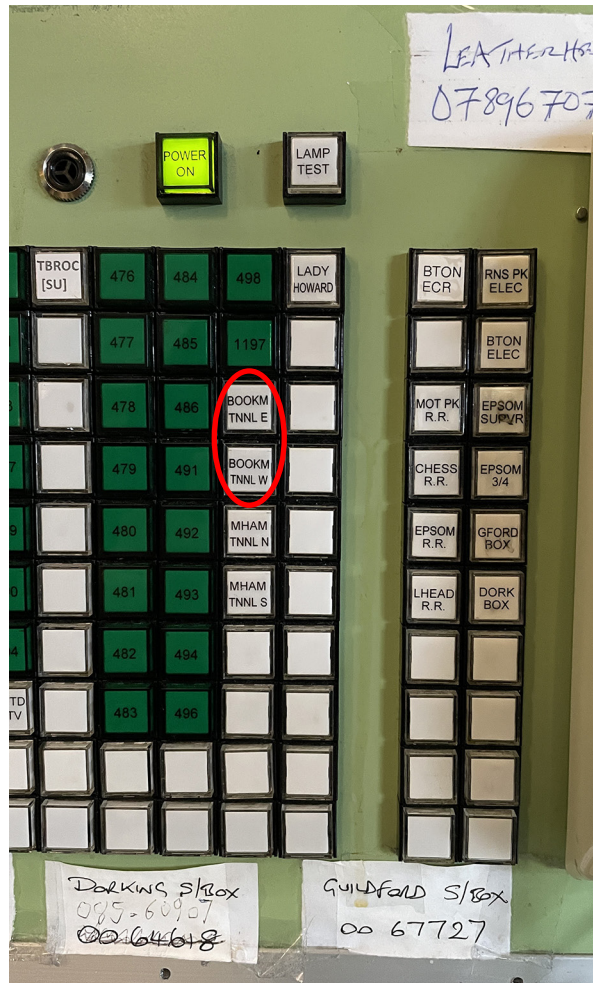
Figure 11: Phone concentrator on Wimbledon panel No.4 with Bookham Tunnel east and west telephone buttons highlighted.

- 109 The signaller was initially contacted by trackworker 1 at 10:56 to test the telephone at the western end of Bookham Tunnel (paragraph 53). When an incoming call is received from the Bookham Tunnel telephones, there is an audible ring on the concentrator phone, and the button labelled 'Bookm Tnnl E' or 'Bookm Tnnl W' flashes (figure 11). This indicates where the call is coming from. To answer the call, a signaller needs to lift the receiver and press the flashing button. Although the buttons on the concentrator for the two tunnels are positioned relatively close together on the concentrator (figure 11), the signaller was provided with information to show that the call was coming from Bookham Tunnel. The signaller saw the incoming call on the concentrator but did not immediately answer the call as they were busy. During the follow-up call, trackworker 1 also confirmed they were at Bookham Tunnel. The signaller and trackworker 1 spoke again on the Bookham Tunnel west telephone at 10:57.

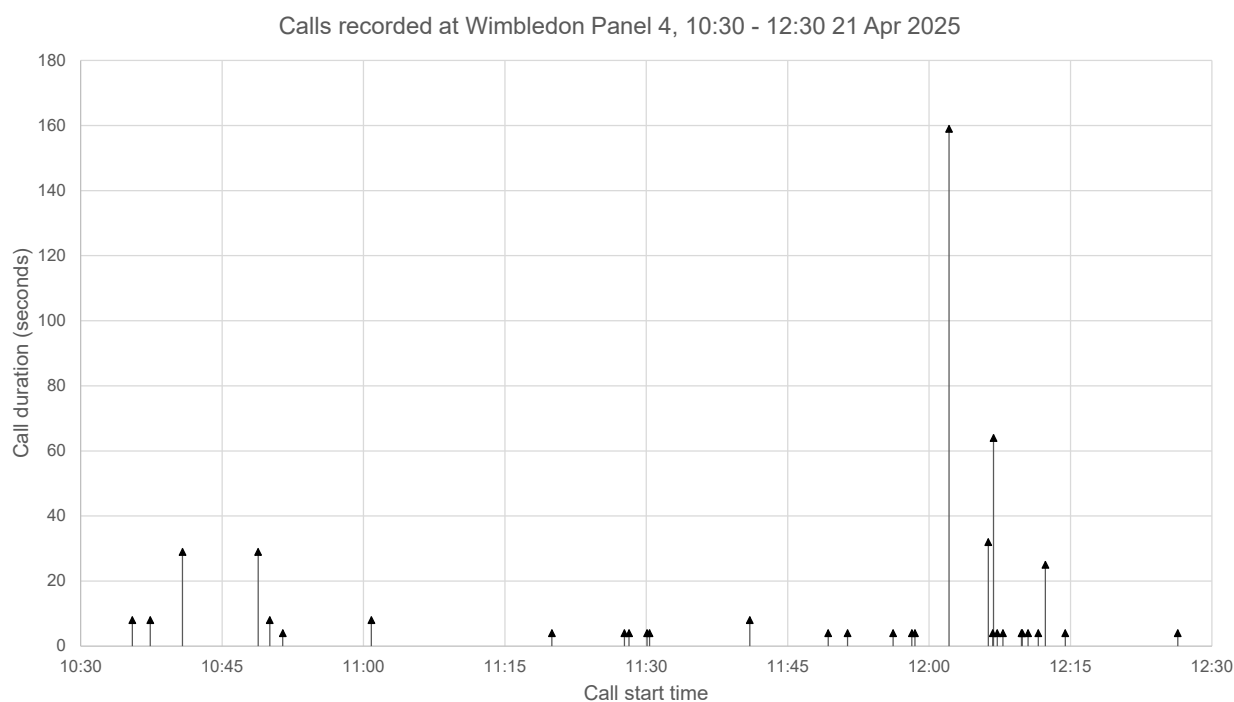
- 114 Witness evidence suggests that Tuesdays were seen as busy days for the signaller on duty at Wimbledon as they handled a greater number of preplanned requests compared to other days. This is supported by analysis of incoming calls to the signaller on the day of the incident, which showed an increased workload compared to any other day (figures 18 and 19). Although Network Rail had recently carried out an assessment of the signaller's workload at this control panel, it did not show any issues with signaller workload. This assessment had been done on a Wednesday.

Figure 19: Telephone calls being dealt with by a signaller on a typical day.
