ACCIDENT

Aircraft Type and Registration:	SB-5E glider, G-DEJH
No & Type of Engines:	None
Year of Manufacture:	1970 (Serial no: 5041A)
Date & Time (UTC):	7 August 2019 at 1303 hrs
Location:	Summit of Cross Fell, Pennines, Cumbria
Type of Flight:	Private
Persons on Board:	Crew - 1 Passengers - None
Injuries:	Crew - 1 (Serious) Passengers - N/A
Nature of Damage:	Destroyed
Commander's Licence:	BGA Glider Certificate with Bronze endorsement
Commander's Age:	15 years
Commander's Flying Experience:	69 hours (of which 2 hours were on type) Last 90 days - 21 hours Last 28 days - 9 hours
Information Source:	AAIB Field Investigation

Synopsis

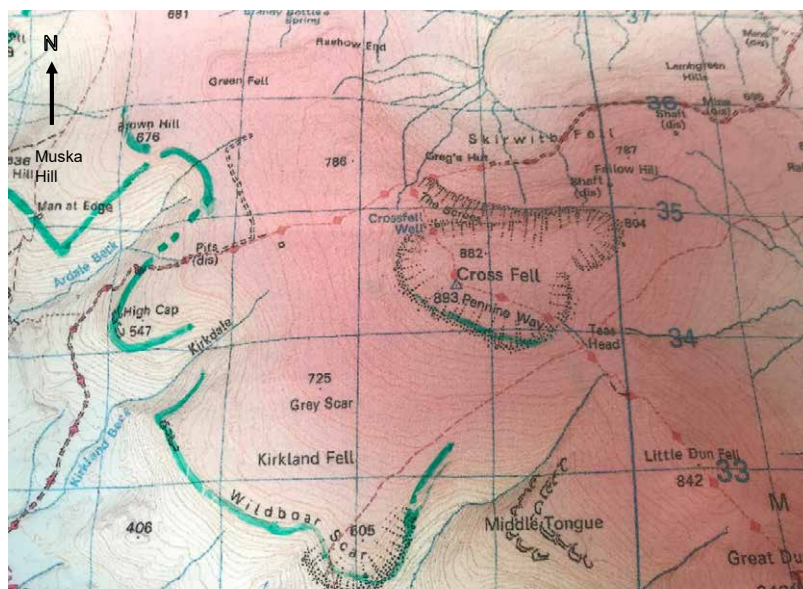
Figure 1

Ordnance Survey Map used for the briefing on the day of the accident

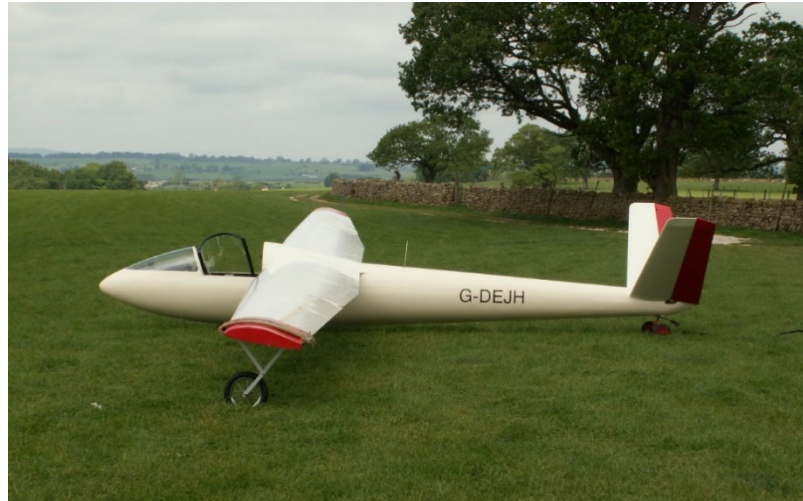
Figure 4

G-DEJH is a SB-5E single-seat, wooden glider with a distinctive V-tail (Figure 4). It was manufactured in 1970, imported to the UK in 1981 and the last logbook entry in April 2019 showed it had flown 2,261 flying hours. Following this accident only one other model of this type, an SB-5B, remained operational in the UK.

SB-5E glider, registration G-DEJH (Image used with permission)

It was observed that the ruddervators were not mass balanced and it was found that the centre of gravity (CG) was aft of the hinge line; this was later confirmed by the manufacturer to be by design.

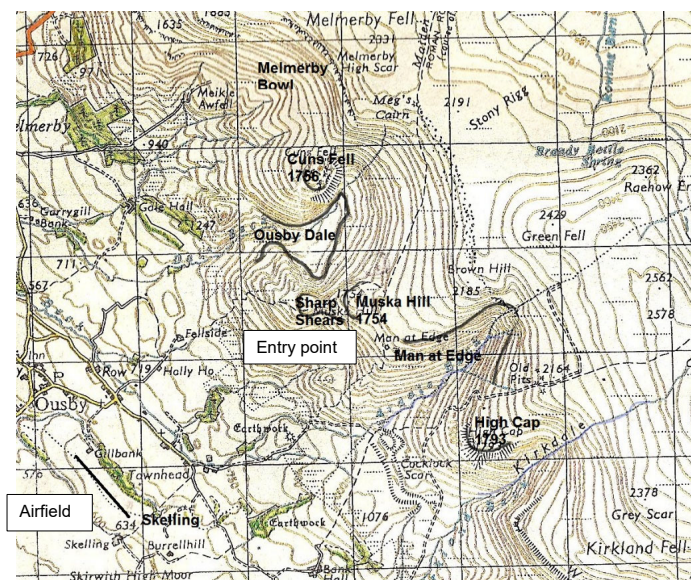
Figure 7

The gliding club operated from an unlicensed field (Figure 7), approximately 4 nm west-north-west from the summit of Cross Fell. The ridges used by the club lie beneath the summit of Cross Fell and are recognised as ideal, but challenging, due to the complex ridge structure¹⁵ and its gullies. After entering the area at Muska Hill, pilots are advised to be above 1,500 ft aal before either crossing in front of Man at Edge to the south, or into Ousby Dale to the north.

The ridge structure below Cross Fell
