Rail Accident Investigation Branch

Rail Accident Report

Fatal accident at Stratford London Underground station 26 December 2023

Report 01/2025
January 2025

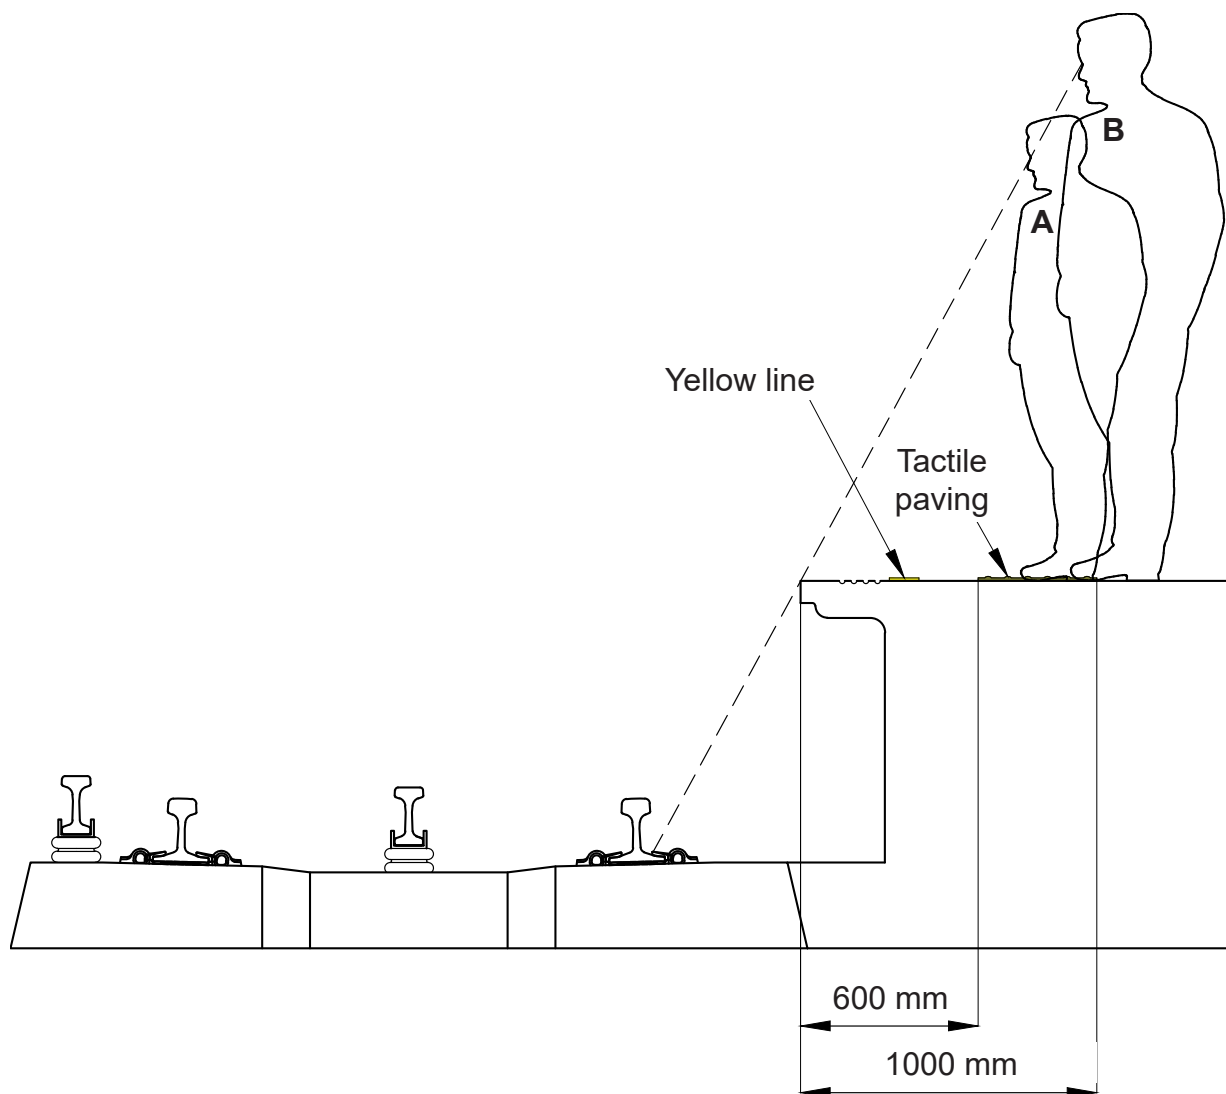
- 61 RAIB undertook a reconstruction to understand how visible the passenger on the track would have been to people on platform 13. Due to the location and orientation of the passenger, a person standing on the platform would need to be standing at, or near to, the platform edge to be able to see the passenger. The reconstruction showed that the distance from the platform edge that someone would be required to stand to see the closest running rail ranged from around 0.8 metres for someone who is 5 feet (1.52 metres) tall to 0.95 metres for someone who is 6 feet (1.83 metres) tall (figure 6).

Figure 6: Diagram showing sighting angles and distances of a 5ft (1.52 m) person (A), and a 6ft (1.83 m) person (B).

- 67 Station CCTV footage shows that TO2 entered platform 13 at 14:50 around 5 minutes after the passenger fell onto the track. On entering the platform, TO2 saw the passenger's bag and applied the standard TfL procedure for dealing with unattended property (paragraph 37). CCTV footage shows that TO2 did not look towards the track while doing this. As the bag was located around 1.5 metres from the platform edge, TO2 would not have been able to see the passenger even if they had looked towards the track at this point (paragraph 61 and figure 6). TO2 later stated that they were unaware of the passenger.
