Report on the investigation of  
the flooding and foundering of the stern trawler  
***Opportune (LK 209)***

approximately 36 nautical miles east of Lerwick, Shetland  
Islands, Scotland

on 24 March 2024

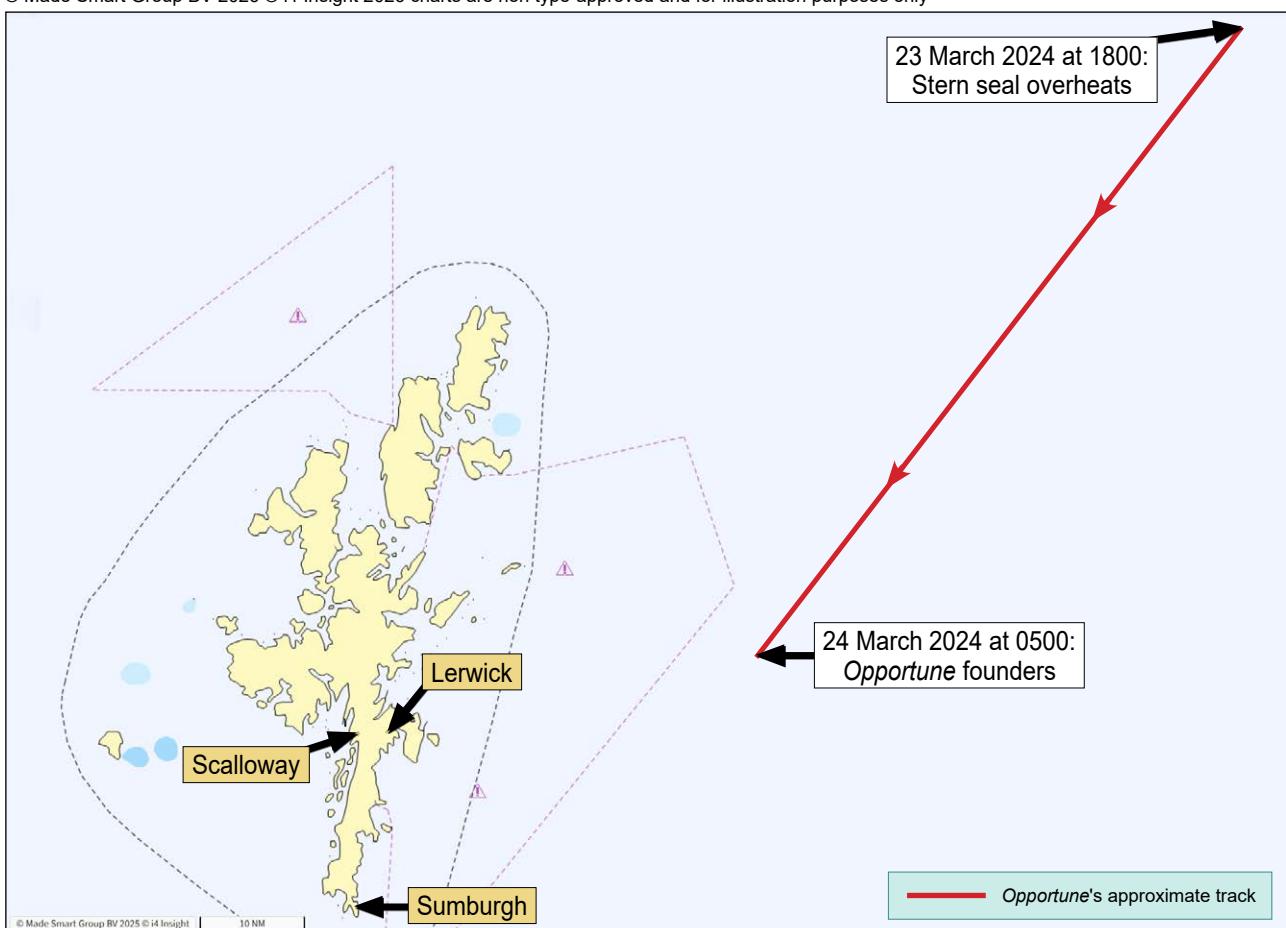
**Figure 1:** Position of *Opportune* when stern tube issues occurred and location of foundering

At about 1800 on 23 March, while hauling nets approximately 100 nautical miles (nm) north-east of Lerwick, Shetland Islands (**Figure 1**), *Opportune*'s tailshaft<sup>1</sup> high temperature alarm sounded in the wheelhouse. The mate went to the engine room to investigate and used an infrared thermometer to find that the stern seal was running hotter than the normal running temperature. The mate informed the skipper, who directed the crew to haul the fishing gear and then stopped the main engine to allow further investigation.

*Opportune* foundered approximately 36nm east of Lerwick, Shetland Islands in over 100m of water (**Figure 1**). The wreck was not examined by the investigation due to its remote location. The owner's records for *Opportune* were kept on board and were lost when the vessel sank.

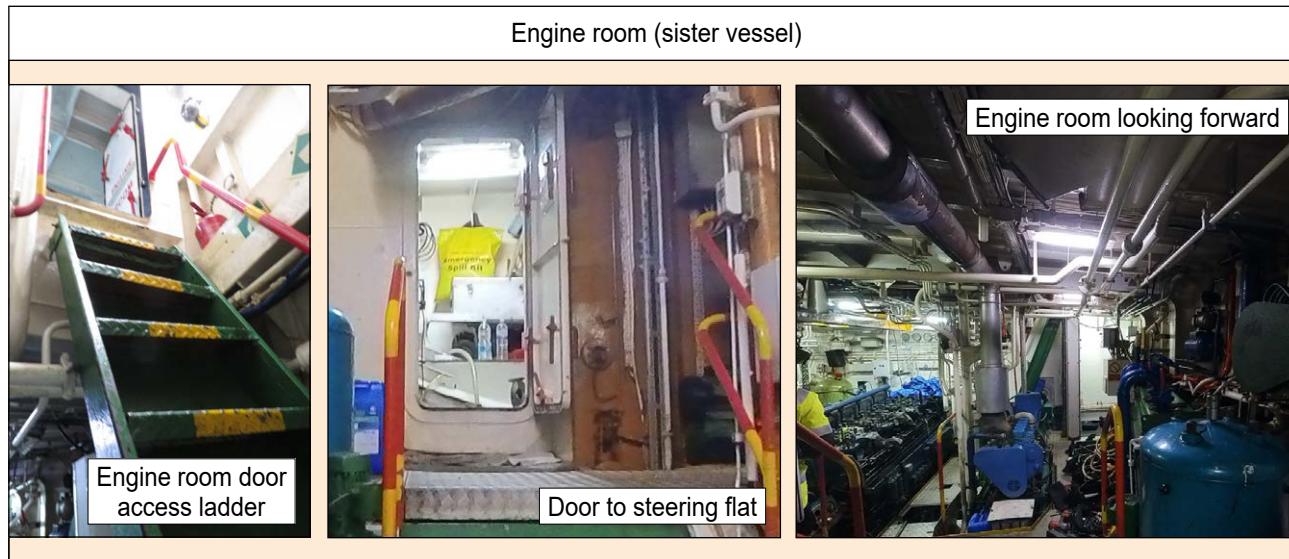
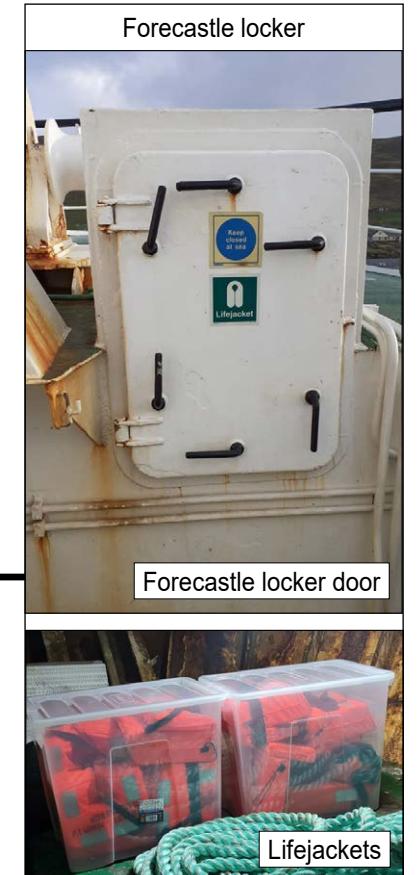
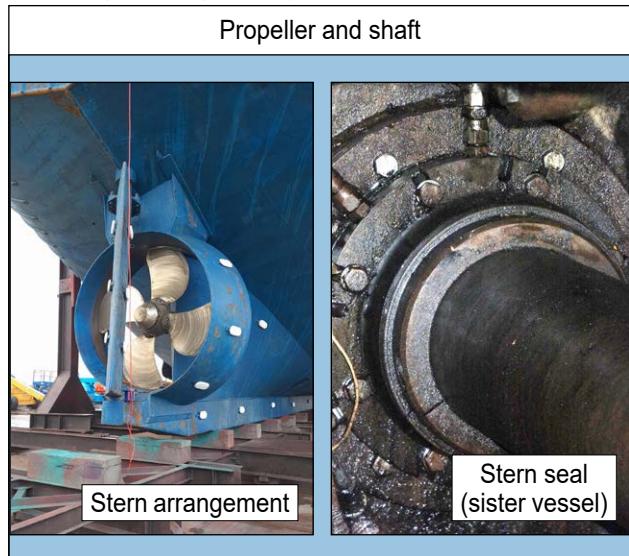
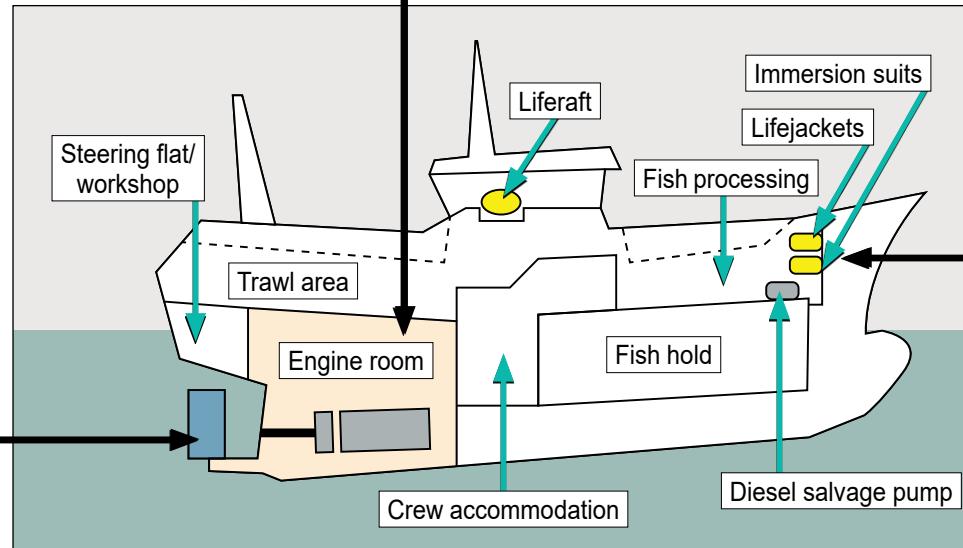
Figure 2: *Opportune*'s general arrangement

*Opportune*'s engine room was located below the main deck, at the stern (**Figure 2**). The engine room was the largest compartment on board and most of the space was below the waterline. The engine room had forward and aft entrances accessed from the main deck via watertight doors. The steering flat/workshop was situated aft of the engine room and accessed via a watertight door in the aft engine room bulkhead; this door was normally left open.

*Opportune* was fitted with a single main engine that operated through a gearbox to drive a four-blade variable pitch propeller. The propeller was located inside a nozzle positioned immediately in front of the vessel's rudder (**Figure 2**). The port and starboard electrical generators were located on either side of the engine room on top of the freshwater tanks, which created a well under the main engine.
