Rail Accident Investigation Branch

# Rail Accident Report

## **Freight train derailment at Sheffield station 11 November 2020**

Report 07/2021  
October 2021

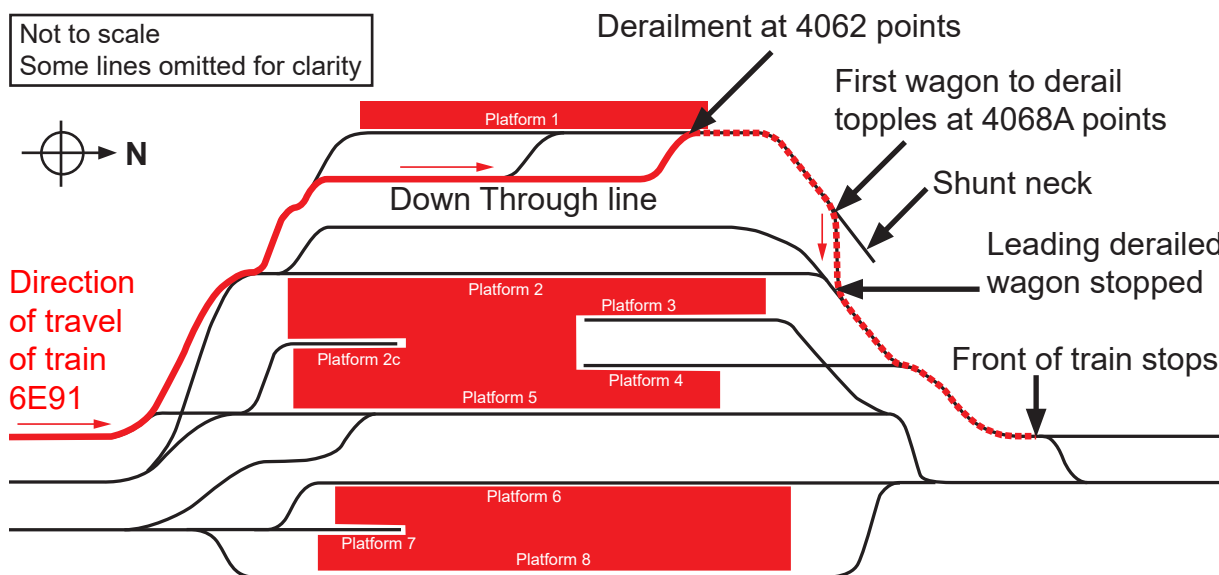
Figure 4: Track layout at Sheffield, showing the route of the derailed train

4 The accident occurred within 4062 points at 158 miles 52 chains,<sup>1</sup> at the north end of Platform 1 in Sheffield station. At this location, the Down Through line joins the Platform 1 line (figure 4).

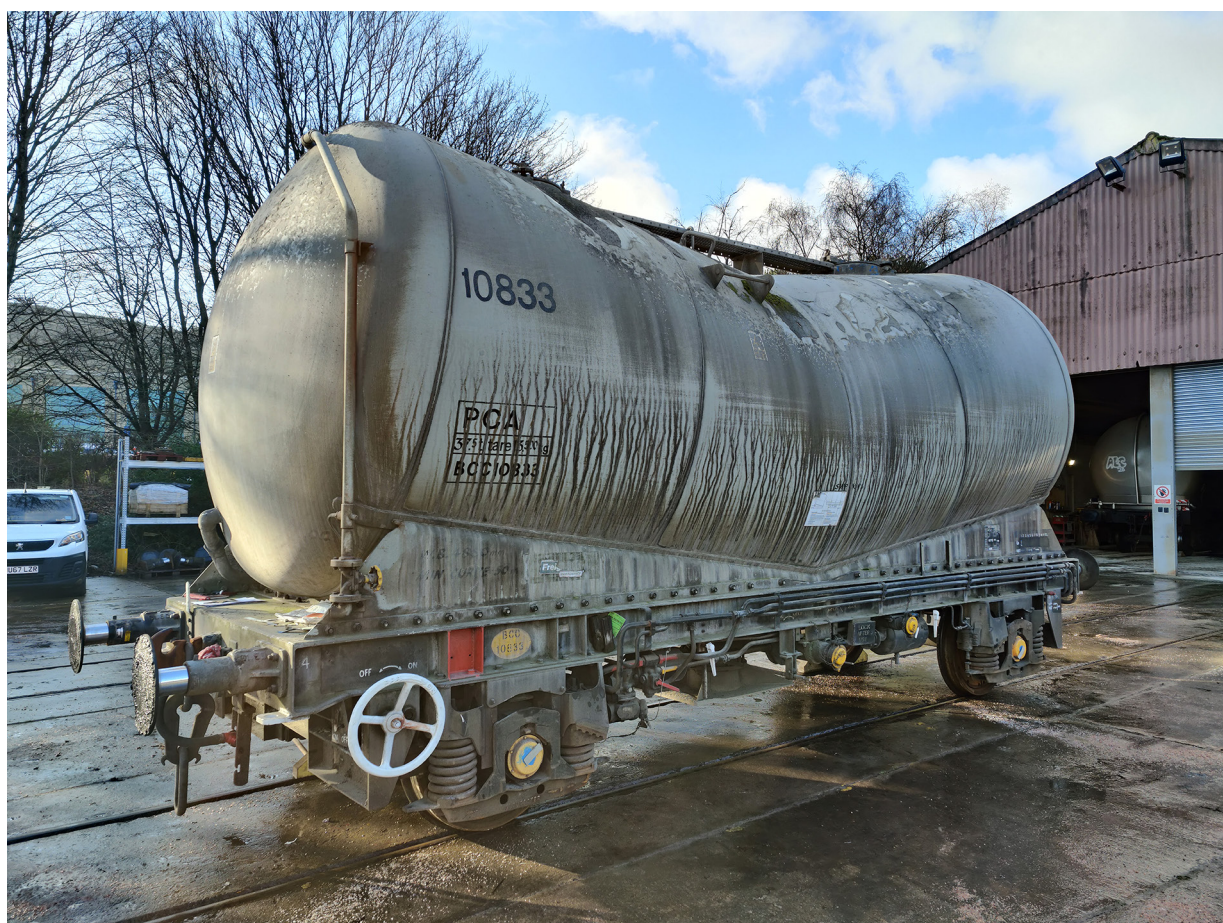
Figure 5: PCA cement tank wagon

- 11 The PCA wagons in the train were part of a fleet of wagons that were built in the UK between 1981 and 1987. These are two-axle wagons each consisting of a frame that supports a mild steel tank which is used to carry cement powder. These wagons have a gross weight of 51 tonnes when laden and weigh around 13 tonnes when empty. The wheelbase of each wagon is 4.88 metres.
- 12 RAIB found no evidence of any significant defects in the wagons or their suspensions after the derailment.

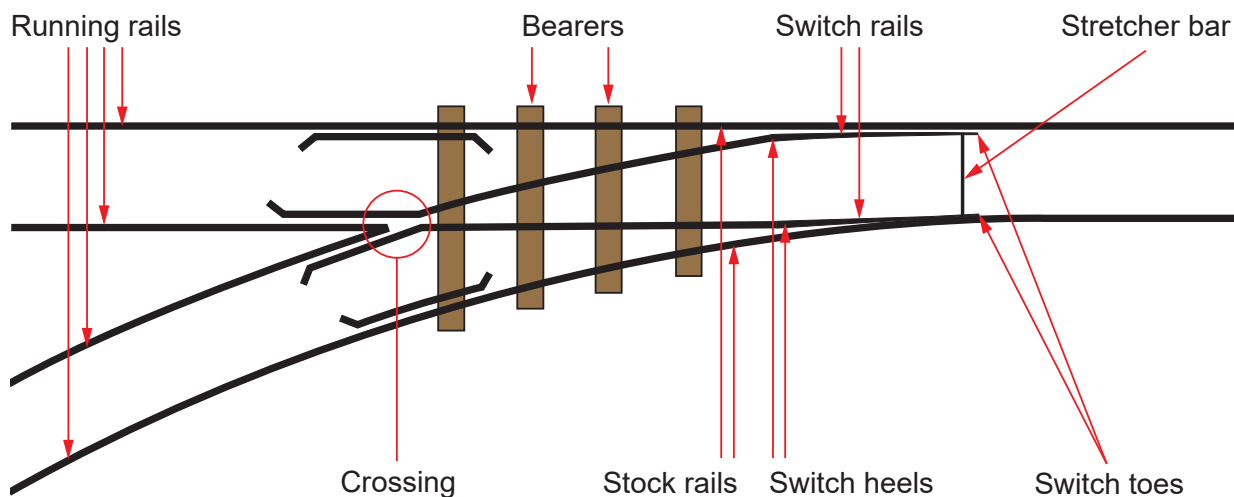
Figure 7: Sketch showing the component parts of a set of points (switch and crossing)

- 20 As the twelfth wagon in the train passed through 4062 points, its leading wheelset derailed, with the right-hand wheel (in the direction of travel) dropping into the gap between the two rails (known as the 'four-foot'), due to the distance between the rails (or 'gauge') having become too wide (figure 6). This occurred between the crossing and the switch rail of 4062 points (figure 7).

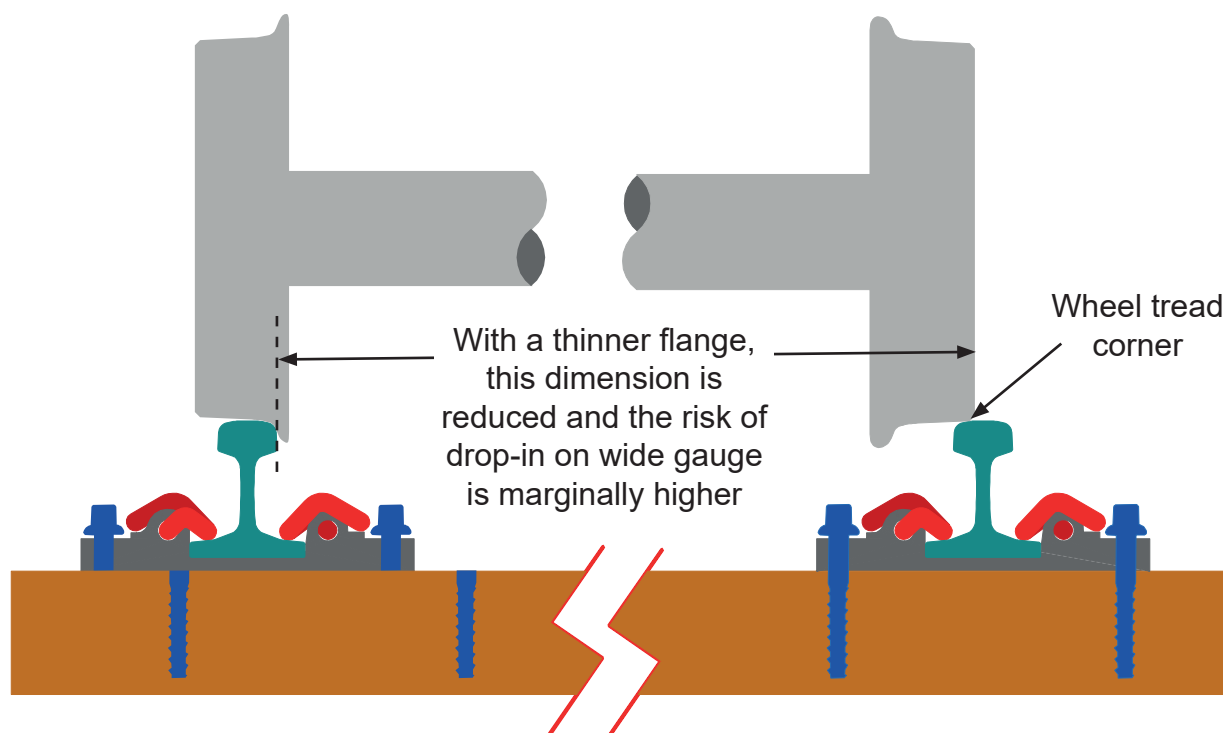
Figure 11: Illustration of the possible effect of a narrower wheel flange

- 35 It was noted that the wheel flanges on the left-hand wheels on both wheelsets were slightly thinner than those on the right-hand wheels (figure 10). However, they were all well within the acceptable maintenance specification limits. It is possible that a thinner left-hand wheel flange could result in the wheelset being positioned slightly further to the outside rail on a right-hand curve, such as at the point of derailment. This means that the associated wheel tread corner on the right-hand wheel would also be positioned slightly closer to the four-foot on the right-hand rail, and so be fractionally more at risk of derailment (figure 11). The estimated difference in position on the twelfth wagon is only about 1-2 mm.

- 36 Wagon 12 ran in the same train, in the same orientation, and by the same route through Sheffield station, on the two nights prior to the derailment. This suggests that the slightly thinner wheel flanges were unlikely to be a significant factor in the derailment.
- 37 RAIB also examined wagons 10, 11 and 13 and found no defects. In addition, the maintenance records indicated that maintenance activities for all the wagons inspected had been carried out by their due dates and that there were no outstanding defects.
- 38 RAIB obtained data from the wheel impact load detector system at Grindleford, that the train had passed over between Hope and Sheffield. This recorded no abnormal weight distribution that would indicate uneven loading or a problem in the wagons' suspensions.

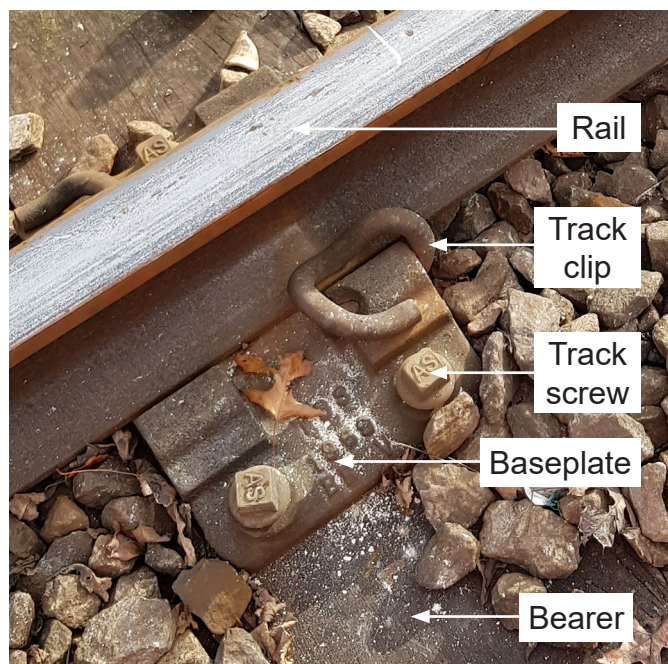
Figure 12: Illustration of rail secured to bearer by baseplates, clips and track screws

#### **40 Multiple track screws securing the rail baseplates to the bearers had failed prior to the derailment.**

- 41 The track at the derailment location, inside the length of 4062 points, consisted of flat-bottomed rail held on metal baseplates by spring 'Pandrol' type clips (figure 12). Each of the baseplates was secured to timber bearers by three track screws, with most of the baseplates having two track screws on the four-foot side of the rail, and the third on the outside.

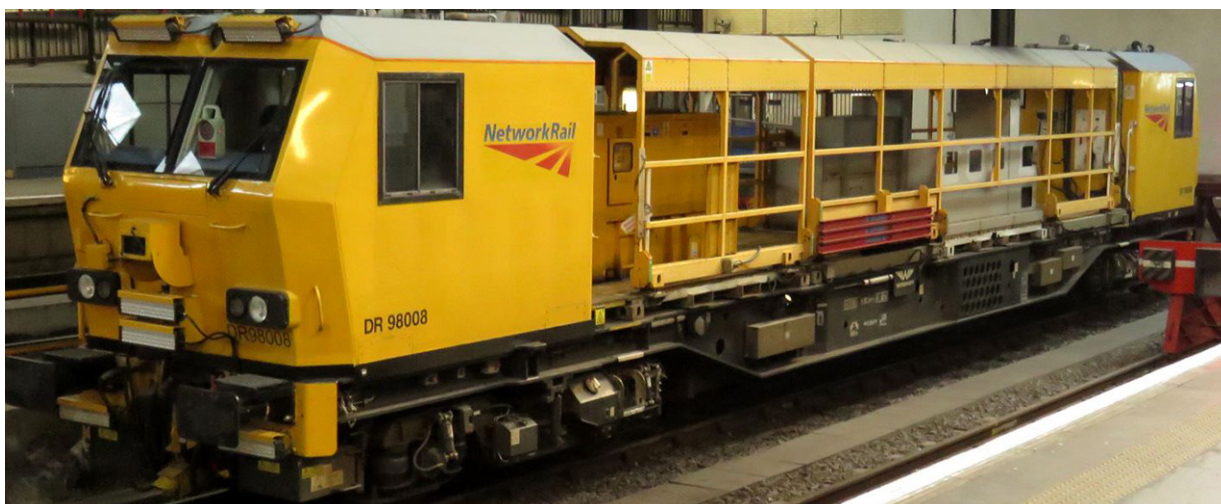
Figure 18: Network Rail's MPV based track recording vehicle (image courtesy of Brian Creasey)

**73 No dynamic geometry measurements had been recorded at 4062 points for 15 months prior to the derailment. This is a probable factor.**

- 74 'Dynamic track geometry' is a term used to describe the geometry of track as trains pass over it, and so includes any changes resulting from the wheel loading from a train. Network Rail uses track measurement trains to measure dynamic track geometry across the network on a routine basis. However, most of these are unable to record some characteristics, for example gauge, at low speed, and they only take a single defined route when passing through stations. As a result, there are many areas in stations and other locations with complex track layouts where dynamic geometry does not get fully recorded by the track measurement trains. Network Rail has a single multi-purpose vehicle (MPV) that is equipped to be used for dynamic geometry measurement in such locations (figure 18).

- 75 The MPV was scheduled to visit Sheffield station every three months, to record the track geometry for all through lines and terminal platforms. However, no recording runs had been made by the MPV since November 2019, because it had been out of service for overhaul and upgrading.

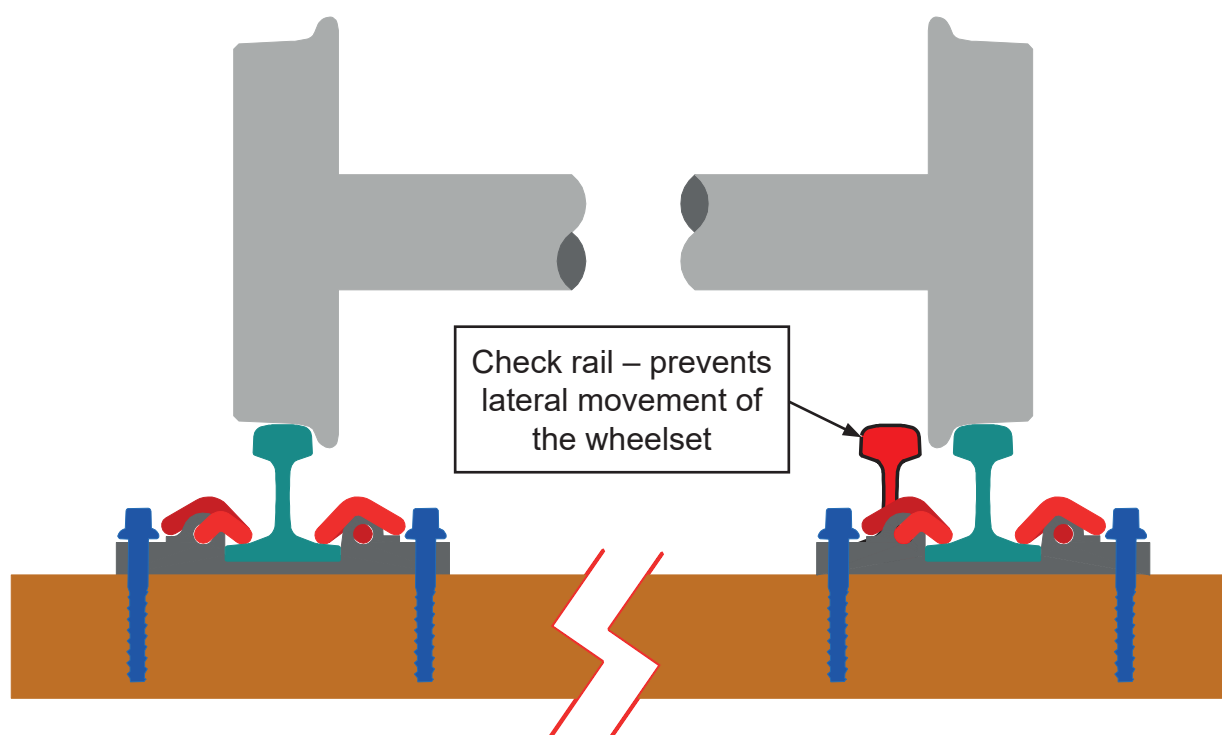
Figure 20: Illustration of a check rail on the inside rail of a curve

**102 The design of 4062 points did not include the fitment of a check rail at the sub-200 metre radius curve between the crossing and the heel of the switch.**

- 103 A check rail is a component provided alongside a running rail to assist guidance to flanged wheels by restricting their lateral movement (figure 20). It is normally used on tight curves to manage derailment risk and is positioned on the four-foot side of the inner rail of a curve.
