# Rail Accident Report

## **Collision between passenger trains at Salisbury Tunnel Junction, Wiltshire 31 October 2021**

Report 12/2023  
October 2023

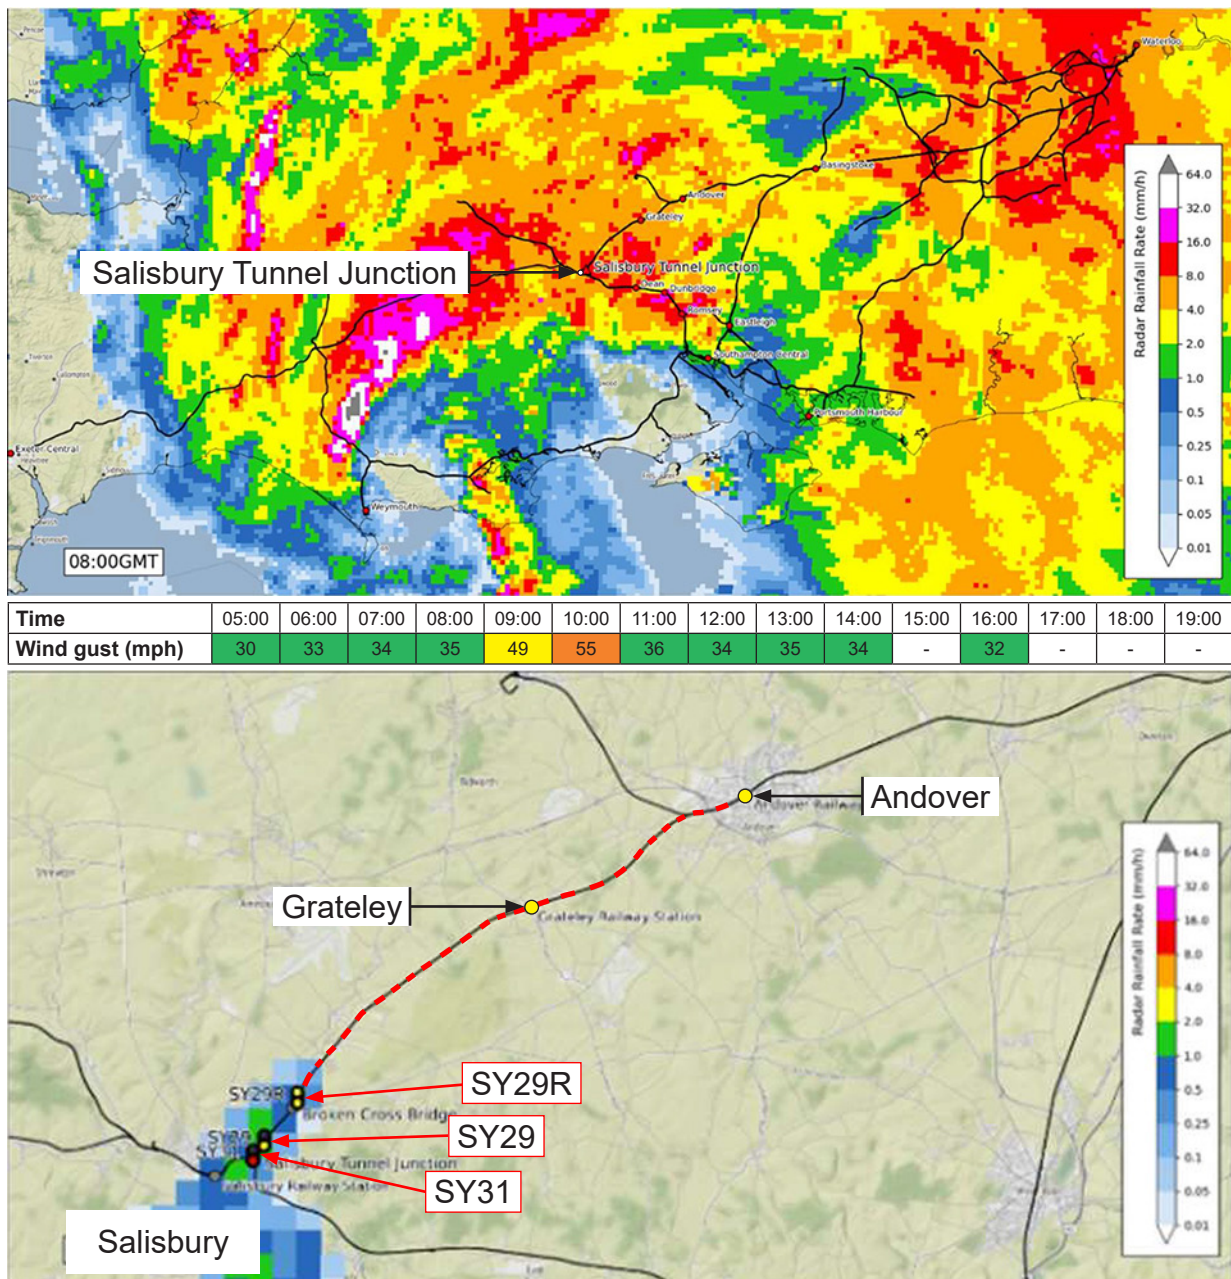
- 46 After the weather front had passed, the area remained windy for the rest of the day with peak wind gusts of approximately 23 to 37 mph (37 to 60 km/h). Between 18:35 and 18:40 hrs, radar imagery showed a band of drizzle passing over the Up and Down Main lines in the area of Salisbury Tunnel Junction, just before the passage of train 1L53 (figure 6).

Figure 6: Met Office radar image (top) showing weather front for 31 October 2021 with wind gust speeds (middle) and macro radar image (bottom) showing the weather front passing over the Salisbury area and railway line (moving south-eastwards) between 18:35 and 18:40 hrs, in relation to the location of signals SY29R to SY31 (© Crown copyright 2023, the Met Office).

- 135 Wet wheel/rail adhesion levels on a contaminated railhead are significantly lower than dry adhesion levels. The wheel/rail adhesion conditions encountered by train 1L53 would have been adversely affected by a band of drizzle which passed over the Salisbury area between 18:35 and 18:40 hrs (figure 6), around five minutes before the train approached Salisbury Tunnel Junction. This also meant that train 1L53 probably saw significantly reduced wheel/rail adhesion compared to the two previous trains that had been required to stop at signal SY31 (see paragraph 178).

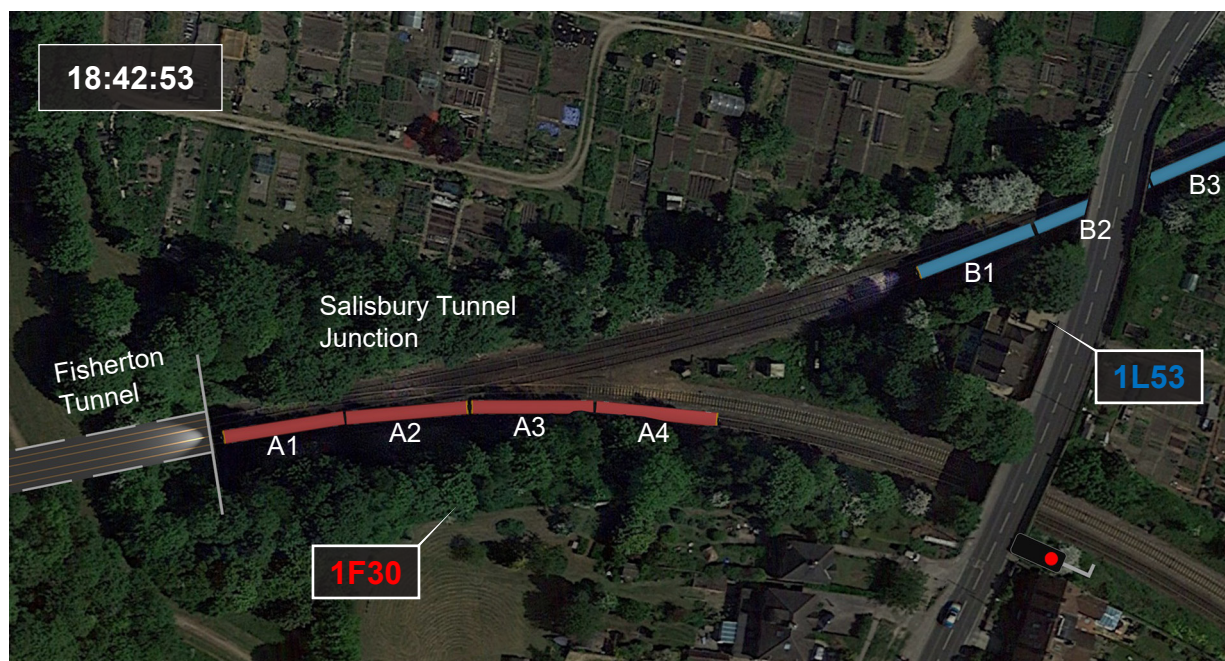
- 68 The driver of 1L53 saw train 1F30 appear from the left and move into the path of his train. Believing there was little he could now do to prevent a collision, he got out of his seat with the intention of exiting the cab into the saloon. However, in doing so, he tripped over his bag, and fell onto the floor just before the collision occurred (figure 9).

Figure 9. Diagram showing train 1L53 (carriages marked as B1 to B3) and train 1F30 (carriages marked as A1 to A4) immediately before the collision.

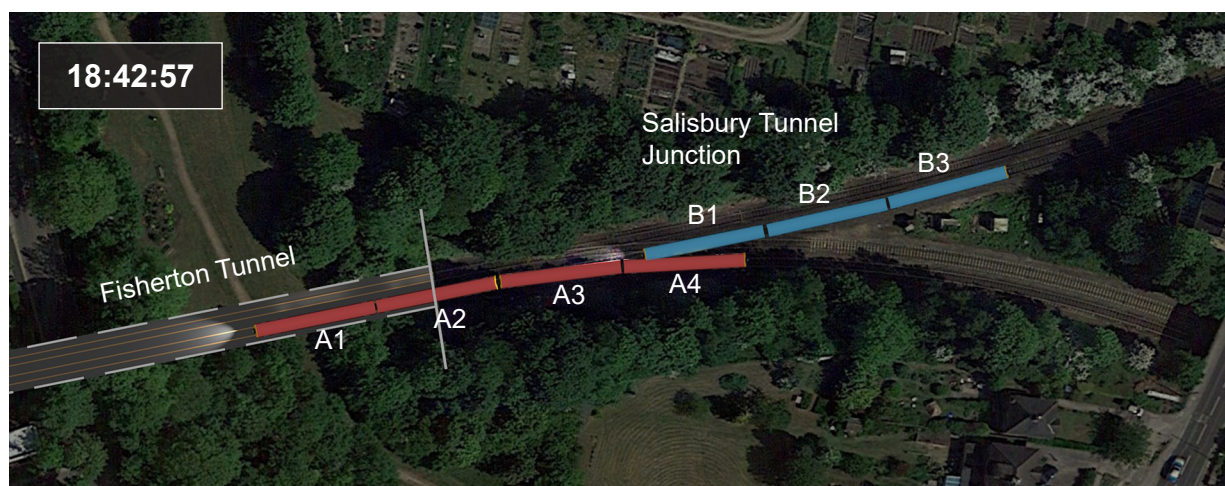
- 69 As train 1F30 was entering Fisherton Tunnel, train 1L53 collided with its right-hand side, near the front of the fourth carriage (figure 10). Evidence from the OTDR on train 1L53 suggests that the collision occurred at 18:42:57 hrs, with train 1L53 travelling at a speed of approximately 52 mph (84 km/h). The OTDR on train 1F30 recorded its speed as being around 20 mph (32 km/h) at the time of the collision.

Figure 10: Diagram showing train 1L53 colliding with train 1F30.

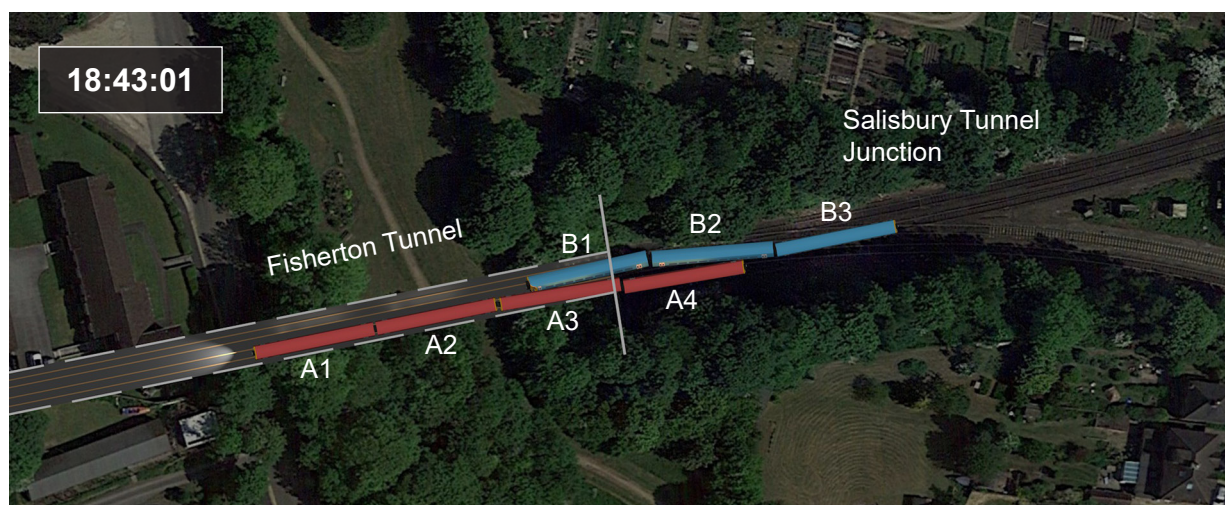
- 70 The 32 mph (51 km/h) speed differential between the two trains meant that train 1L53 travelled forwards in heavy contact along the right-hand side of the fourth carriage of train 1F30. It then continued along the right-hand side of the third carriage, with the leading left-hand edge of the cab of train 1L53 embedding itself in the front end of this carriage (figure 11).

Figure 11: Diagram showing trains 1L53 and 1F30 derailed into Fisherton Tunnel.

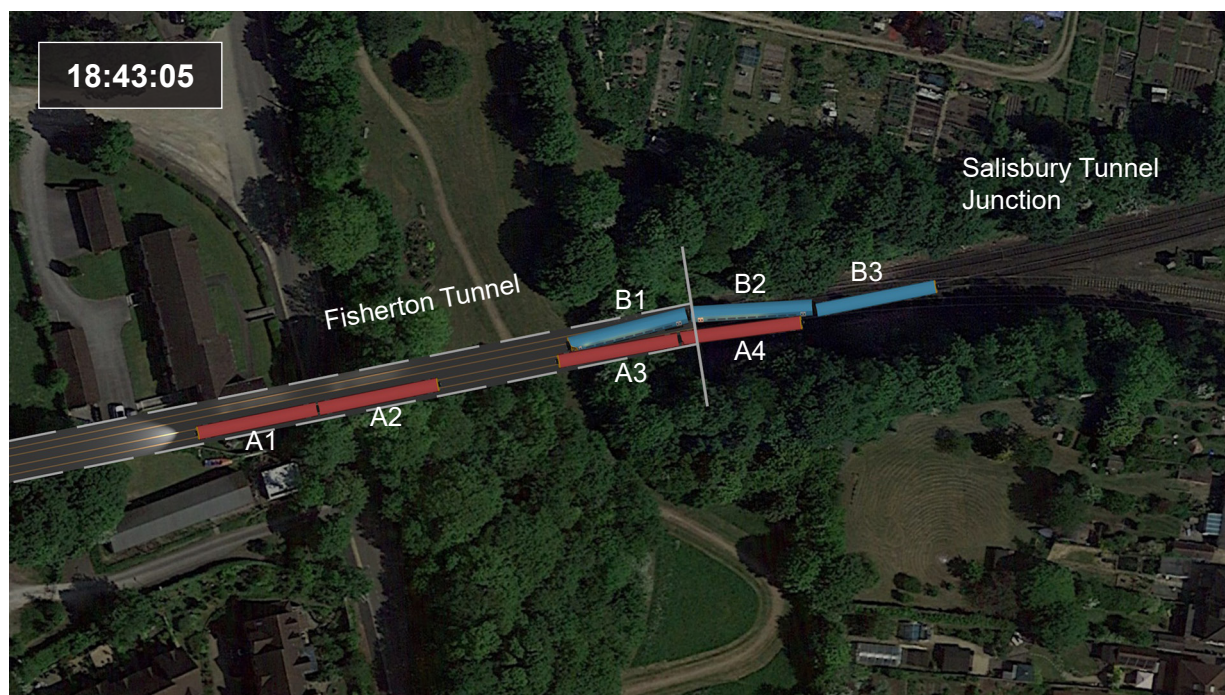
- 72 Both trains travelled into Fisherton Tunnel, with the tunnel walls acting to keep the carriages upright. The rear two carriages of train 1F30 and all carriages of train 1L53 derailed, with the cab of train 1L53 being severely damaged. The front carriage of train 1L53 came to rest adjacent to the leading end cab of the third carriage of train 1F30 (figures 13 and 14).

Figure 13: Diagram showing carriages A2 and A3 separated within Fisherton Tunnel.

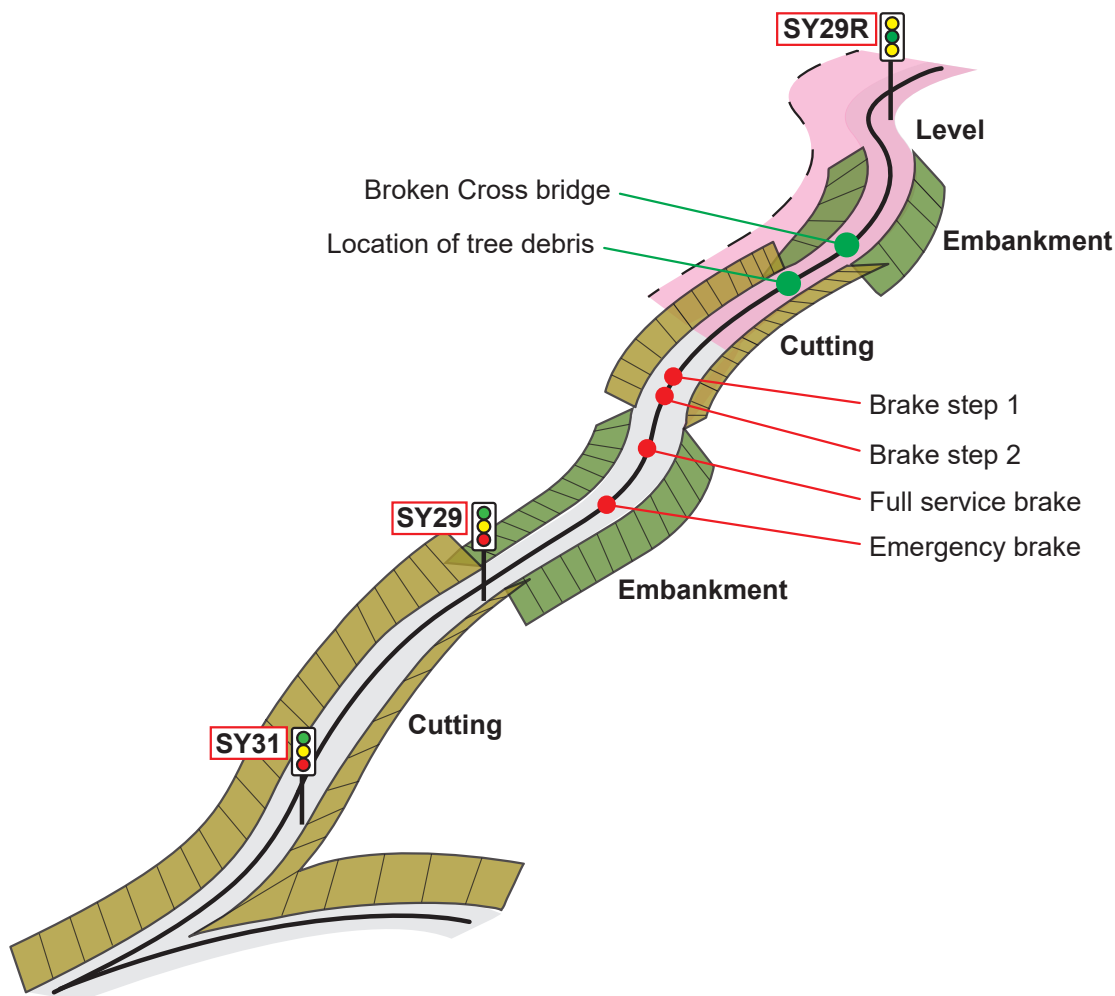
Figure 16: Topography data showing the embankment/cutting profiles, including the previously classified high risk of low adhesion site (pink shaded area - see paragraph 143), the location of Broken Cross bridge, tree/associated debris (green dots), the braking points of train 1L53 (red dots) and signals.

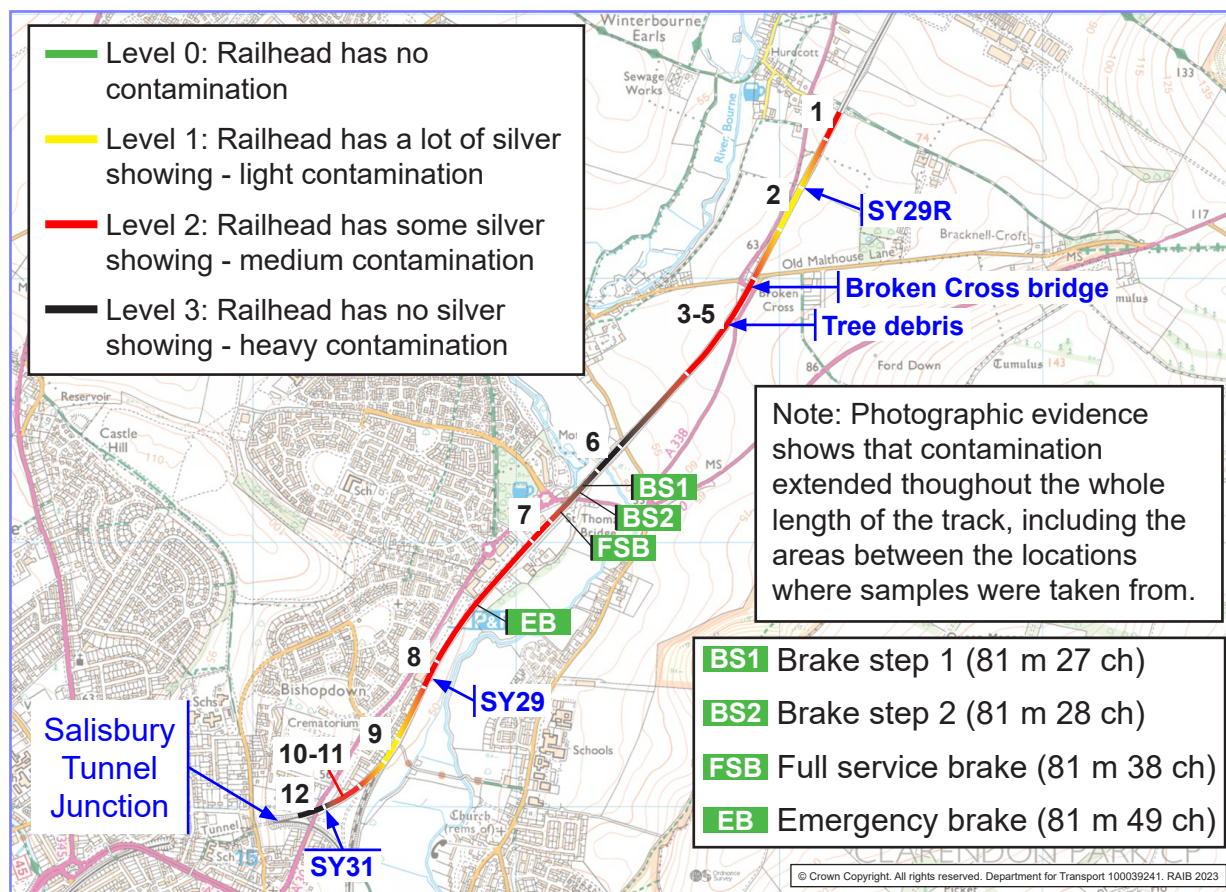
130 When RAIB deployed to the site of the accident on the night of 31 October 2021, its inspectors undertook an initial visual examination of the Down Main line on the approach to the accident site. The railhead generally showed signs of medium contamination (level 2), but with some evidence of heavy contamination (level 3), where the driver started braking and on the immediate approach to Fisherton Tunnel. Comparison with the guidance given in Wessex route's autumn working arrangements document for assessing contamination indicated that the levels of contamination found on the approach to the braking zone used by train 1L53 and on the approach to Fisherton Tunnel would be likely to have resulted in low to very low adhesion (paragraph 84 and figure 24). All the contamination found was comparable with that expected from successive train wheels crushing leaf material and other contaminants onto the railhead, building up the thickness of contamination in layers (paragraph 82). Testing undertaken in 2006 suggested that a significant percentage of any railhead contamination would be removed by water jetting (paragraph 83 and see paragraph 245). As such, much of the contamination would have been a result of the weather conditions since the last railhead treatment MPV run (see paragraph 133) coupled with a high density of vegetation and topography on the various sections of the Down Main line (see paragraph 136).

131 RAIB commissioned the University of Sheffield to conduct a detailed tribology (friction) survey at 12 sample locations over 3.3 km on approach to the accident site (figures 24, 25 and 26). This survey took place on 3 November 2021, while the line remained closed and undisturbed. Measurements and samples were taken under wet and dry conditions. In dry conditions, values of the coefficient of friction were measured as being between 0.09 and 0.35, while for wet conditions the values were measured as being between 0.02 and 0.20. The University of Sheffield also noted that *'most wet values for the contaminated rail head samples that were analysed were below those required for effective braking'*.

Figure 24: Post-accident sample locations and (below) Network Rail classification of contamination levels (NR/L3/OPS/045/4.07).

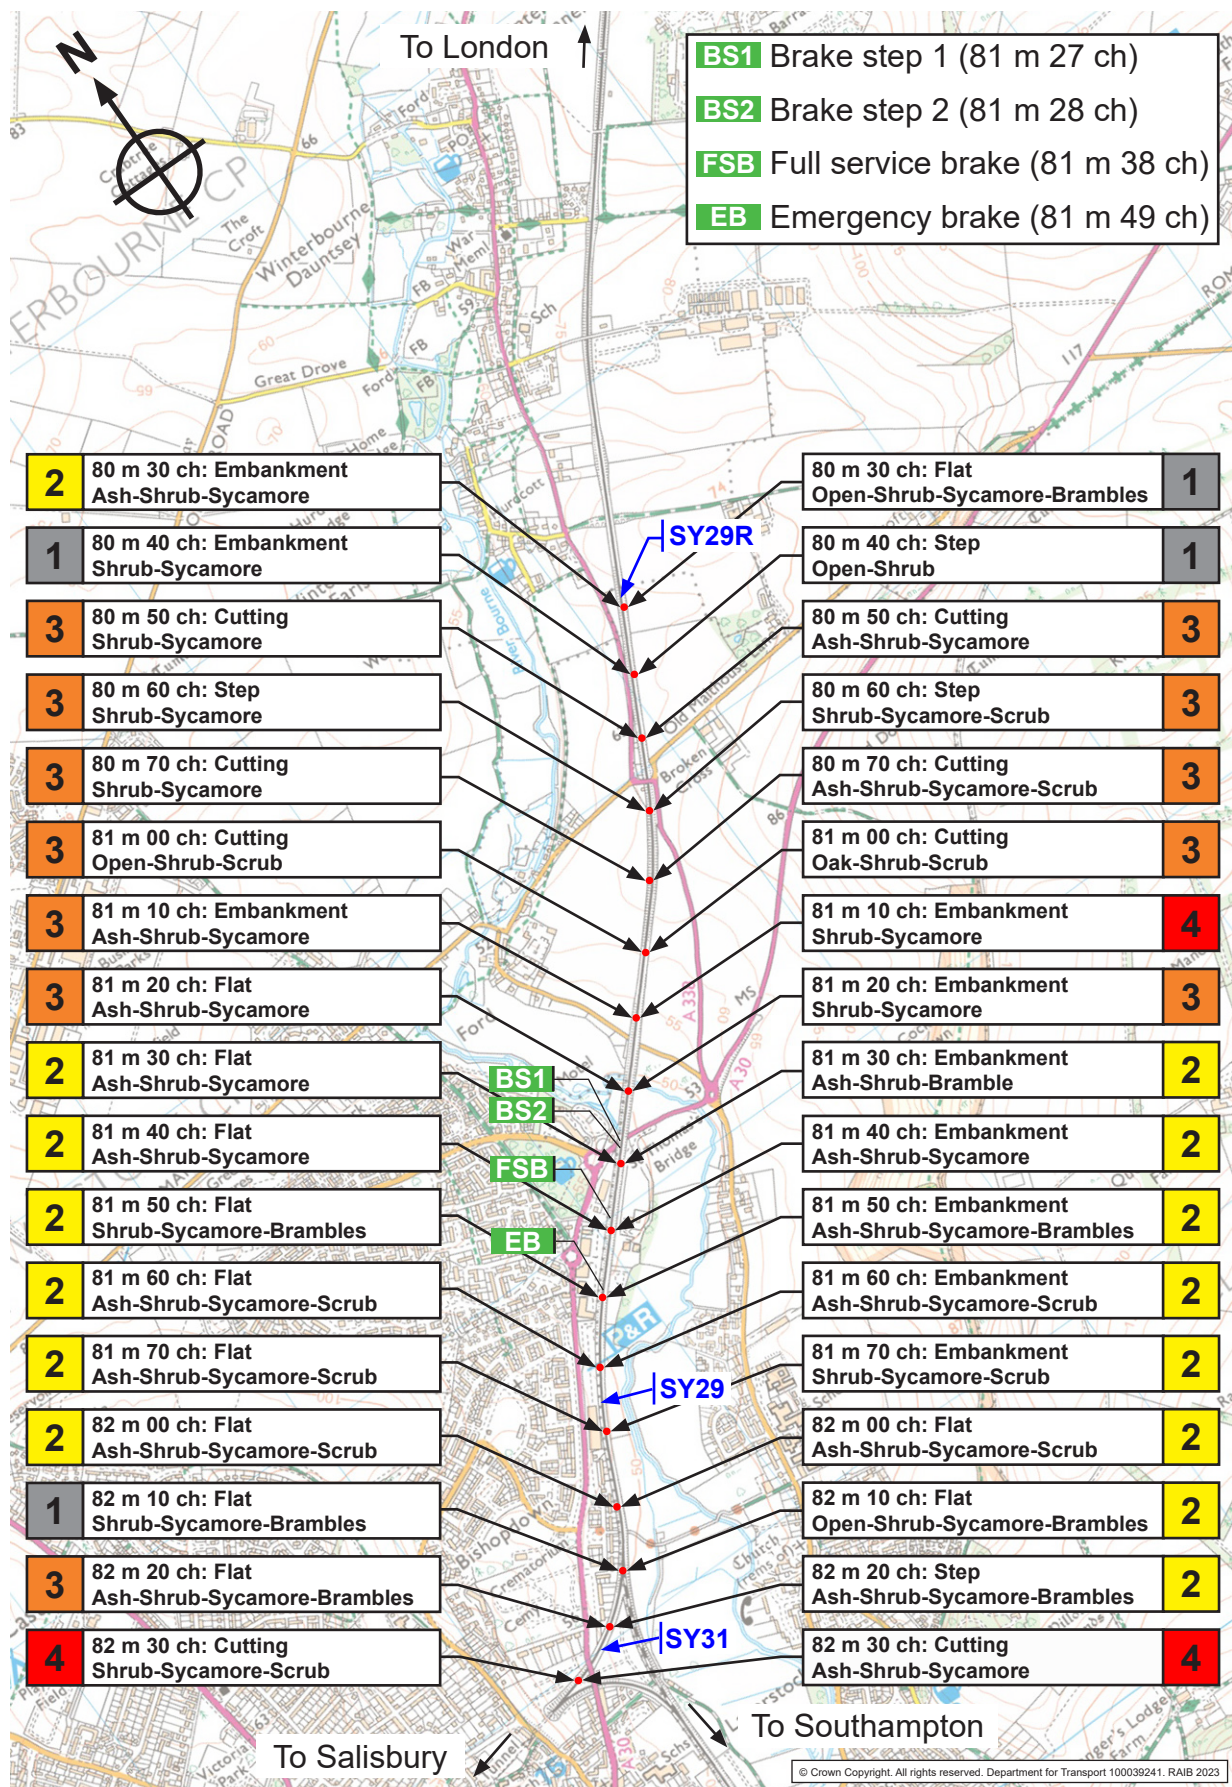
- 146 In June 2021, arboriculture specialist contractors undertook a further leaf fall inspection of the Down Main line. The results from this assessment showed the presence of several level 4 sites between 80 miles 30 chains and 82 miles 30 chains but no level 5 sites (figure 29). The risk scores resulting from this inspection for the sites that had previously been identified on the Down Main line in 2018 and 2019 as level 4 or level 5 were scored at lower levels. Of particular note was the section around 80 miles 30 chains. This was reassessed as a level 1 site having previously been scored as a level 5 site. This scoring meant that none of the line was categorised as being an HRLA site and, as such, no actions to reduce the trees or vegetation were required. However, RAIB found that this section was not removed from the table of HRLA sites, likely because the SDS risk assessment process (paragraph 139) is undertaken on an annual basis and requires consideration of other operational experience as well as the leaf fall risk assessment.

Figure 29: Network Rail (Wessex) data in diagrammatic format showing mileage, topography, tree species and leaf fall risk assessment data scores (June 2021).

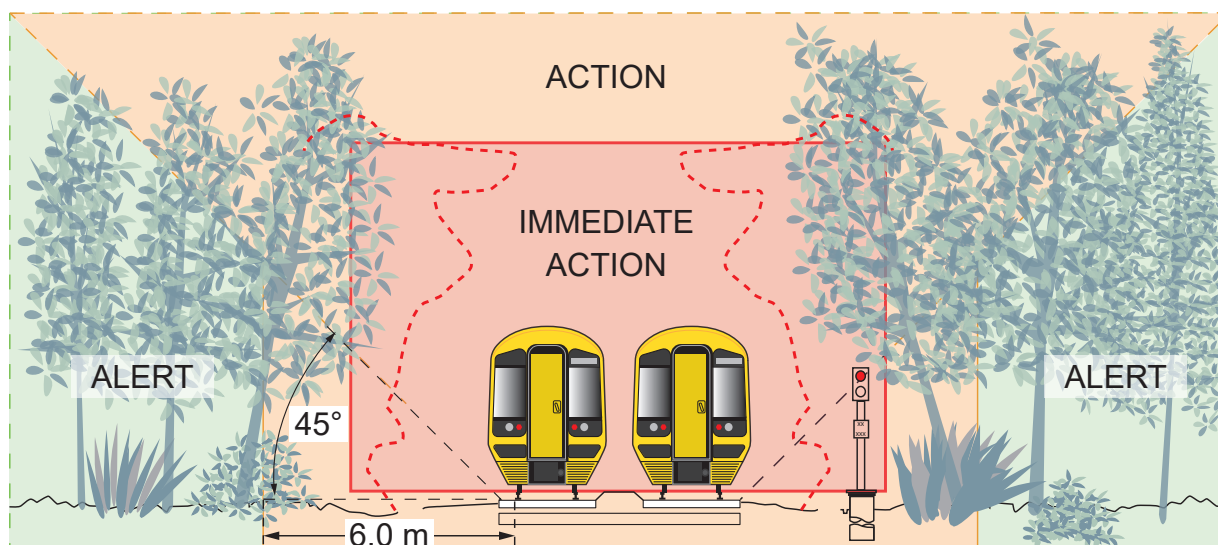
Figure 31: RAIB diagram showing the action zones from Network Rail standard NR/L2/OTK/5201, train profiles similar to class 159 trains, and tree growth as found on certain sections of the main lines between signals SY29R and SY31 (red dotted line).

148 Furthermore, an examination of the section of line from signal SY29R to beyond signal SY31 after the accident (paragraph 130) showed there were areas of medium to heavy railhead contamination which would have resulted in low levels of wheel/rail adhesion, even on sections that had low scores in the 2021 risk assessment. The amount and condition of the vegetation and trees were also seen to be non-compliant with the wider requirements of NR/L2/OTK/5201 (figure 31).

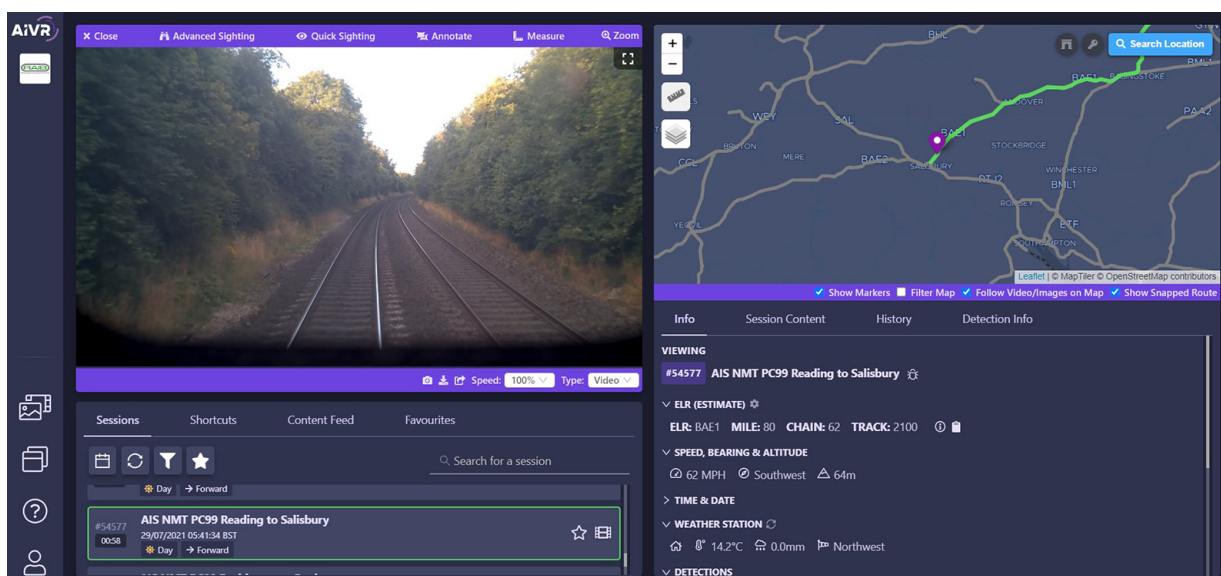
- 152 The last vegetation inspection undertaken by the MDU before the accident was carried out remotely between 13 and 14 June 2021 by the section manager reviewing footage that had been taken the previous week from high-definition trainborne cameras (figure 33).<sup>21</sup> No WAIFs were raised from this inspection since the section manager was aware that existing work orders were already in Ellipse from the previous inspection in 2019. The tree and vegetation work to reduce the risk was further deferred to April 2022 (paragraph 150).

Figure 33: Automated Intelligent Video Review software for cab/remote assessments of vegetation (image courtesy of Network Rail and One Big Circle).

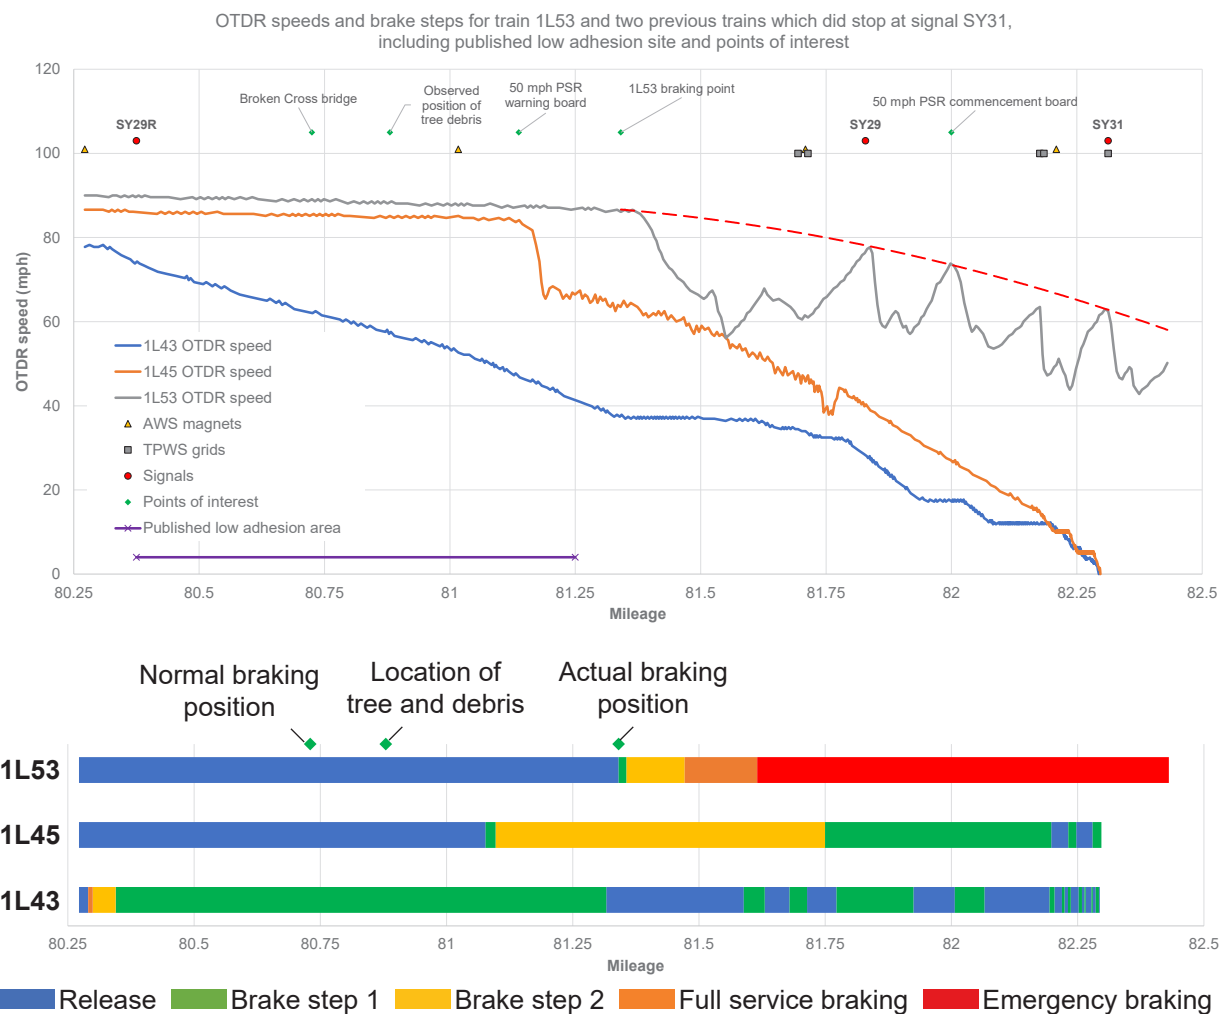
- 179 The last train to encounter signal SY31 showing a red aspect before train 1L53 was train 1L45 (formed of a three-carriage class 159 unit). At 16:45 hrs, when the weather was still dry, the driver of train 1L45 braked shortly before the PSR warning board, beyond the location of the fallen tree, but around 420 metres before the actual braking point of train 1L53, while travelling at 84 mph (135 km/h). Train 1L45 took approximately 1,980 metres to stop. This consisted of approximately 790 metres in brake step 1 and 1,080 metres in brake step 2. For the remainder of the distance, train 1L45 was coasting. Train 1L45 stopped approximately 25 metres on approach to signal SY31. Although the driver of train 1L45 braked later than the driver of the earlier train 1L43, and encountered a greater level of WSP activity, this train was also able to stop before passing signal SY31 (figure 34).

Figure 34: Speeds for trains 1L43 (blue), 1L45 (orange) and 1L53 (grey) as recorded by their respective OTDRs, and important locations. The red dashed line indicates an approximation of train 1L53's 'ground speed'. The OTDR has recorded the measured wheel as travelling more slowly because it is sliding. A similar but less pronounced effect can be seen during part of train 1L45's data. Braking techniques employed by train drivers of trains 1L43, 1L45 and 1L53 are shown in the graph below.

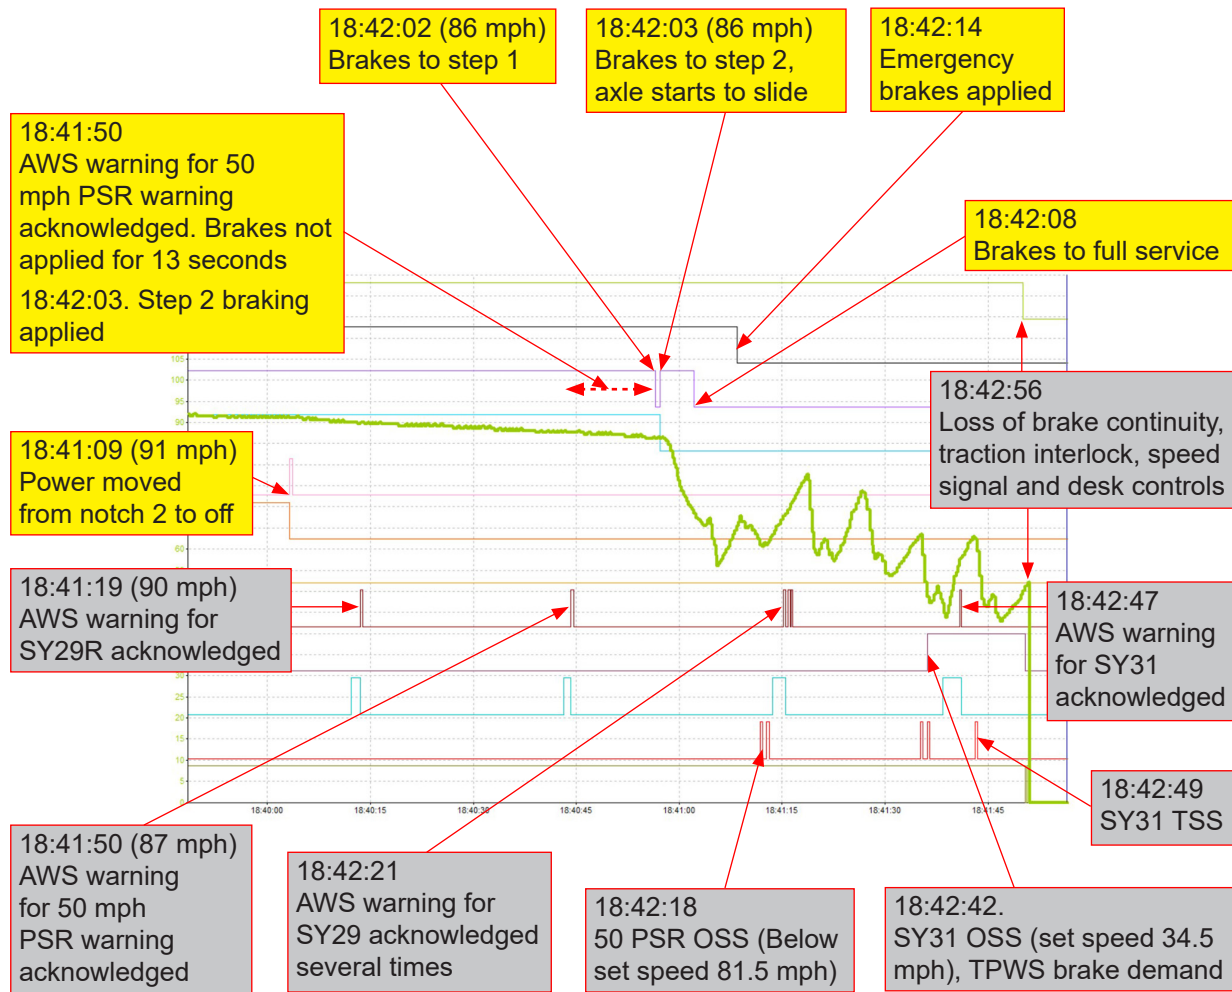
- 175 The driver stated that on the evening of the accident he intended to use the fallen tree and associated debris that he had seen on his earlier journey to London as his marker after which to start braking (paragraph 47 and see paragraph 181). The tree was 250 metres beyond Broken Cross bridge and braking here was also consistent with the range of braking points used by other drivers. However, OTDR data shows that the driver actually applied the brakes approximately 750 metres beyond the location of the fallen tree and associated debris and 1,000 metres beyond Broken Cross bridge, with the train travelling at 86 mph (138 km/h) (figure 35 and see paragraph 189).

Figure 35: Annotated OTDR trace from train 1L53 showing braking and AWS/TPWS activations and acknowledgements.

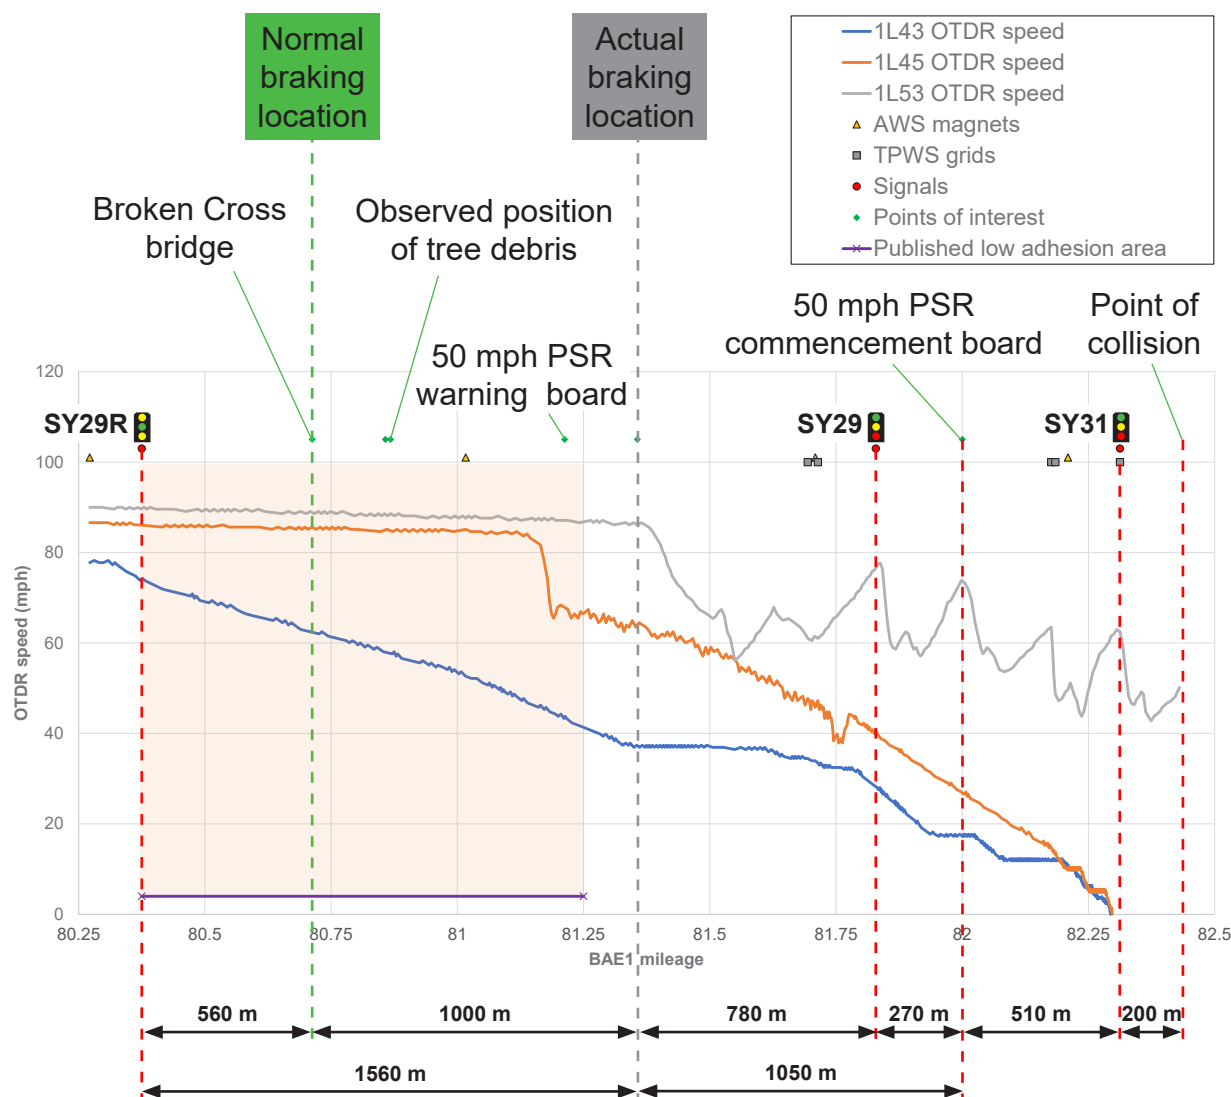
- 186 The signalling on the approach to Salisbury Tunnel Junction provides an excessive braking distance for passenger trains between signals SY29R and SY31 (figure 36). Excessive braking distances mean that drivers must delay full braking beyond the double yellow aspect signal, otherwise they could stop short of the red signal and/or incur time delays on their journey.

Figure 36: Annotated OTDR traces from trains 1L43, 1L45 and 1L53 showing important locations and distances.

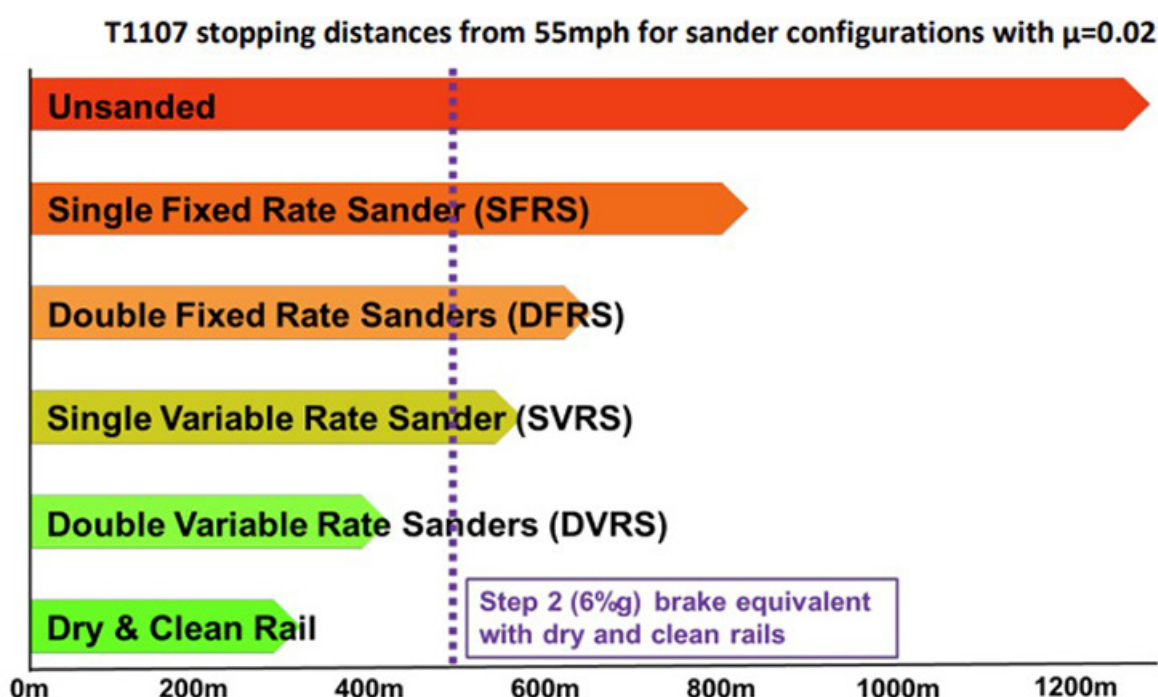
- 221 RSSB research illustrates the potential benefits of enhanced sanding systems, as shown in figure 39. RAIB has undertaken a simple analysis, using the underlying data from the RSSB research, to estimate the effect if train 1L53 had been fitted with a DVRS system. The higher sand delivery rates of a DVRS system would certainly have provided better low adhesion braking performance, which would have led to a reduced collision speed. Although it is not possible to be certain of the actual benefits of DVRS in the specific circumstances of this accident, the analysis undertaken by RAIB suggests that it is probable that the collision would have been avoided altogether. The analysis also suggests that it is possible that a DVRS equipped train would not have passed signal SY31.

Figure 39: Diagram from RSSB research project T1107 showing the potential benefits of variable rate sanding systems.

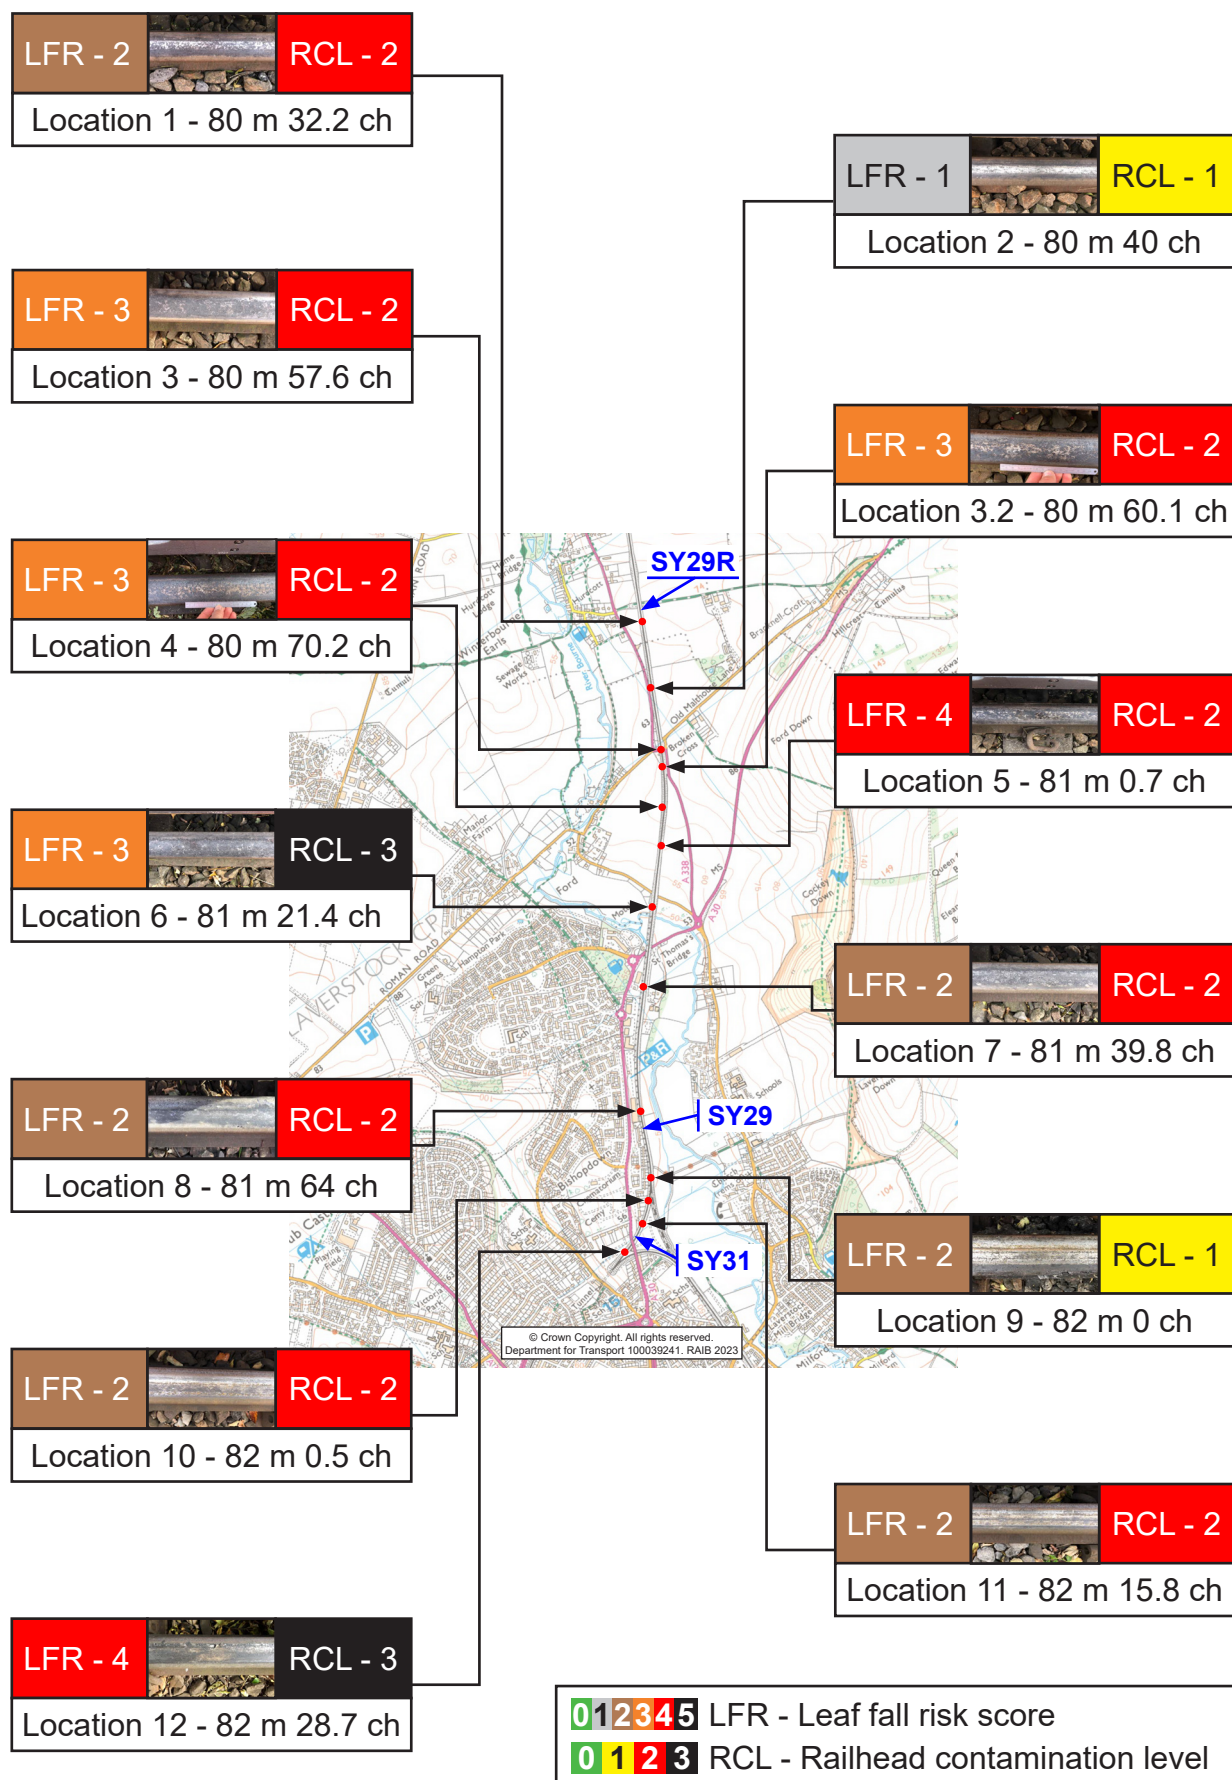
223 Documentary and witness evidence shows that before the accident Network Rail's Wessex route had not correctly identified sections of track as HRLA sites. This was probably because the information (figure 40) that the SDS was provided with and which they were using to identify such locations was inaccurate. These inaccuracies arose because the process employed to inspect and risk assess locations, and the subsequent dissemination of the information gathered, was ineffective (paragraph 136).

Figure 40: Braking locations for train 1L53 with predicted leaf fall risk scores (0 to 5) from the leaf fall assessment completed in June 2021 and corresponding physical railhead contamination level found on site (0 to 3) on 31 October 2021.

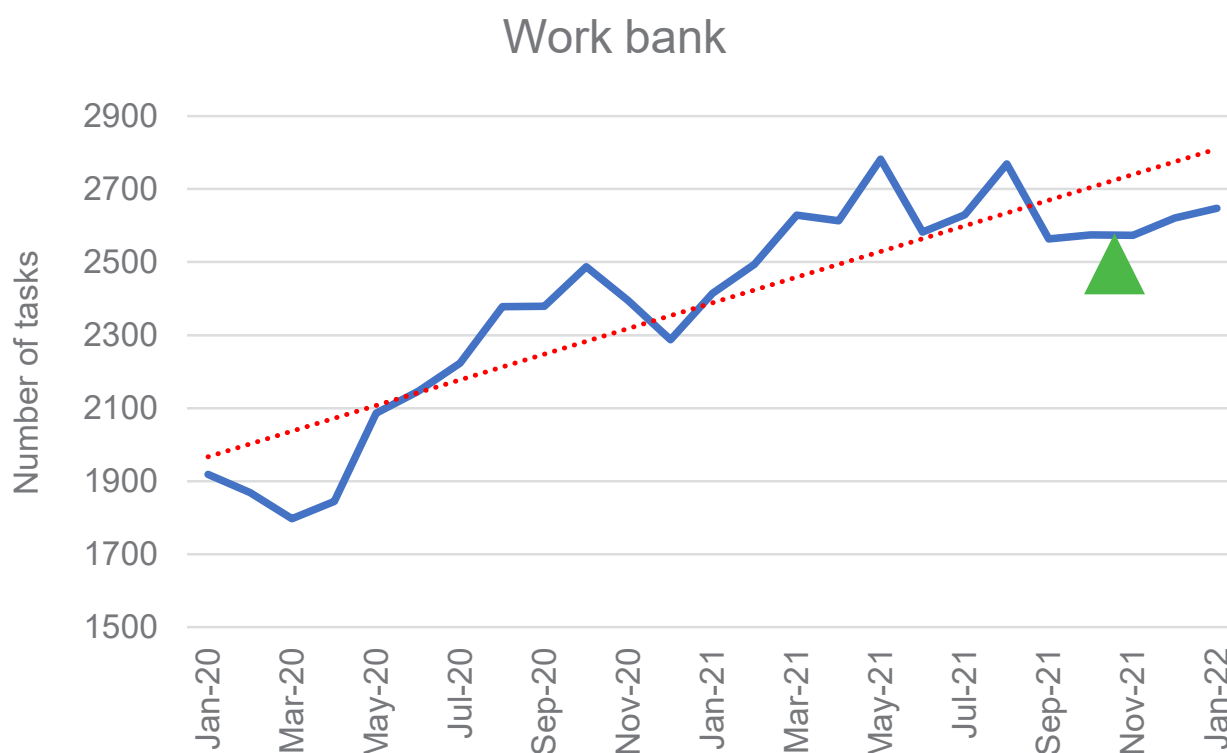
- 227 Despite this report, MDU off track staff reported that its increasing workload combined with a shortage of resources between May and August 2021 (figure 41) meant that it could not address the existing work bank and that the MDU was 'fighting' in response to arising incidents. Additionally, witness evidence is that there was also a perceived problem with the availability of contractors. Consequently, the MDU did not have the time or resources to prioritise and plan the vegetation assessment and management work.

Figure 41: Ellipse work bank (number of tasks) levels (blue solid line) and mean average level (red dotted line) between January 2020 and January 2022 (green triangle shows accident date).
