# Rail Accident Report

## **Collision between passenger trains at Salisbury Tunnel Junction, Wiltshire 31 October 2021**

Report 12/2023  
October 2023

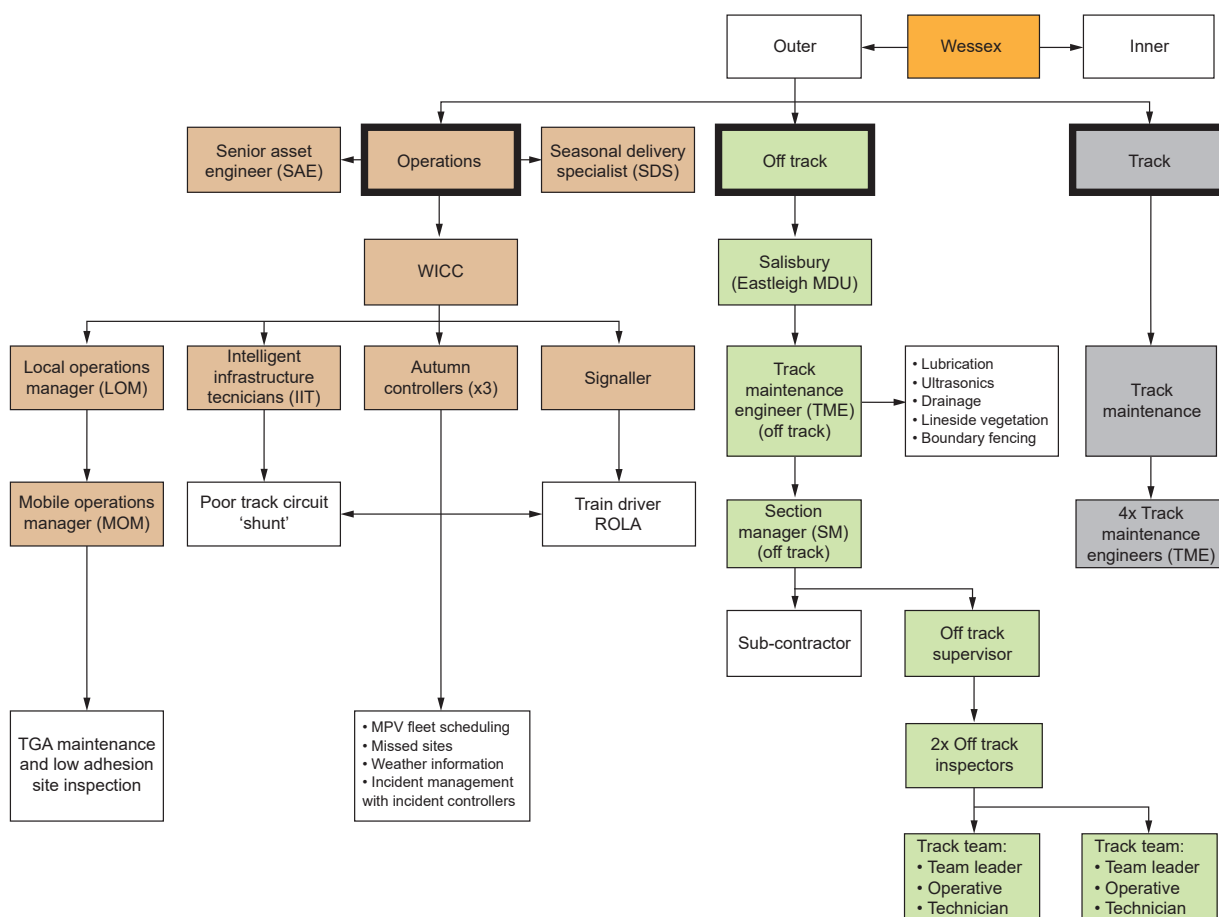
231 The management of autumn preparedness requires planning and co-ordination between Network Rail's operations and off track functions (figure 42). As outlined below, witness and documentary evidence show there was no apparent strategy to promote collaboration between these departments to manage leaf fall risk. This led to what witnesses described as a 'silo' culture within Network Rail's Wessex route, with very little co-ordination between, or information shared across, these functions. This was an issue which was also identified by the Office of Rail and Road (ORR) in 2020 (see paragraphs 299 to 305).

Figure 42: Network Rail's Wessex route departments involved with the co-ordination, planning, maintenance and response to autumn.

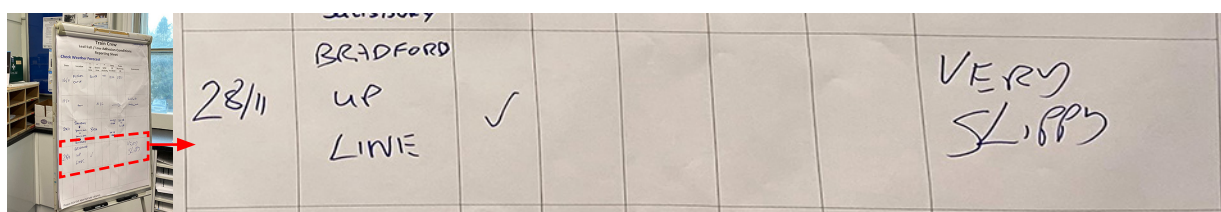
- 274 During autumn 2021, SWR's driver managers installed flip charts at booking-on points as an informal means for drivers to communicate to each other any adhesion issues during their journeys (figure 44). Witness evidence shows that some drivers did not consult the flip charts, either because they did not book on for duty at the booking-on point or because they believed they were out of date by the time they read them. Some drivers were under the impression that reporting low adhesion on the flip chart meant that they were not required to formally report it to the signaller.

Figure 44: Flip chart (dated 28 November 2021) used by drivers at Salisbury depot to report low adherence conditions and other safety issues.
