**SERIOUS INCIDENT**

<b>Aircraft Type and Registration:</b>	MBB-BK 117 C-2, G-MPSB	
<b>No &amp; Type of Engines:</b>	2 Arriel 1E2 turboshaft engines	
<b>Year of Manufacture:</b>	2005 (Serial no: 9068)	
<b>Date &amp; Time (UTC):</b>	12 March 2021 at 1150 hrs	
<b>Location:</b>	North Weald Airfield, Essex	
<b>Type of Flight:</b>	Private	
<b>Persons on Board:</b>	Crew - 2	Passengers - None
<b>Injuries:</b>	Crew - None	Passengers - N/A
<b>Nature of Damage:</b>	Distorted aft crosstube between skids	
<b>Commander's Licence:</b>	Airline Transport Pilot's Licence (Helicopters)	
<b>Commander's Age:</b>	52 years	
<b>Commander's Flying Experience:</b>	7,170 hours (of which 2,196 were on type) Last 90 days - 28 hours Last 28 days - 14 hours	
<b>Information Source:</b>	AAIB Field Investigation

**Synopsis**

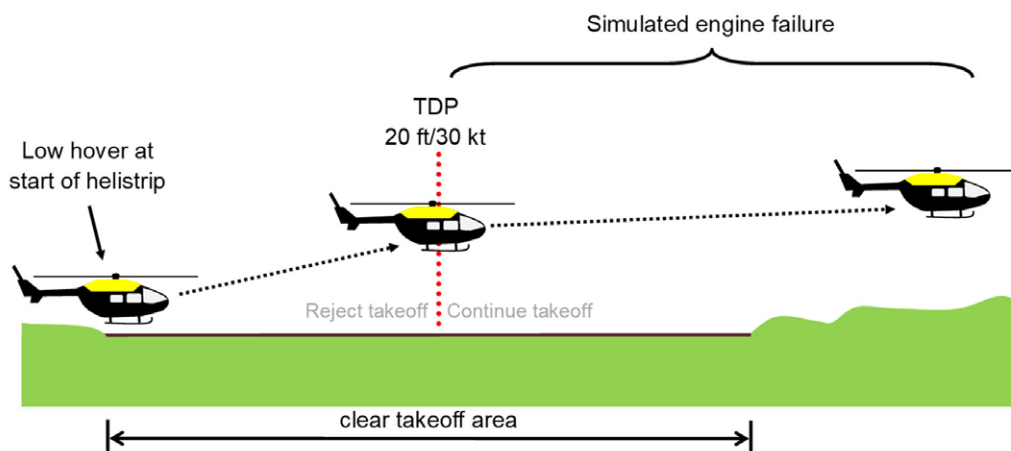
**Figure 2**

The intention was for the commander to demonstrate a Category A (Cat A) Clear Heliport takeoff procedure with a simulated engine failure after the takeoff decision point (TDP) and a continued takeoff (Figure 2). This was to lead into a single-engine circuit to Runway 20.

Overview of Cat A Clear Heliport takeoff profile with simulated engine failure after TDP

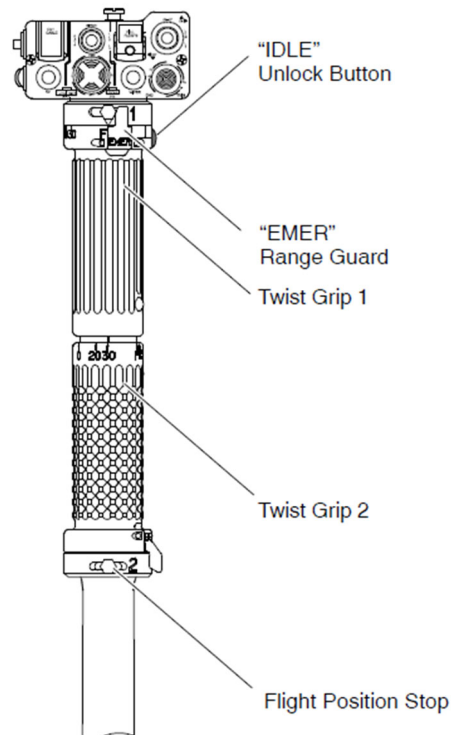
**Figure 4**

BK 117 C-2 collective pitch lever showing twist grip positions

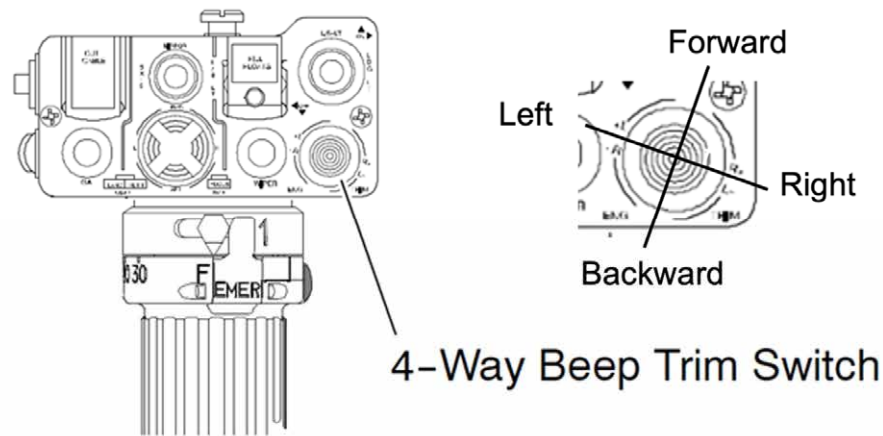
**Figure 5**

The beep trim switch axis is offset approximately 30° clockwise to align with the natural direction of thumb movement when pushing forward with the pilot’s hand on the collective.

The switch will return to centre once thumb pressure is released and is gated so that it cannot be moved from one position to another without first being centred.

Four-way beep trim switch (with beep trim axis inset)

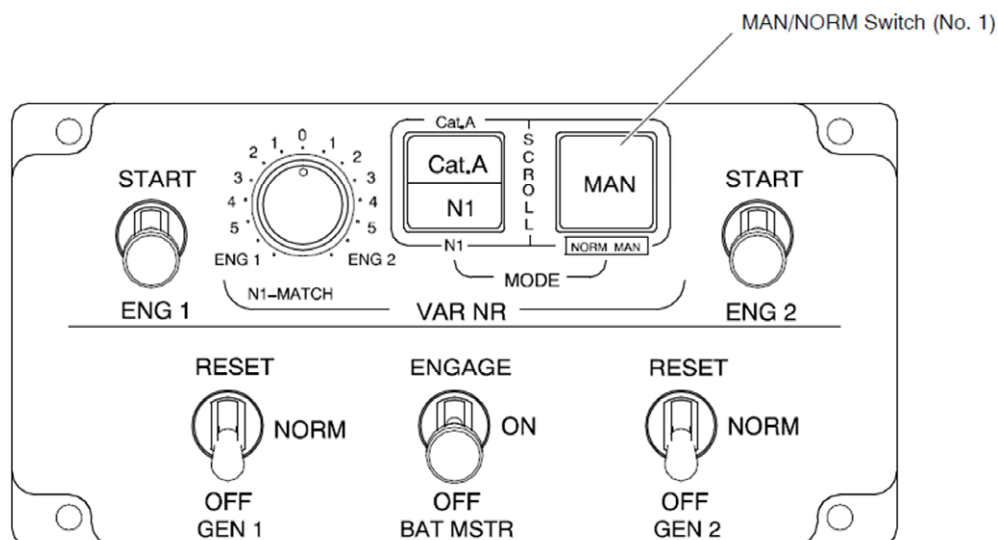
**Figure 6**

VARTOMS control panel

If the VARTOMS identifies that there is an engine torque split of greater than 15% the system will automatically switch to manual mode and the MAN button will illuminate yellow. If a VARTOMS failure is detected a caution will be illuminated on the CAD.

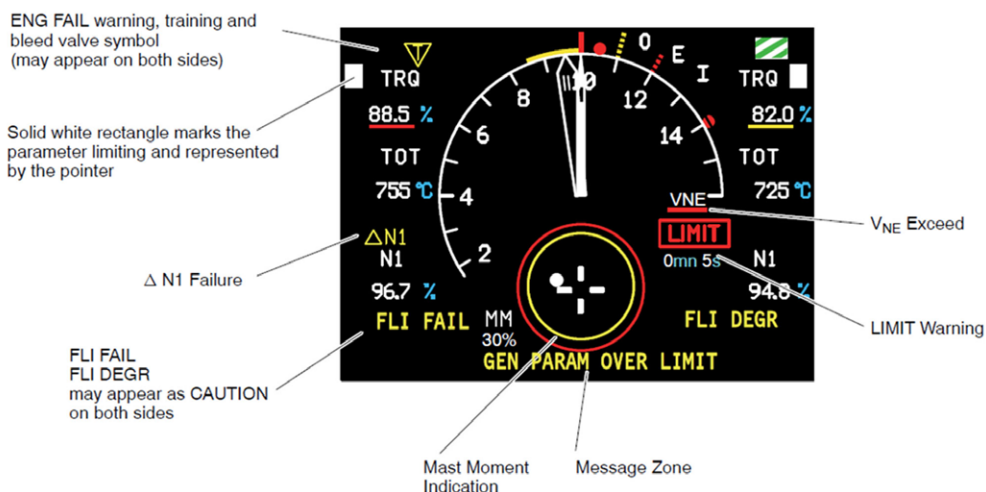
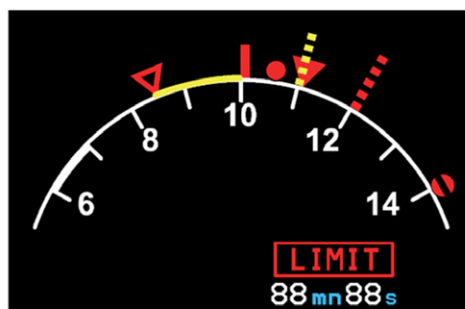
**Figure 7**

FLI indications and legend (CPDS<sup>4</sup> V2006 Software as installed in G-MPSB)  
(images courtesy of the manufacturer)

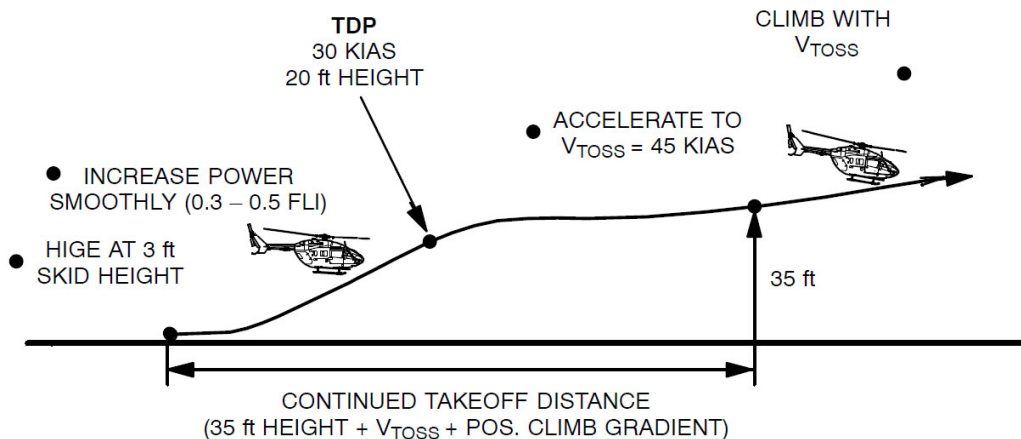
**Figure 10**

The Cat A Clear Heliport profile is designed such that the helicopter can either land safely or climb away should one engine fail during the takeoff. Between starting the takeoff acceleration and reaching TDP<sup>6</sup> the helicopter can decelerate and land within the clear takeoff area remaining ahead. After TDP a rejected takeoff within the available clear heliport area is no longer assured and the pilot is required to fly a continued takeoff (CTO). For a CTO, the pilot accelerates the helicopter to 45 KIAS ( $V_{\text{TOSS}}$ <sup>7</sup>) while climbing to 35 ft before then climbing away with due regard to obstacles on the planned departure track (Figure 10).

RFM Cat A Clear Heliport initial climb profile for single engine failure after TDP (RFM Fig.5B courtesy of the manufacturer)

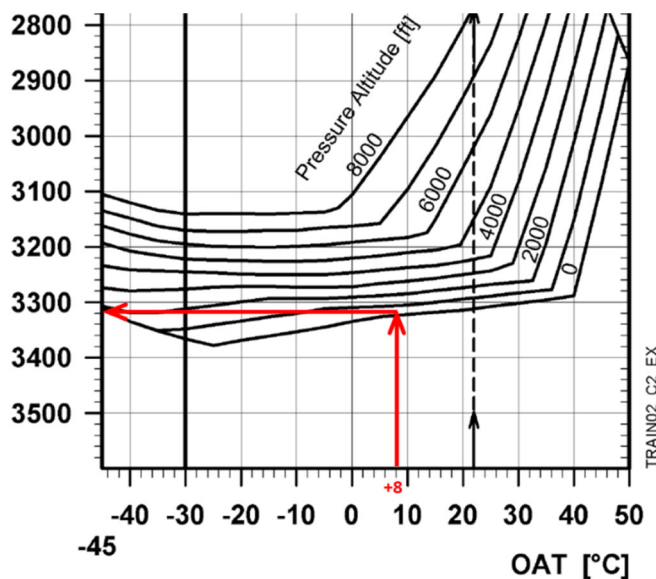
**Figure 11**

Calculating the maximum mass for simulating OEI conditions during Cat A Clear Heliport training with one engine at IDLE<sup>8</sup> requires interpolation of the corresponding RFM performance chart<sup>9</sup> (Figure 11). Using the environmental conditions at the time of the incident, the maximum training gross mass (MTGM) for G-MPSB was approximately 3,320 kg.

Fig. C1 Training takeoff and landing gross mass category a (clear heliport)

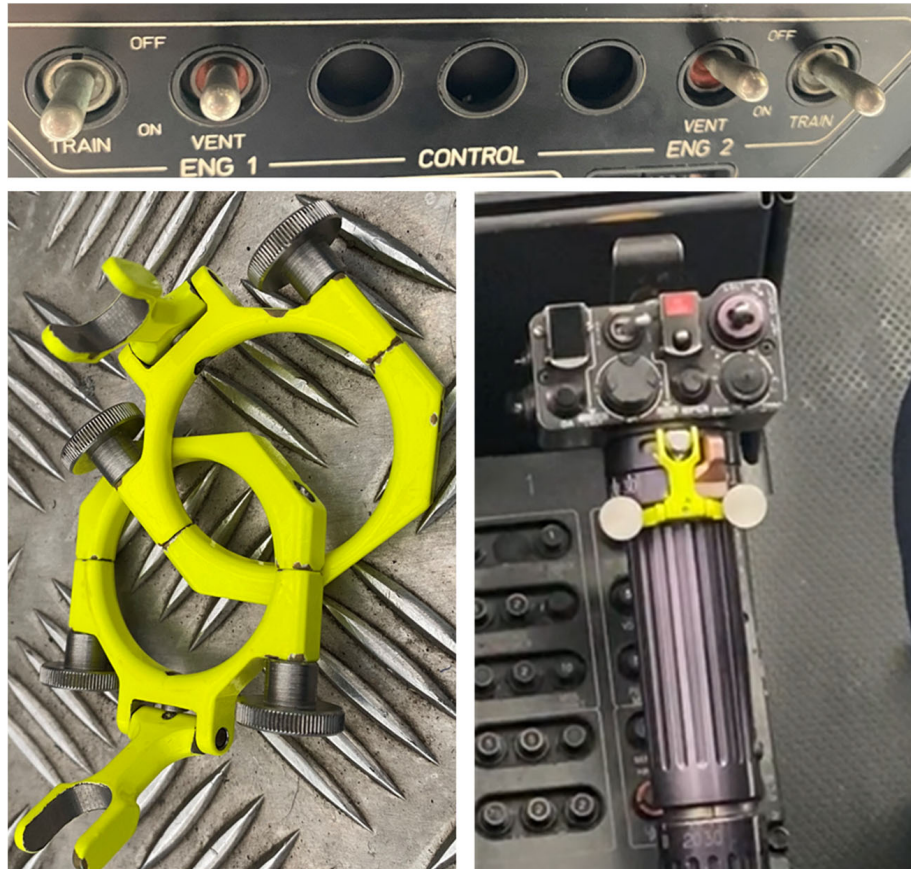
**Figure 12**

**Manufacturer's OEI training device.** The manufacturer's training device system<sup>11</sup> employs collars to restrict throttle movement, which can be affixed to either twist grip throttle, and training switches on the overhead console (Figure 12) which modify the FLI display to simulate the OEI condition. The system can be used at gross weights at or below MTGM, but the BK 117 C-2 RFM only explicitly requires it to be used for Cat A OEI training when at MTGM<sup>12</sup>. Opinions varied, across the BK 117 C-2 user groups consulted by the investigation, as to the merits of using the training device system. The investigation heard that the manufacturer, and at least one other large helicopter training organisation, exclusively used the training device for OEI training. G-MPSB's operator had previously experienced engine overtorque incidents when using this system and their training manual<sup>13</sup> explicitly prohibited its use. Several pilot witnesses who spoke to the investigation stated that fitting the collars and the associated throttle '*tuning*' procedure was "fiddly" and wasted valuable rotors-running training time<sup>14</sup>. A manufacturer's OEI training report<sup>15</sup> provided to the investigation stated that '*experience has shown that the estimated time to set up the collar is about 2 minutes on the ground.*' Some pilots reported that, once configured, there was no guarantee that the engine setup would not drift in a very short time.

Manufacturer's training device (collars and overhead switches)
