Rail Accident Report

Collision between a tram and a cyclist, near Audenshaw tram stop, Manchester 1 September 2021

Report 08/2022
August 2022

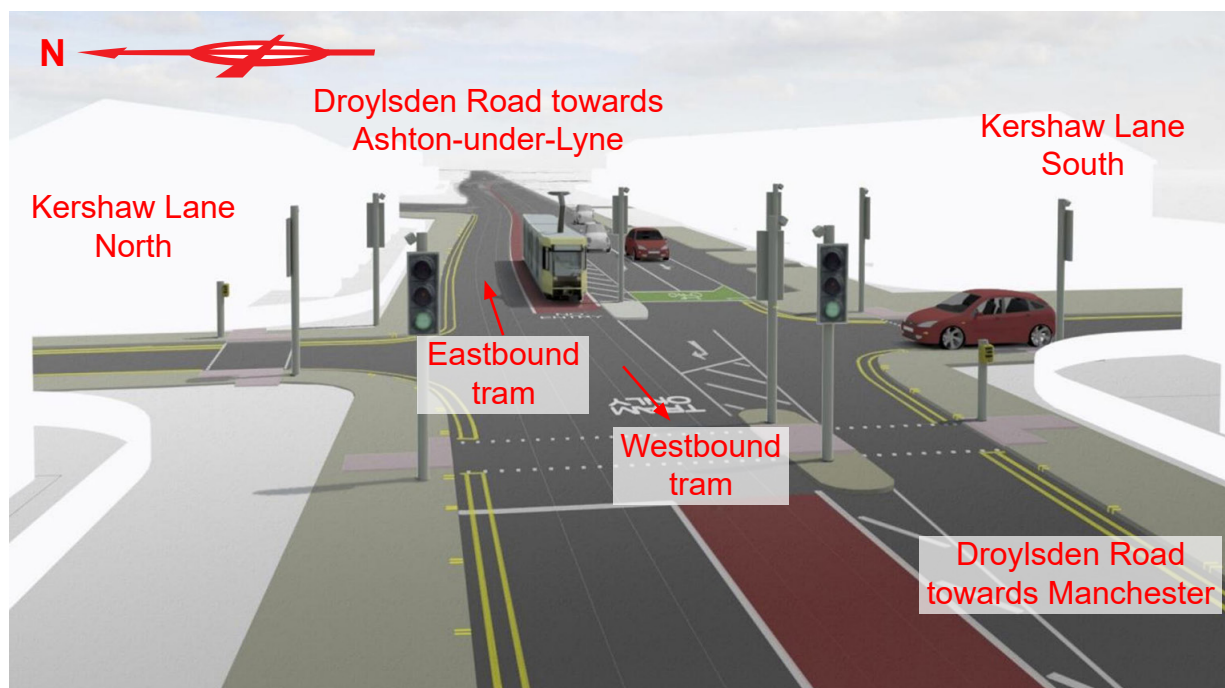
Figure 3: graphical representation of the junction layout, looking east (courtesy of TfGM)

- 10 The crossing at the western arm of the junction with Kershaw Lane is provided with a mid-carriageway pedestrian refuge. The refuge, protected by high containment kerbs, is located between the road for westbound vehicles and the track for westbound trams (figures 3 and 4). The refuge also provides a location for traffic signals

- 85 The positioning of the refuge at the Kershaw Lane crossing does not follow this pattern. Eastbound trams and eastbound road vehicles travelling on Droylsden Road share a single lane. However, westbound road vehicles are separated from westbound trams (such as that involved in the accident) and westbound trams use a separate area of the road from which other road vehicles are prohibited (figure 3).

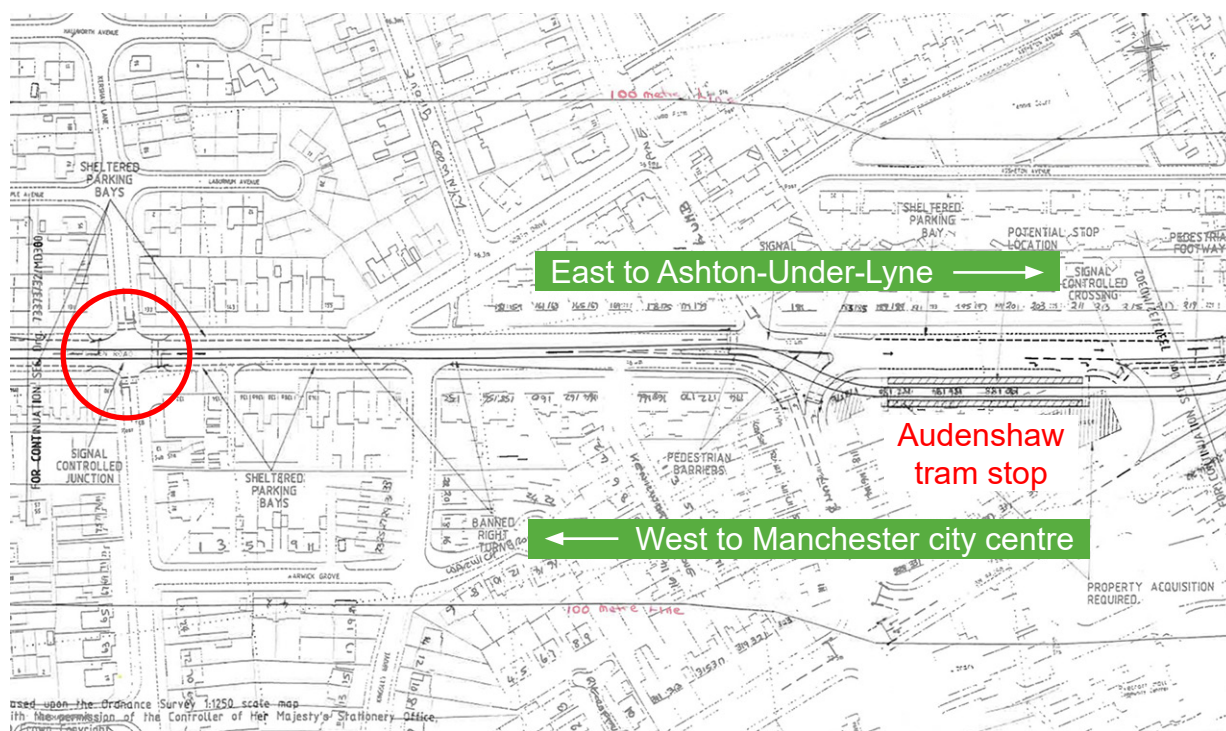
- 50 In 1994, GMPTE carried out a public consultation exercise to seek views on the East Manchester Line project from local stakeholders (such as Tameside MBC and residents). A concept drawing created for the purposes of that consultation (figure 7) shows the tramway laid within the existing carriageway of Droylsden Road. However, at that point, no details regarding track alignment (beyond incorporation of the track within the existing highway) or pedestrian crossings had been considered.

Figure 7: 1994 concept drawing (courtesy of TfGM)

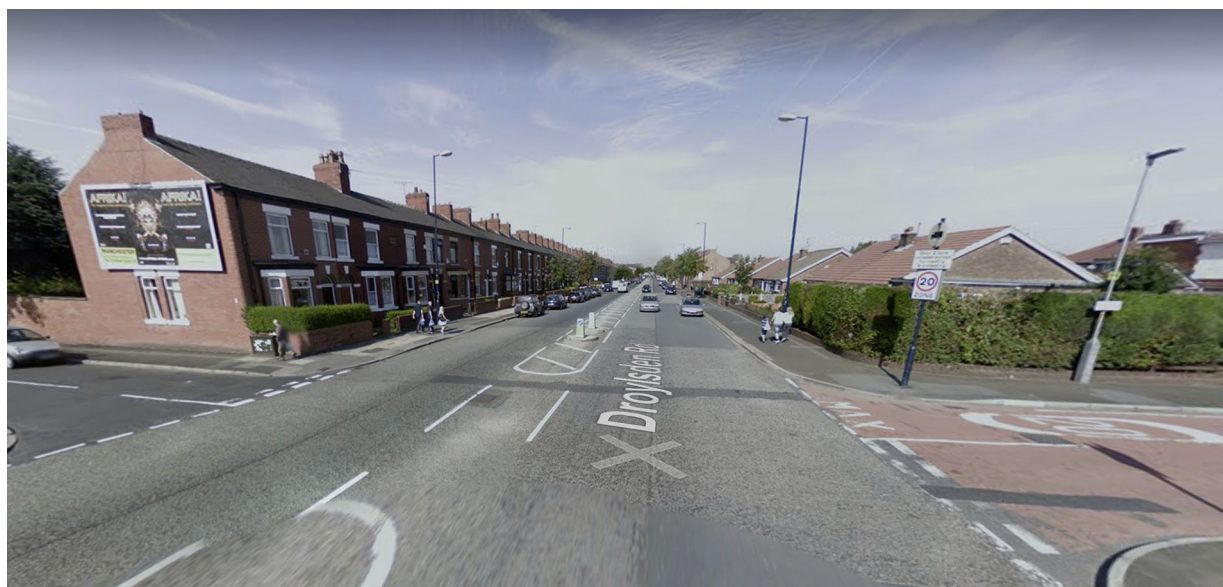
- 51 Before the construction of the East Manchester Line, the Droylsden Road/ Kershaw Lane junction did not have traffic signals. There were no controlled pedestrian crossings, and traffic movements such as right turns were permitted. A set of bollards and a small refuge was provided in the centre of the carriageway at the western side of the junction (figure 8), as part of an uncontrolled crossing route.

Figure 8: Image taken in 2008 of the junction looking west, before the start of East Manchester Line works (courtesy Google Streetview)

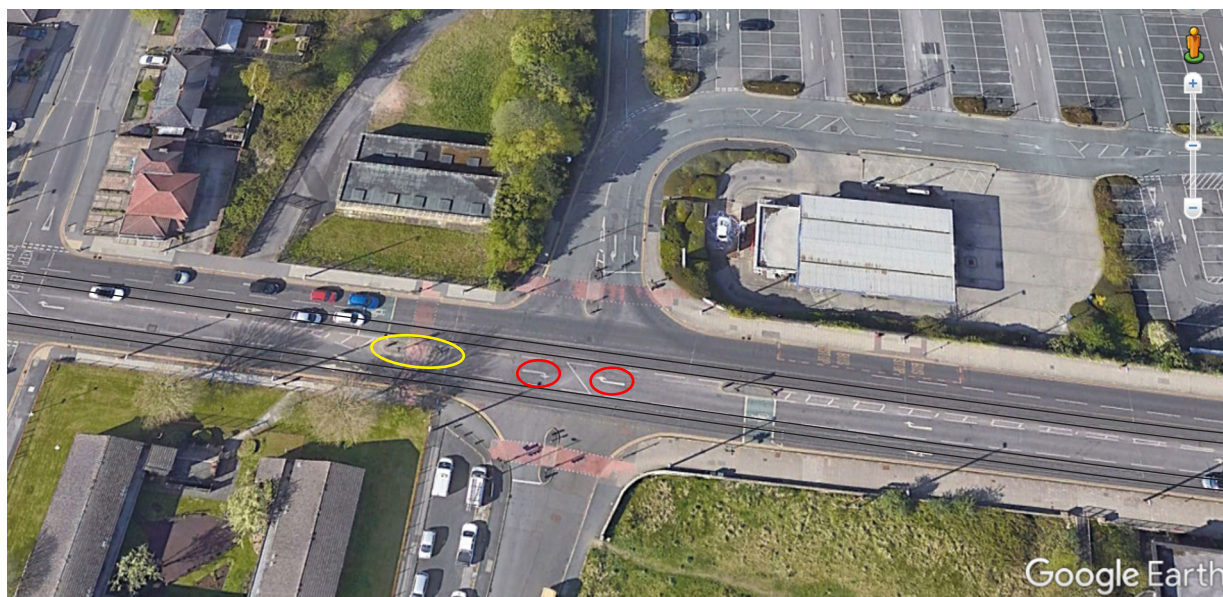
- 58 Despite the problems caused by right-turning road traffic (paragraph 56), design solutions are available. For example, at a location approximately 0.5 mile (0.8 km) to the west of the accident location, the two tramway tracks are integrated with the road traffic in each direction, with right turn lanes being placed between the tramway tracks in the centre of the road (figure 9).
- 59 However, such a layout is incompatible with the Trambahn concept. Placing the right turn lane between the tramway tracks would have meant the loss of a considerable length of the Trambahn, and therefore the loss of many of the benefits of the concept.

Figure 9: Right turn lanes (highlighted red) positioned between tramway tracks, with pedestrian refuge (highlighted yellow) positioned in the centre of the carriageway

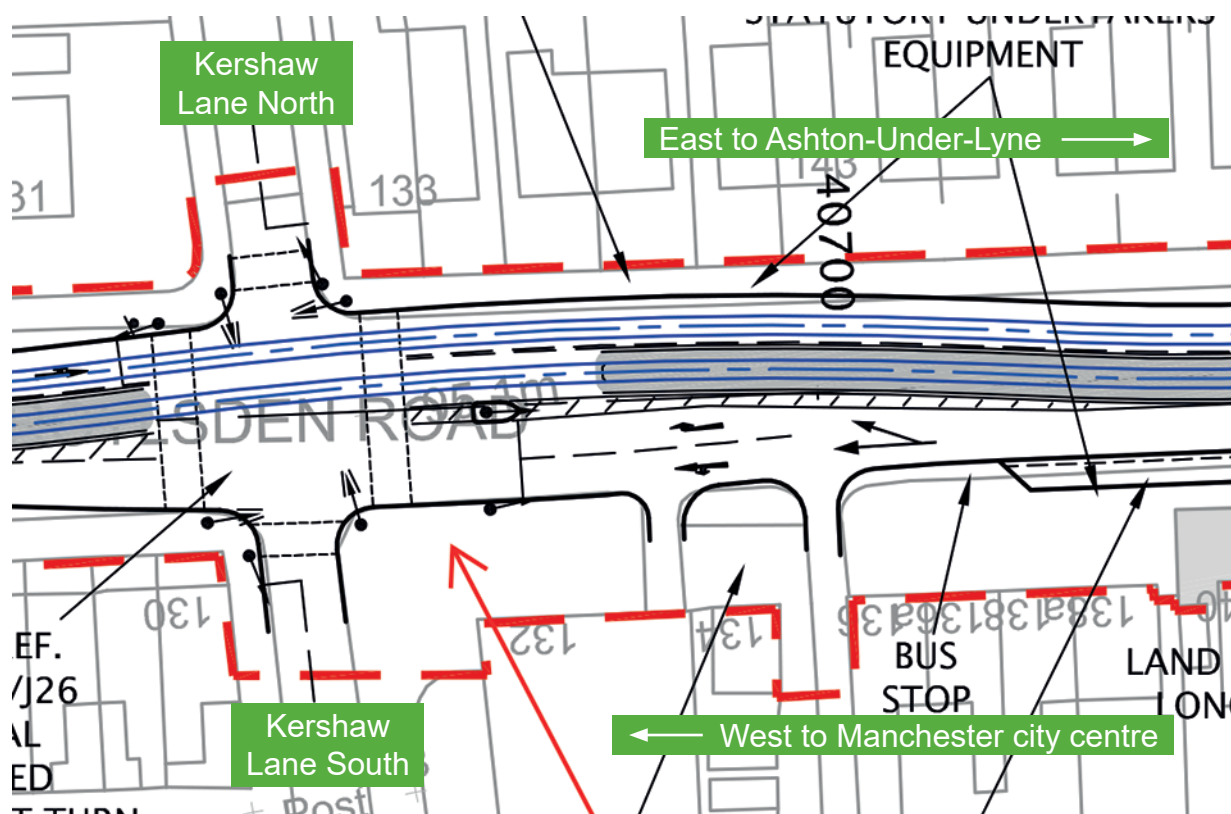
- 62 As such, the outline design (figure 10) included the following features:
- Trambahn for the westbound trams
 - tracks slewed to the north across the junction

- right turn lane for westbound road vehicles wishing to access Kershaw Lane north
 - controlled crossings of all four legs of the junction - Kershaw Lane north, Kershaw Lane south and Droylsden Road to both the east and the west of the junction.

- 63 The design produced on behalf of GMPTE was an outline design. It did not include details such as the provision (or otherwise) of a pedestrian refuge at the crossings of Droylsden Road (or details of any similar refuges). The design also omitted considerations such as parking bays and junction stop lines.

Figure 10: GMPTE-developed outline design, dated January 2010 (Trambahn indicated by areas of tram track shaded grey) (courtesy of TfGM)

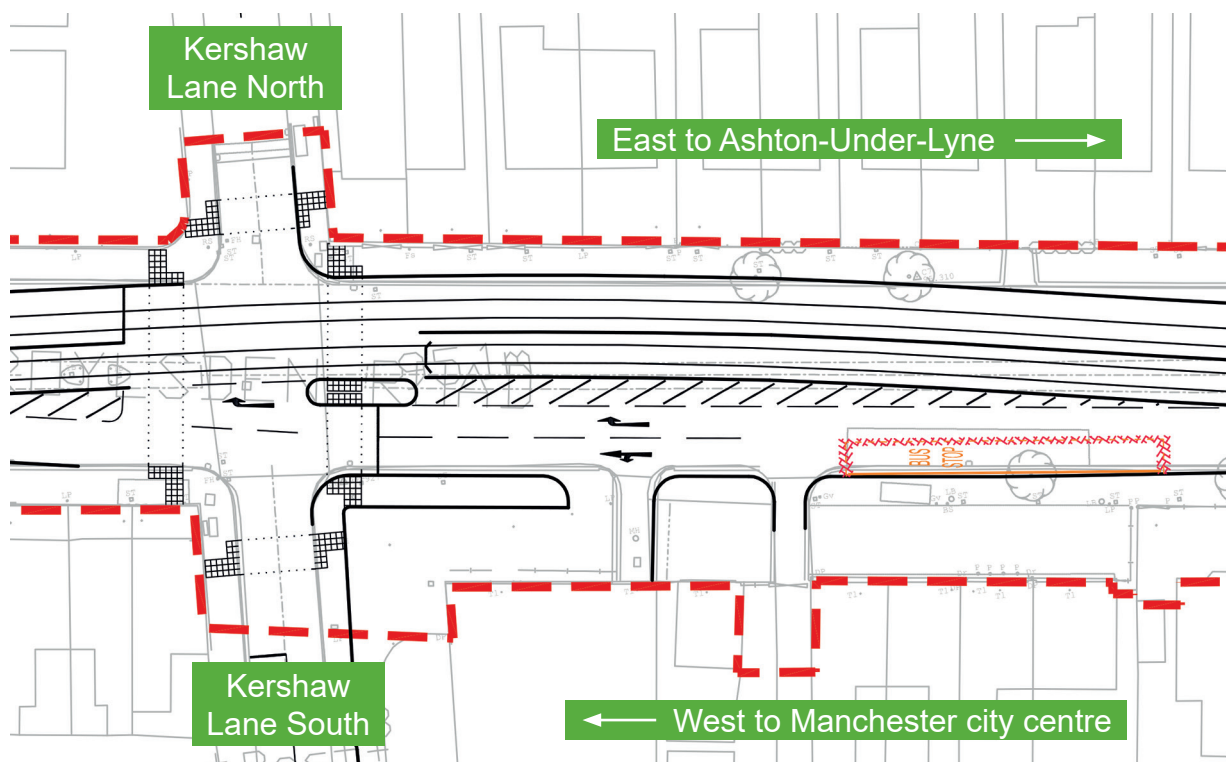
- 65 In April 2010, an initial design (figure 11) for the layout at Kershaw Lane had been prepared which included a pedestrian refuge at the eastern side of the junction, this refuge being positioned to the south of the tram tracks. In this design, the western side of the junction (the location of the accident) was shown as a controlled crossing with no pedestrian refuge.

- 66 This initial design had the advantage of placing a controlled crossing at the location of the likely 'desire line' for pedestrians crossing to and from the convenience store and other businesses at the eastern side of the junction (paragraph 61). However, problems associated with the needs of property owners in the vicinity were encountered with the layout. For these reasons, this initial design was rejected. Design work then progressed with the intent of providing a controlled crossing (on Droylsden Road) solely across the western leg of the junction. By June 2010, MPT's detailed design had progressed to a point where it included the pedestrian refuge in its final position, to the south of both tram tracks. It was this configuration which was ultimately constructed, and which existed at the time of the accident (figure 12).

Figure 11: April 2010 initial design (courtesy of TfGM/MPT)

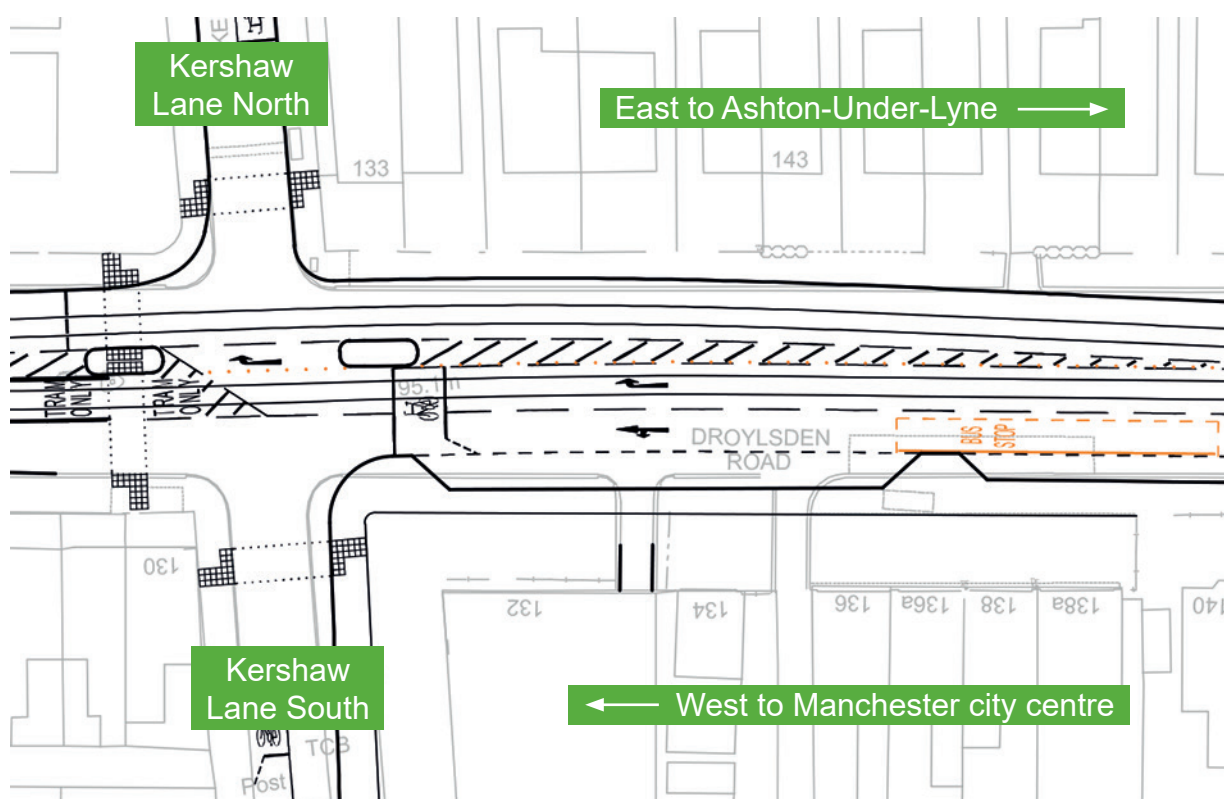
- 68 Local stakeholders, including Tameside MBC, raised concerns about the layout of the tramway in the area and the Trambahn concept in general. These concerns included issues with residents accessing driveways and anticipated problems with unloading delivery vehicles at the convenience store and other businesses. In September 2011, TfGM requested MPT to prepare an alternative layout. In response, MPT prepared a concept design (figure 13) which showed a layout with westbound trams sharing the right turn lane. This layout placed the pedestrian refuge between the tram tracks. However, this layout was later rejected. The reasons for the rejection are discussed at paragraph 107.

Figure 13: September 2011 concept design (courtesy of TfGM/MPT)

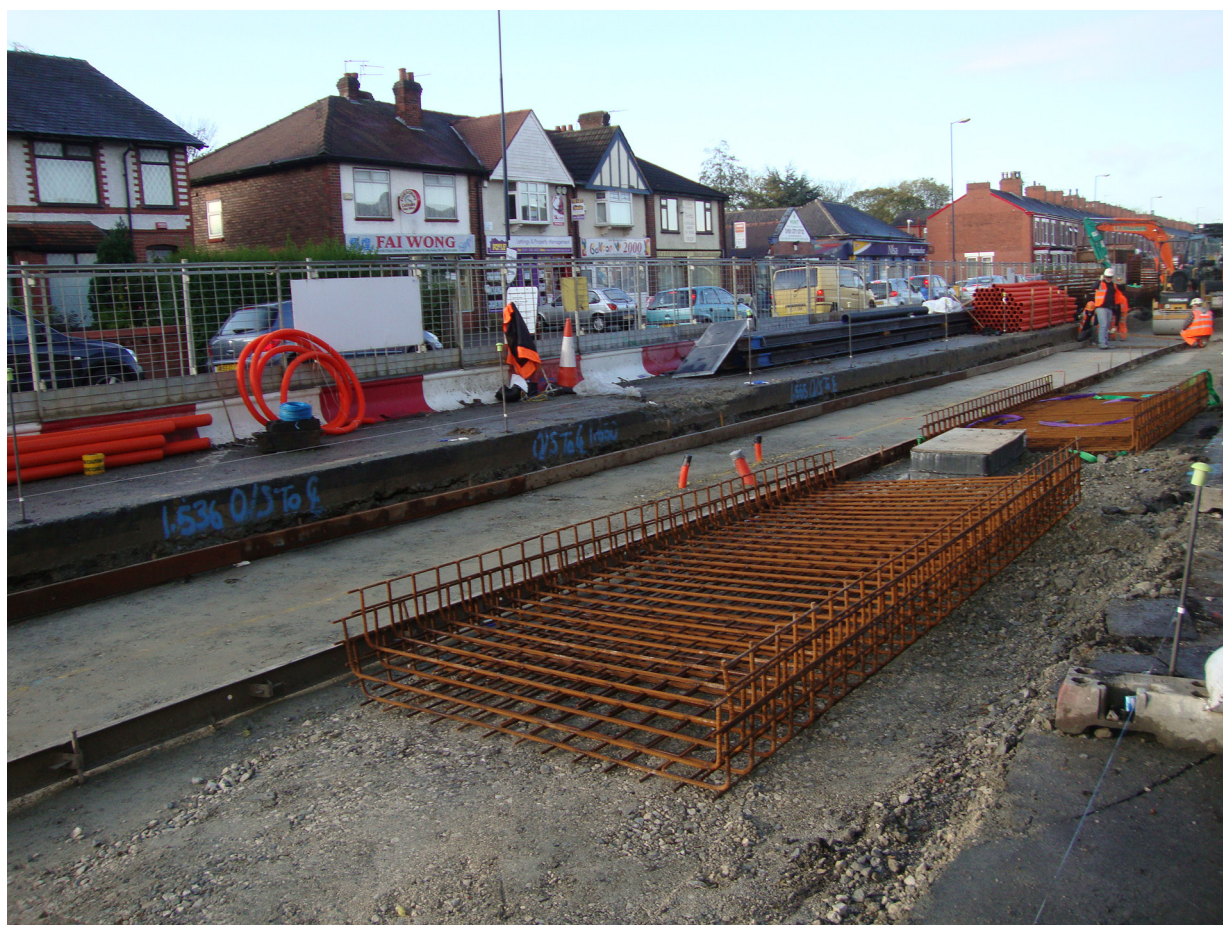
- 70 Construction of the tramway took place during 2011 and 2012. The basic track foundations were completed by November 2011 (figure 14), and the tramway works area around the location of the accident were substantially completed by the end of 2012. The East Manchester Line was opened from central Manchester to Droylsden in February 2013, and from Droylsden, past the location of the accident, to Ashton-under-Lyne in October 2013.

Figure 14: Construction work on Droylsden Road in November 2011. The location of the accident is at the right of the image (courtesy of TfGM)
