On 3 September 2020, the paddle steamer *Waverley* made heavy contact with the eastern pier at Brodick, Isle of Arran, Scotland while attempting to berth following a 2-hour afternoon excursion along the Isle of Arran coast. Twenty-one of the 186 passengers and three of the 27 crew on board sustained injuries because of the impact and *Waverley* suffered damage to its bow above the waterline.

1.1 PARTICULARS OF WAVERLEY AND ACCIDENT

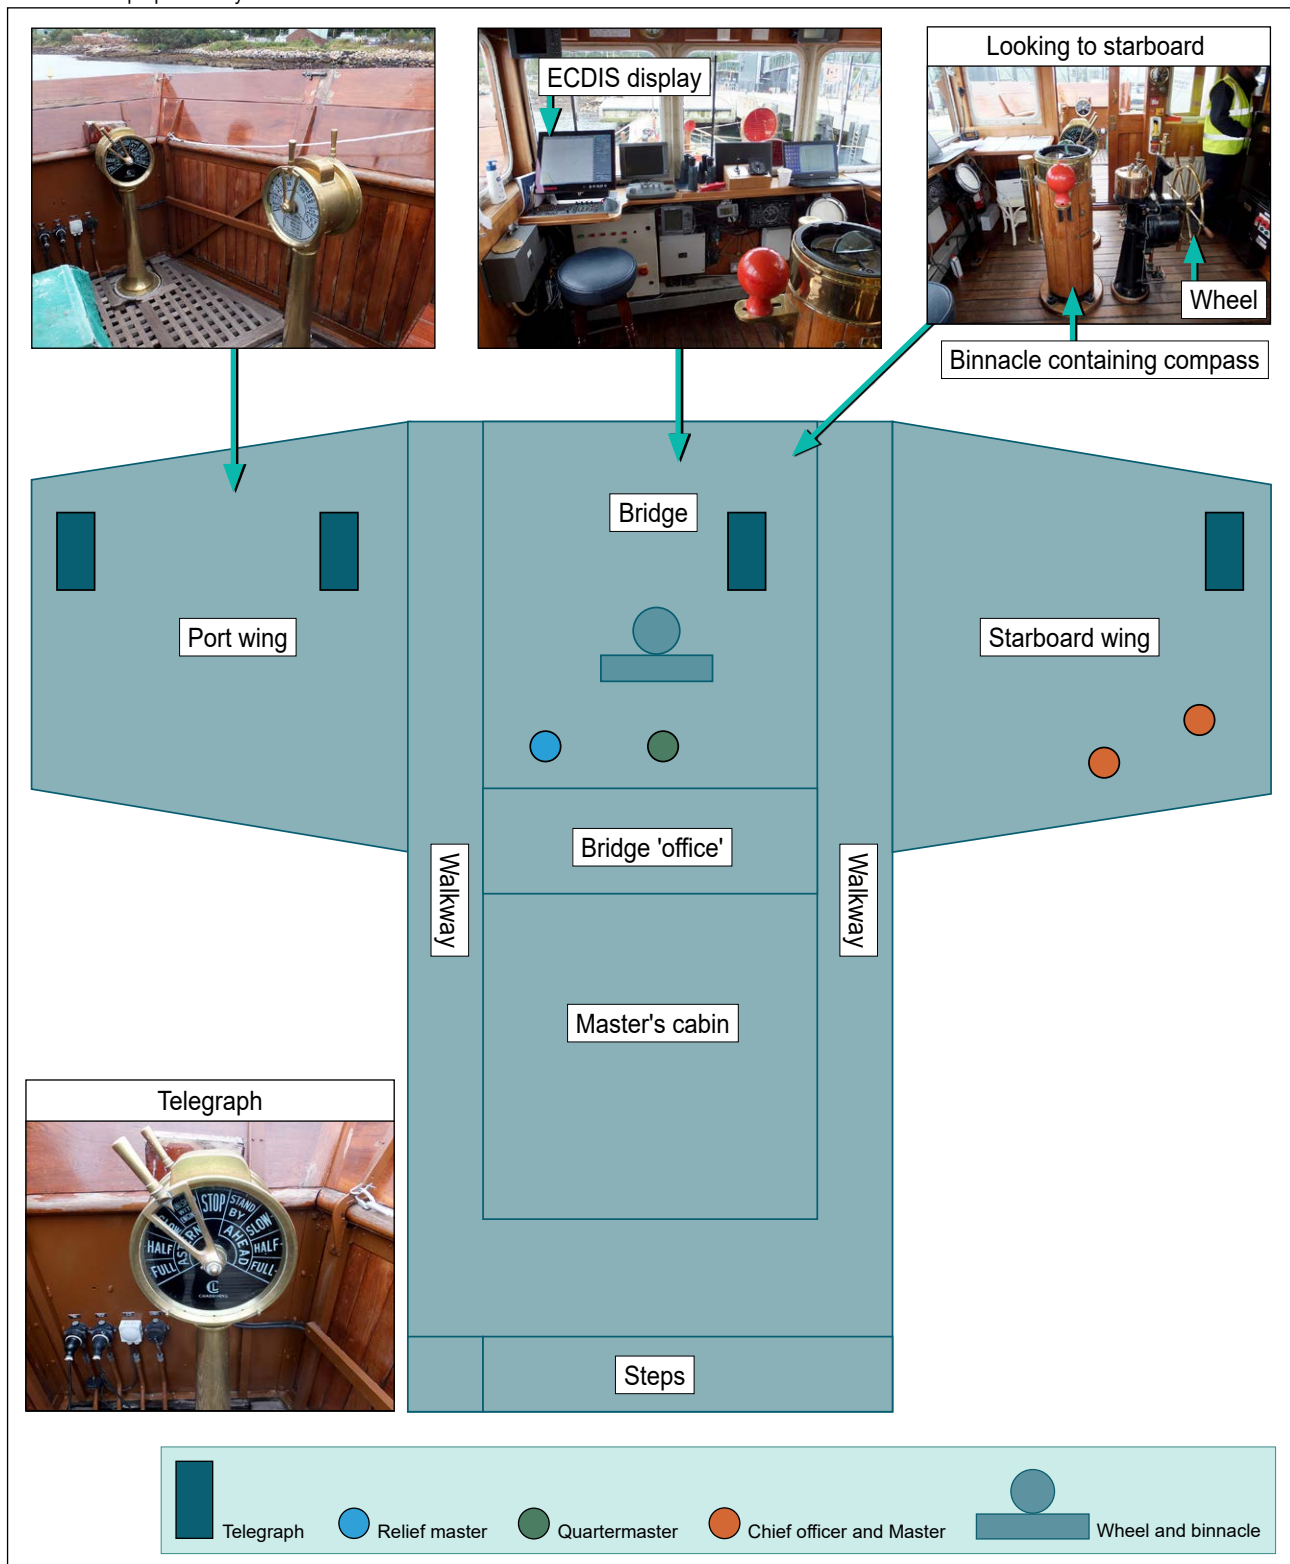
Figure 3: Bridge layout and positions of bridge team during the accident

The enclosed wheelhouse was located on top of the forward deckhouse. The main conning position when berthing was from the bridge wing closest to the berth; the open bridge wings were each equipped with an engine order telegraph. A voice pipe (speaking tube) to the engine room (see **Figure 3**) was in the bridge next to the wheel. The vessel's primary means of navigation was paper charts. A Transas Navi-Sailor 4000 Electronic Chart Display and Information System (ECDIS) was installed in the wheelhouse and was operating at the time of the accident⁷.

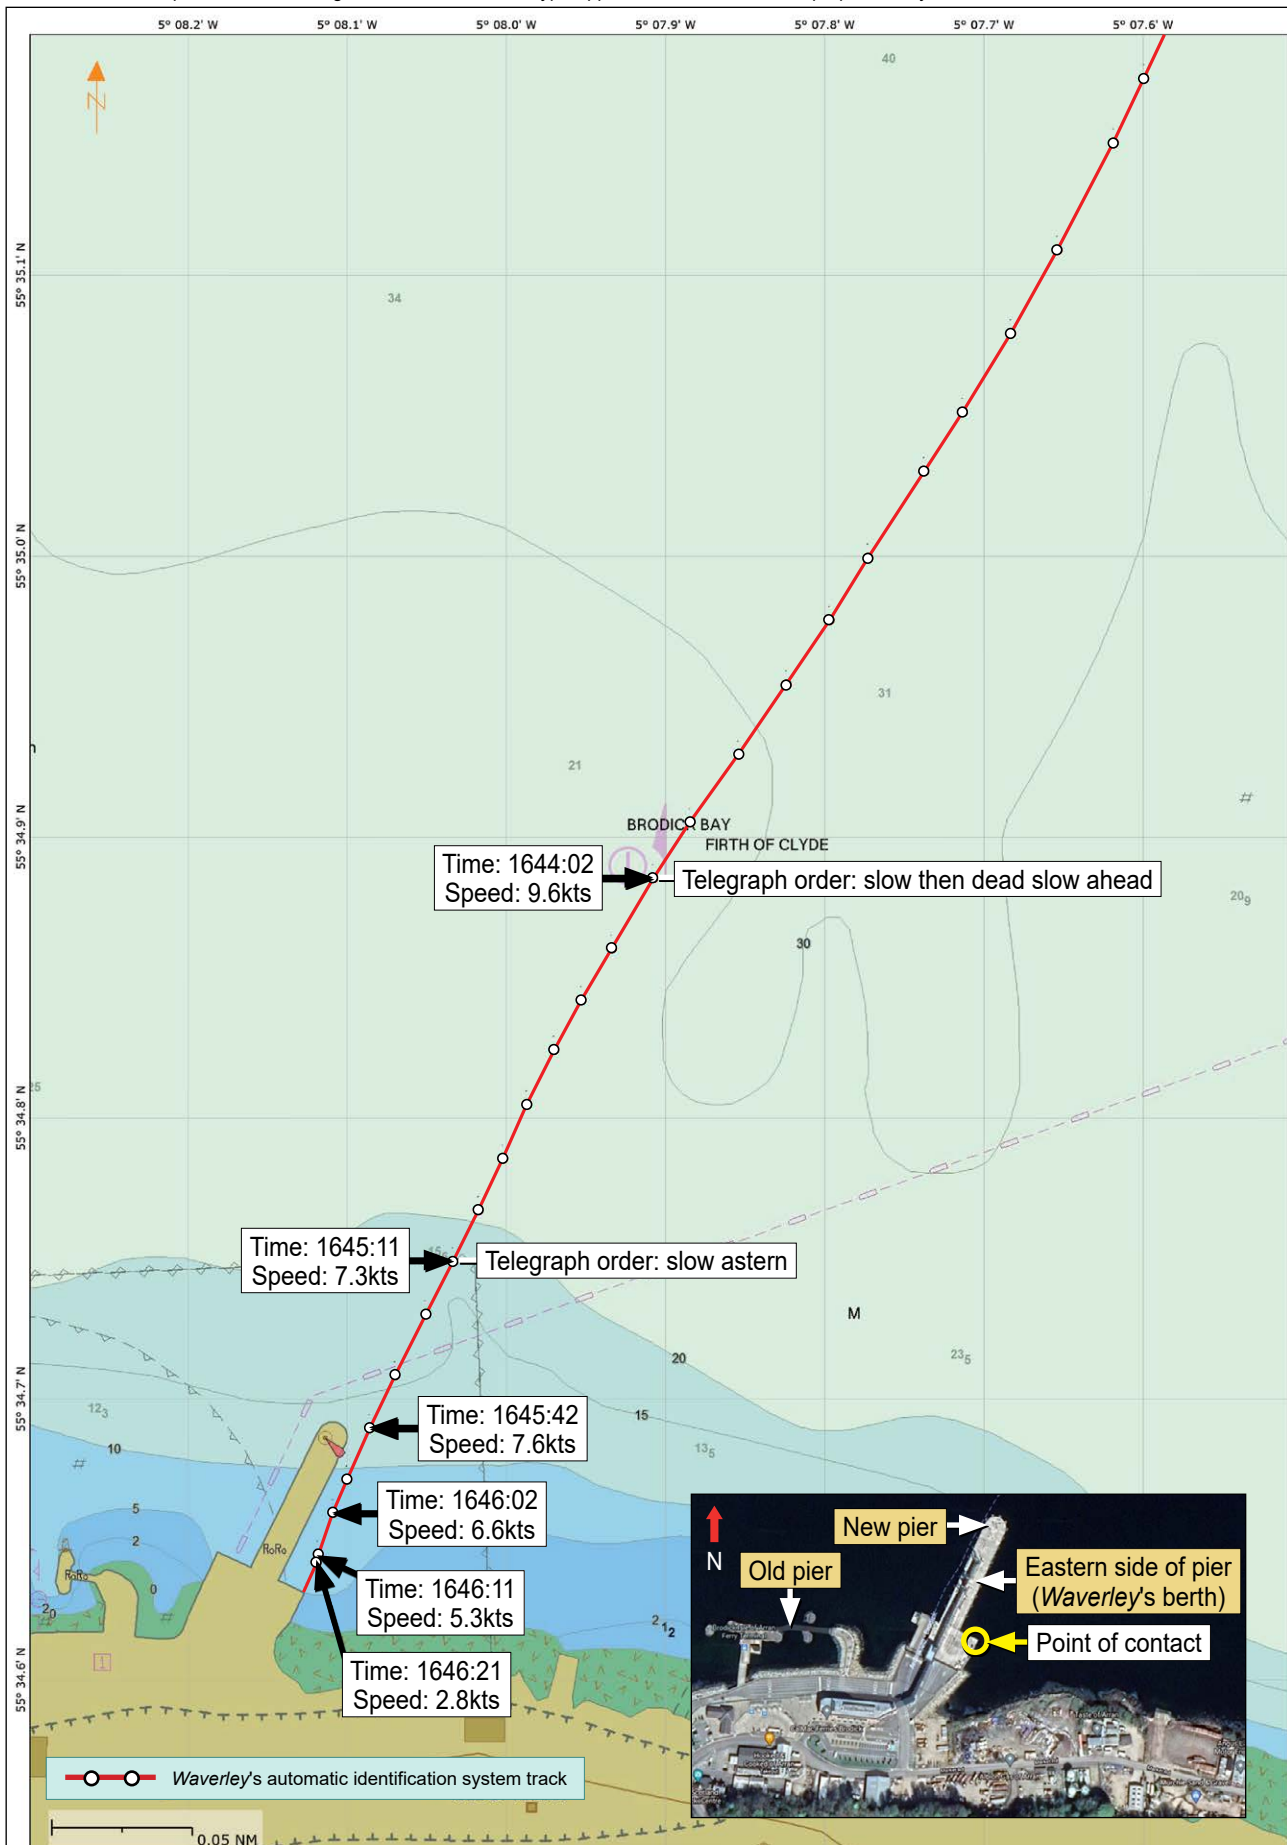
Figure 4: *Waverley's* approach to Brodick pier on 3 September 2020 and (inset) aerial image of Brodick new and old piers

At 1640, *Waverley* entered Brodick Bay making 13kts over the ground; the relief master was standing next to the QM at the helm in the enclosed wheelhouse; and the chief officer (C/O) and master were on the open starboard bridge wing (**Figure 3**). At about 1644, with *Waverley* travelling at 9.6kts, the master ordered slow ahead on the engine order telegraph². The master then ordered dead slow ahead as the vessel shaped a course to approach the berth at the closed end³ of the eastern pier and *Waverley* slowed down. The master ordered slow astern when the vessel was 100m away from the berthing position and, as planned, ordered the QM to apply a 10° turn to port as *Waverley* passed the end of the pier (**Figure 4**).

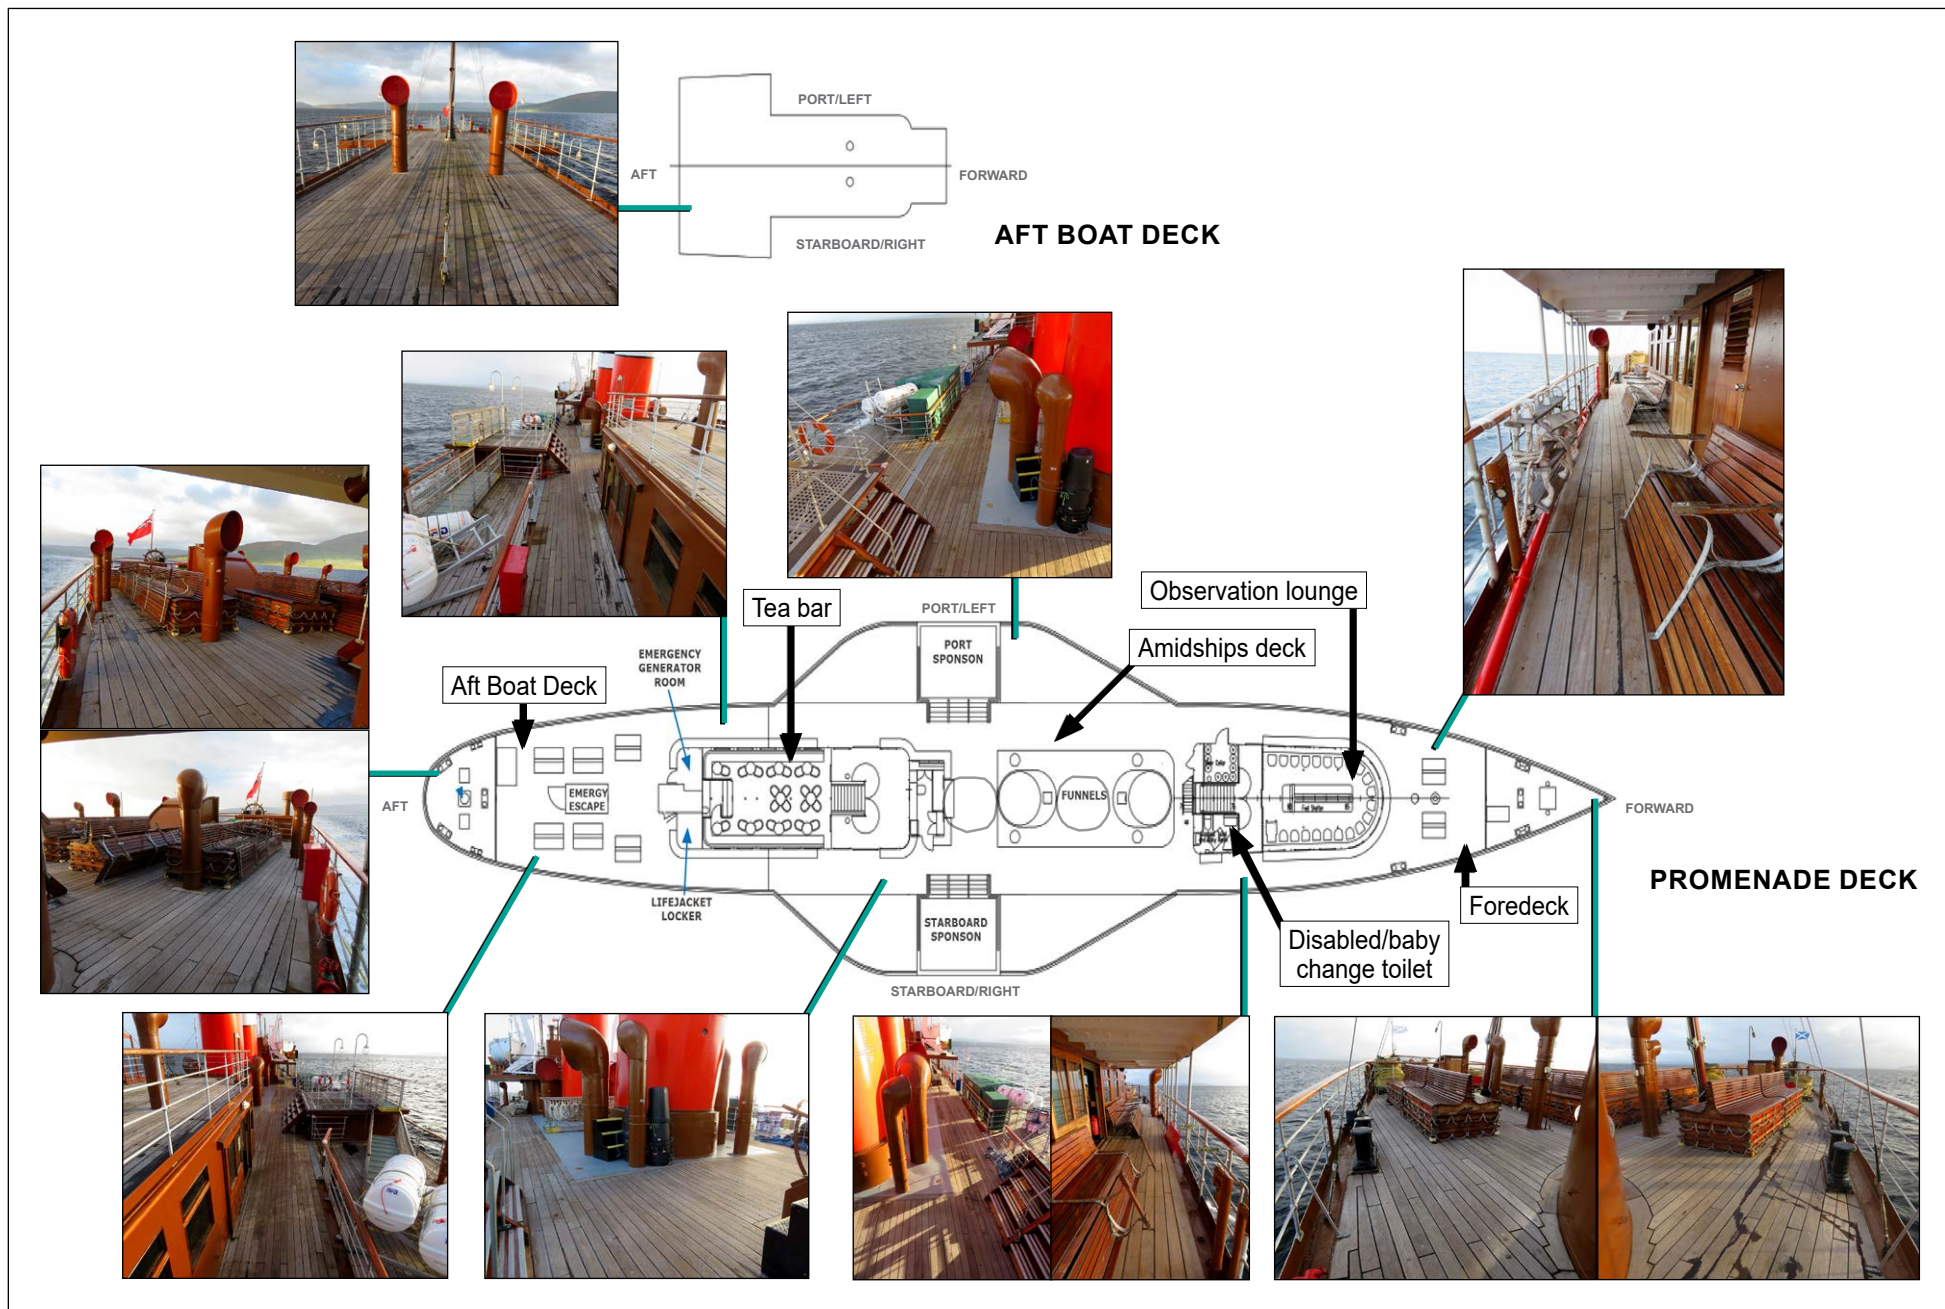
Figure 6: Layout of *Waverley*'s Promenade Deck and Aft Boat Deck (above Promenade Deck) with views of external areas after the accident with deck furniture stowed

When *Waverley* struck the pier many of its passengers and crew were standing up to watch the arrival from positions on the open Aft Boat Deck and Promenade Deck (**Figure 6**) and they either fell to the deck or made contact with the vessel's structure or fixtures and fittings as they were thrown forward. The engine continued to operate astern just after the collision, propelling *Waverley* backwards along the pier. The master stopped the engine and ordered the crew to pass the vessel's mooring lines ashore. The C/O left the bridge to conduct a damage assessment of the bow and the crew passed mooring lines from the deck, which were then secured to bollards on the quay by the waiting linesmen. The vessel was made fast at 1650. The QM made an announcement to reassure the passengers, and crew members who were not involved in the berthing operation provided first aid support to the injured passengers. The master coordinated the immediate incident response with Brodick's port manager and staff. The C/O returned to the bridge and advised the master that the forepeak had been breached above the waterline and that there were no signs of flooding.

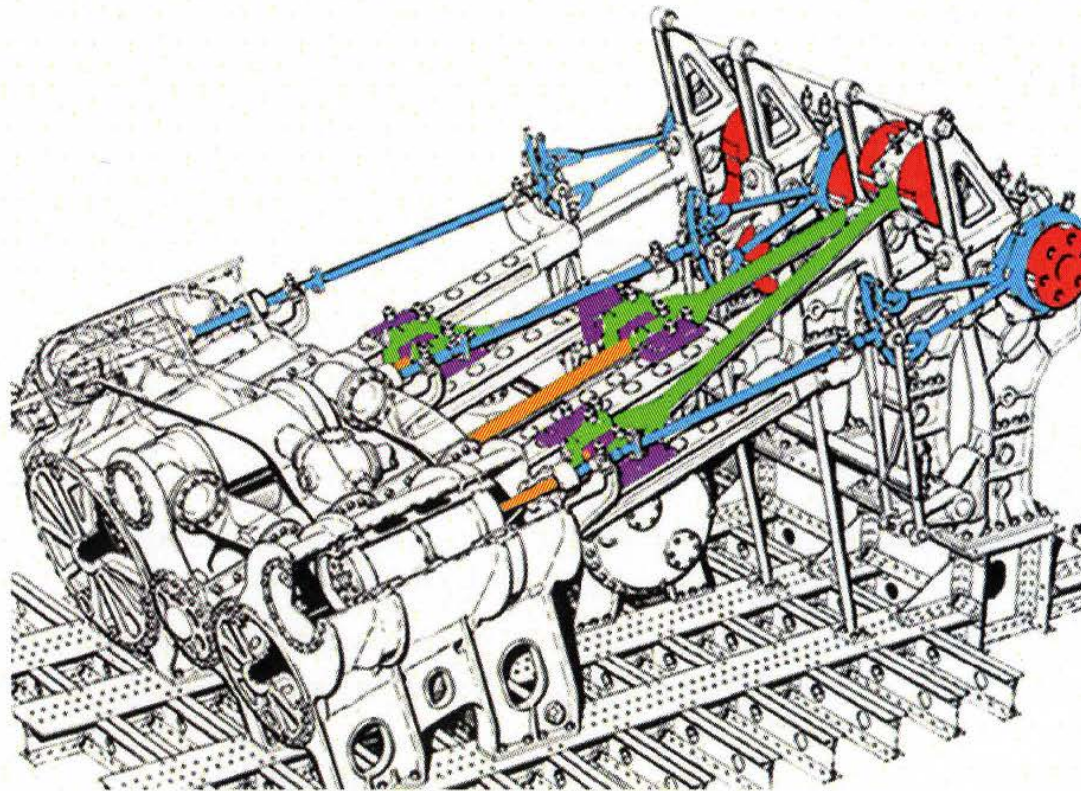
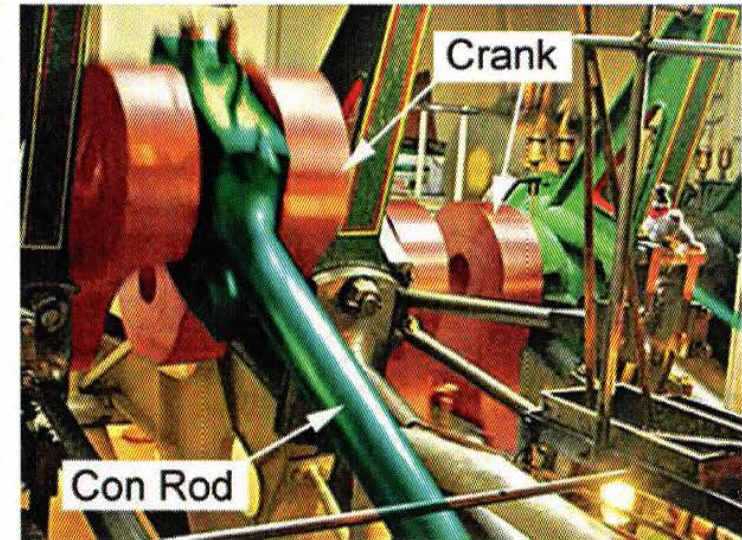
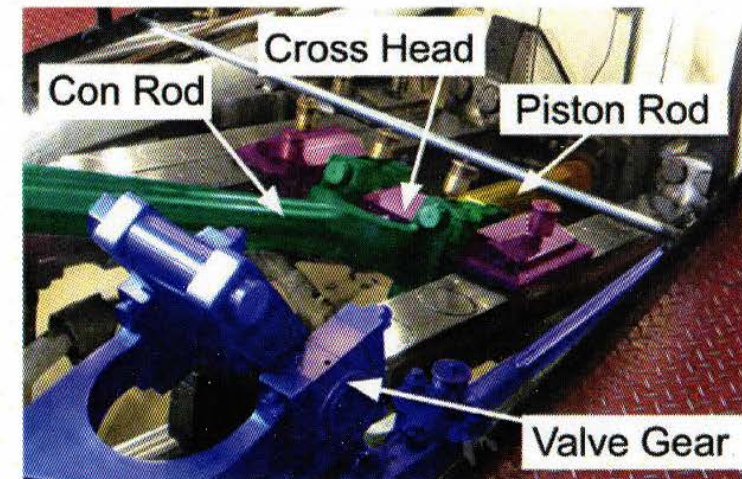
Figure 8: Diagram and photos showing the location of the three cylinders and the condenser

Waverley's incline-mounted, triple-expansion steam reciprocating engine was built in Greenock, Scotland by Rankin & Blackmore Ltd (**Annex A**). It operated using 12.4 bar (180 psi) saturated steam generated by two boilers in the boiler room to drive a HP, medium-pressure (MP), and low-pressure (LP) piston, each housed within its own cylinder. The three pistons were each connected via a connecting rod and crank¹⁰ to the single crankshaft (**Figure 8**), which directly turned both paddle wheels; it was not possible for the paddle wheels to turn at different speeds or in different directions simultaneously.

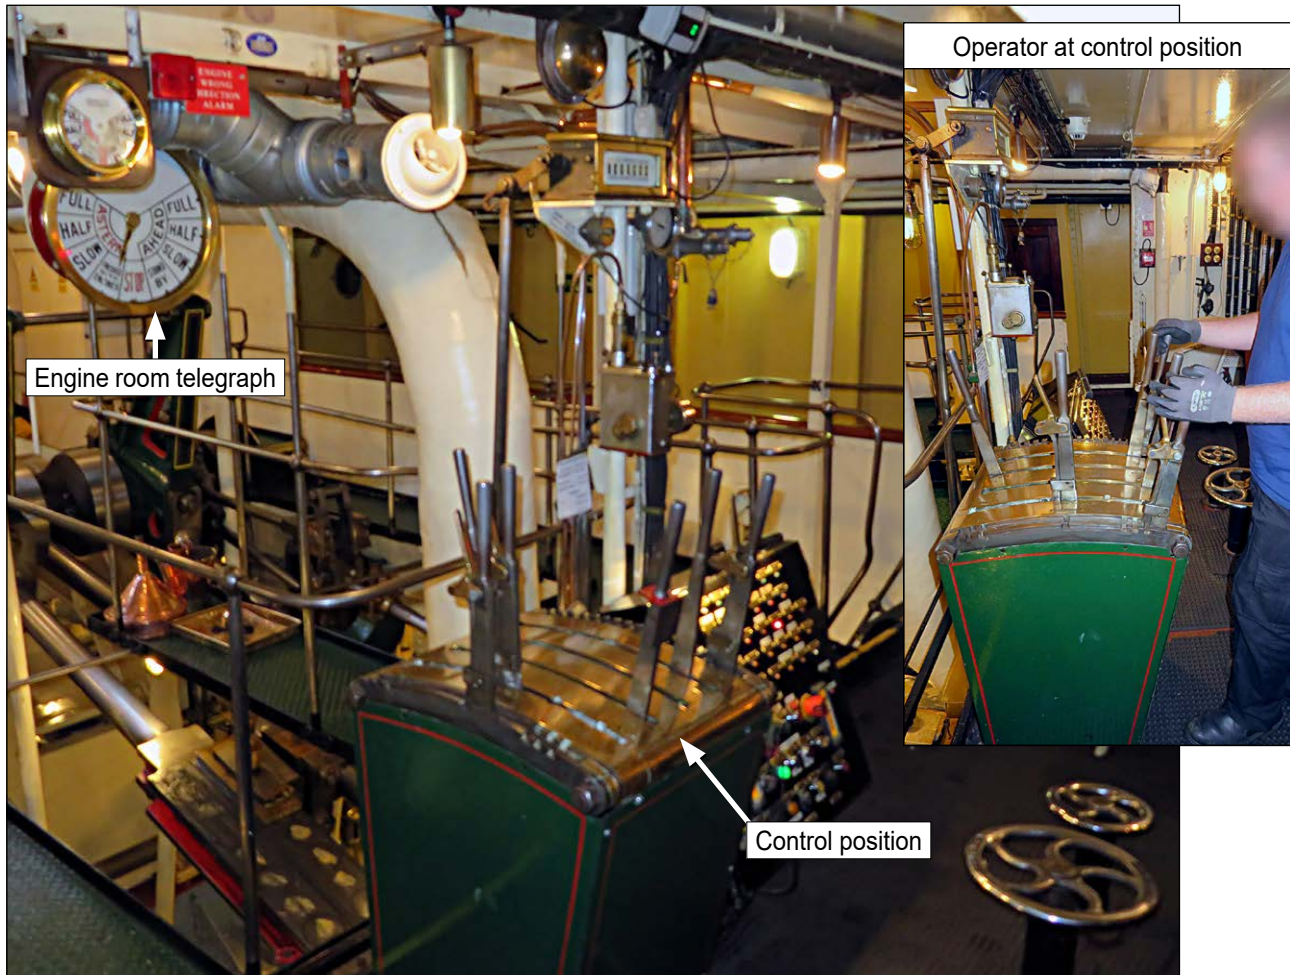
Figure 10: View of the engine room looking forward to starboard and (inset) an operator at the engine control position

The on-watch engineer operated the engine directly from the engine control station in the after end of the engine room overlooking the engine (**Figure 10**). This required the use of six control levers, three primary and three secondary (**Figure 11**), to manually direct the flow of steam through the cylinders to achieve the required direction of crankshaft rotation to provide forward or astern propulsion.

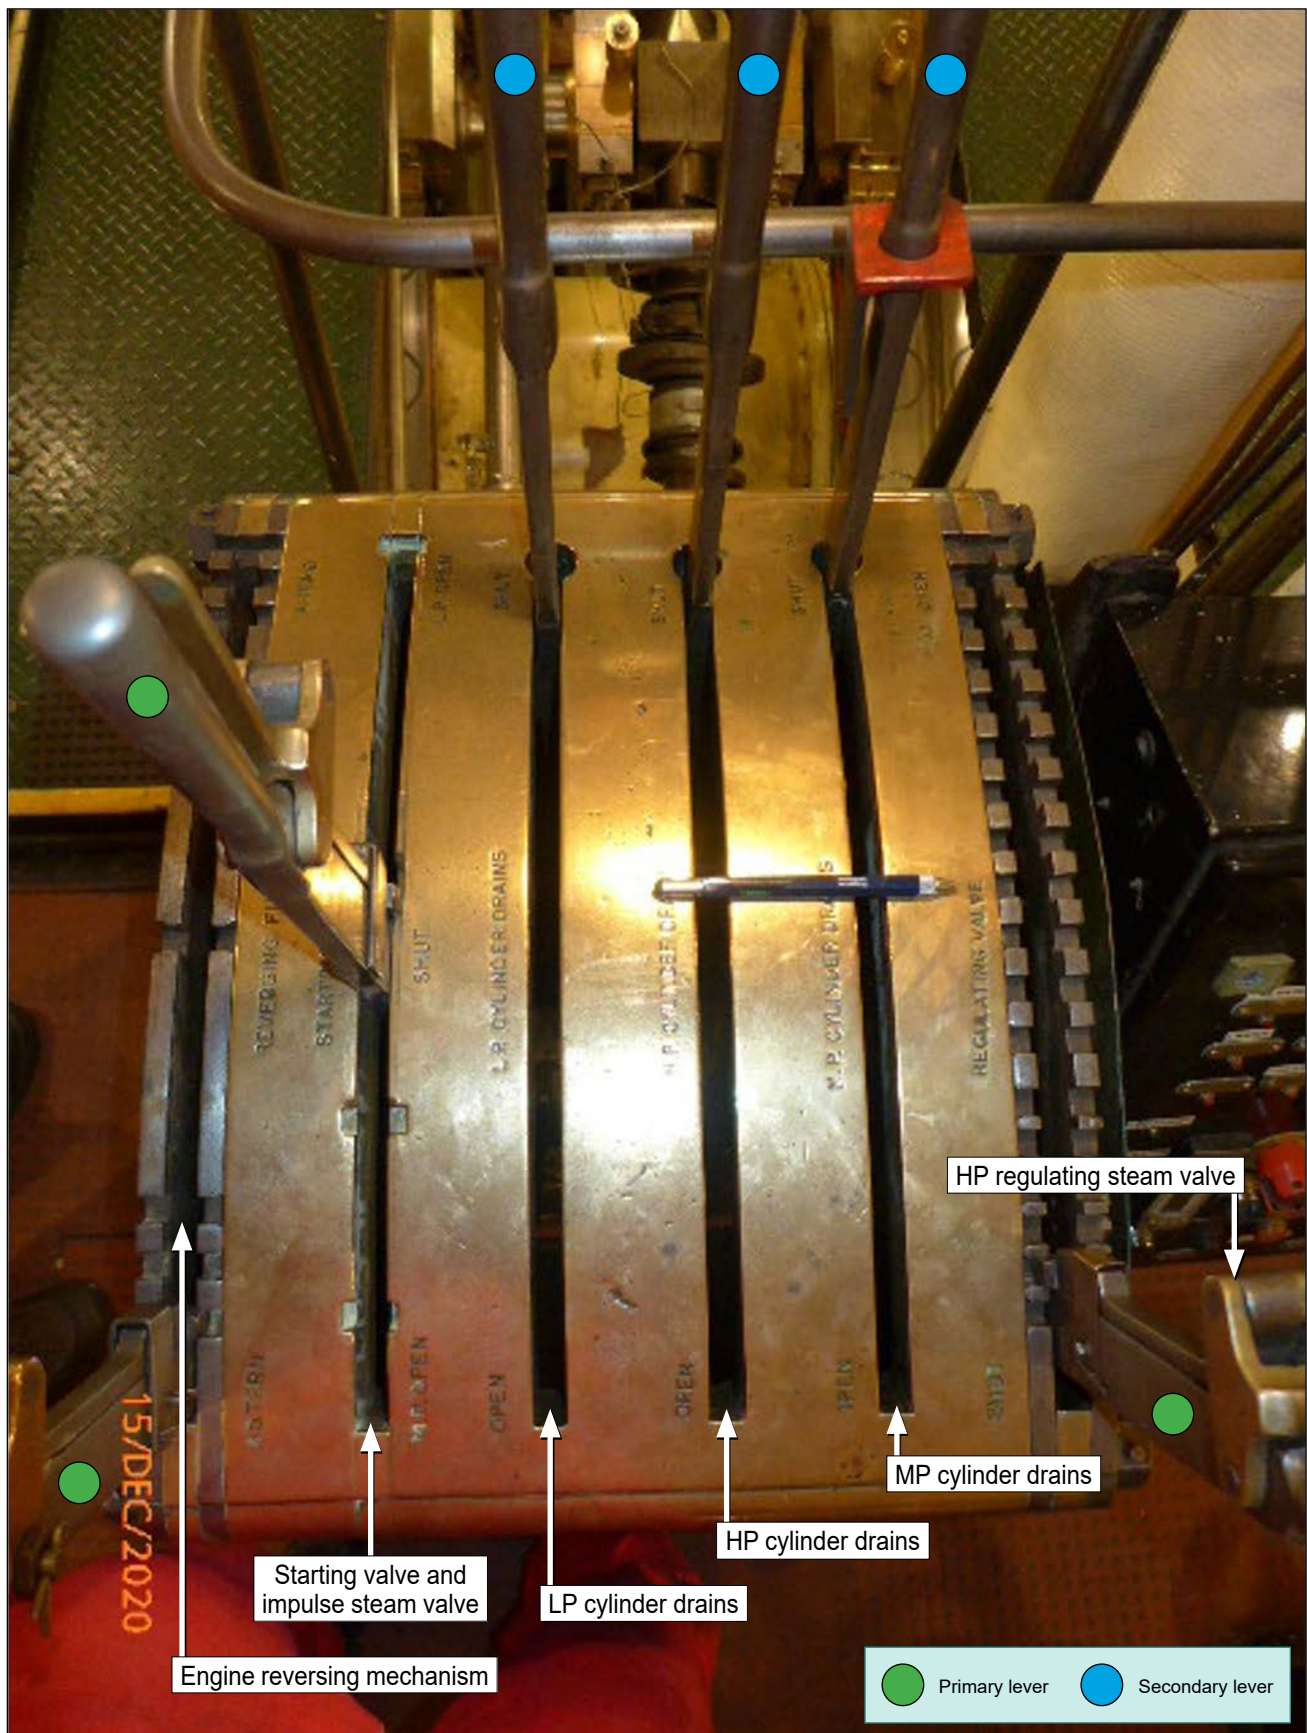
Figure 11: Engine control levers at the engine control position

When a new engine order was received from the bridge, the on-watch engineer adjusted the HP regulating steam valve lever (**Figure 11**) to manage the amount of steam entering the HP cylinder and in turn control the speed of the crankshaft and the paddle wheels.
