Rail Accident Report

**Track workers struck by a train at Margam,
Neath Port Talbot
3 July 2019**

Report 11/2020
November 2020

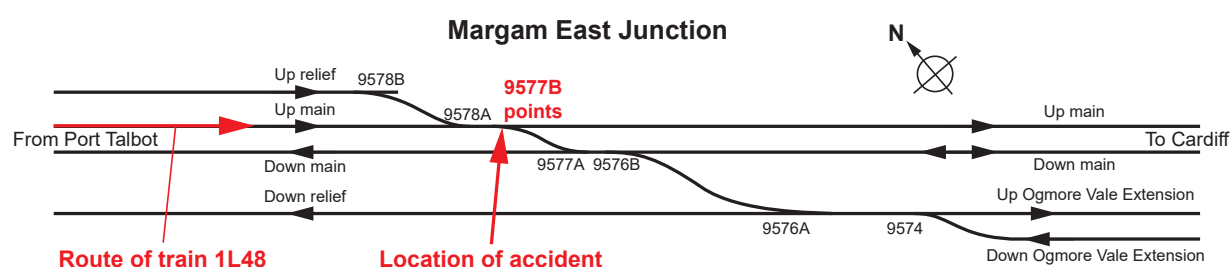
Figure 2: Track layout

- 8 The points involved, numbered 9577B, form part of a *crossover* between the up and down main lines (figure 2). The crossover forms part of the route between the up *relief line*, which is on the north-east side of the main lines and terminates at Margam East Junction, and the up and down Ogmore Vale Extension (OVE) lines, which are on the south-west side of the main lines and give access to a number of freight destinations including Margam Abbey (Port Talbot) steelworks.

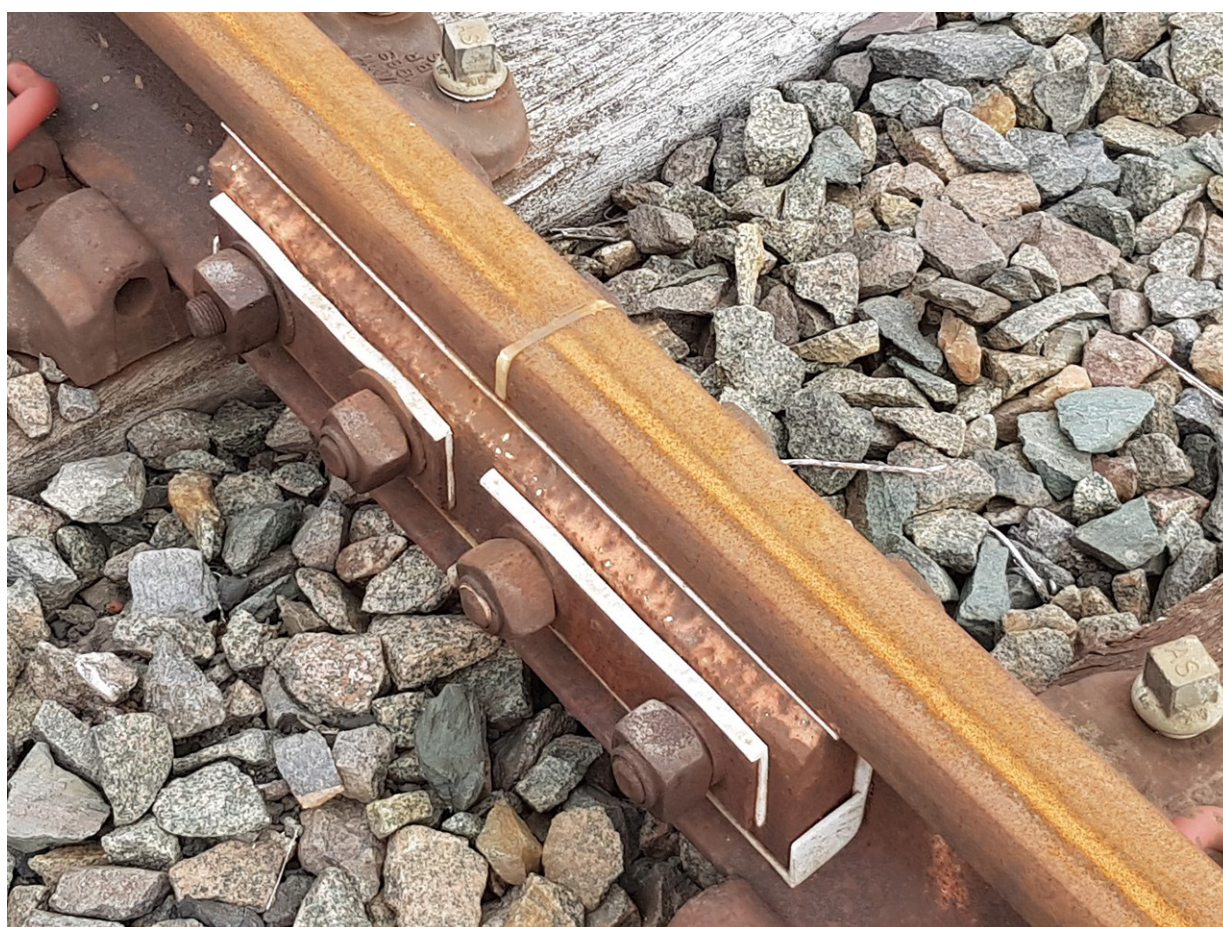
Figure 6: Insulated rail joint

- 70 An insulated rail joint (IRJ), also known as an insulated block joint, is a type of rail joint that uses components that are electrically non-conducting and assembled in such a way as to prevent the flow of electric current between the two adjoining rails (figure 6). Track circuits, which are the basis of the signalling system used in the Margam area, detect whether a train is present or not and control the operation of the lineside signals seen by the train driver. There is a pair of IRJs at each end of each track circuit, one for each rail.

- 71 It is important that the non-conducting property of an IRJ is maintained. Between the two abutting rail ends is an insulating spacer, and a common failure mode is for the rail ends to become deformed by the impact from passing wheels, leading to damage to the rail ends and the top of this spacer. This rail deformation is referred to as 'lipping'. If it is not checked, the two lipped rail ends may eventually make contact, at which point the electrical insulating property of the joint is lost. This will usually show up as a failure of one or both adjacent track circuits, meaning that the signals cannot be cleared for trains to pass.

- 72 If inspection of an IRJ shows that lipping is occurring, the joint can often be repaired by grinding away the deformed portion of the rail ends to restore the gap between them, grinding the top of the spacer to reduce its height, then adding a resin to build up the spacer again. The resin is then smoothed off to match the profile of the rails before it hardens. This operation is referred to by track maintenance staff as 'trimming' the IRJ.

- 73 If inspection of an IRJ shows that trimming is required, it is important that maintenance staff inform the signaller before starting work. This is because the process of grinding the deformed rail ends may bridge the gap between them, leading to a track circuit failure as described in paragraph 71.

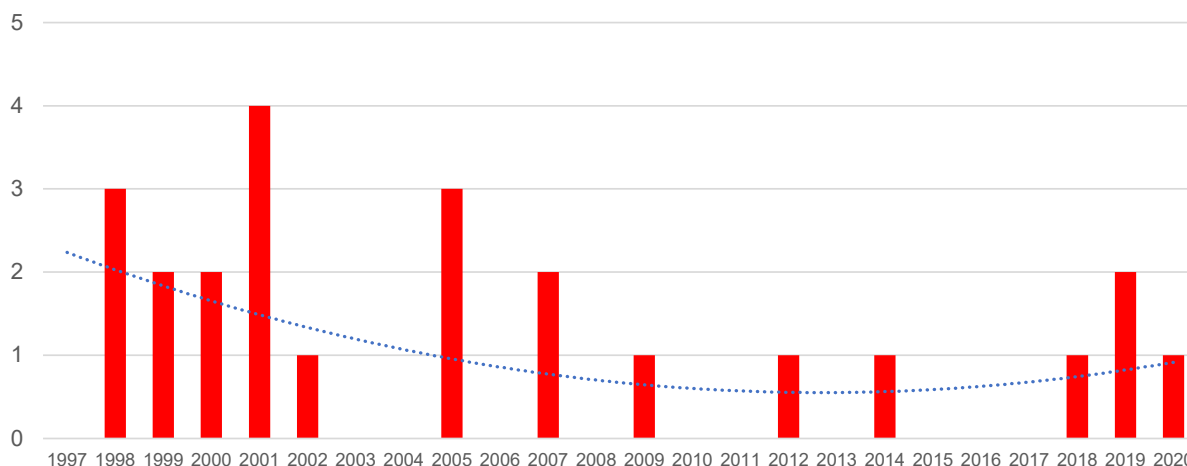
166 Figure 10 shows the number of fatalities as a result of track workers being struck by trains for each year between 1997 and 2020. This suggests a falling trend for most of that period. However, since 2018 there have been three fatal accidents resulting in four fatalities. Following a gradual decline in near misses to around July 2018, there has since been a gradual increase in such incidents, many of which have been judged to have had high potential for causing serious harm to one or more track workers (figure 11).

Figure 10: The number of fatalities as a result of track workers being struck by trains for each year from 1997 to the end of October 2020 (source: RAIB)

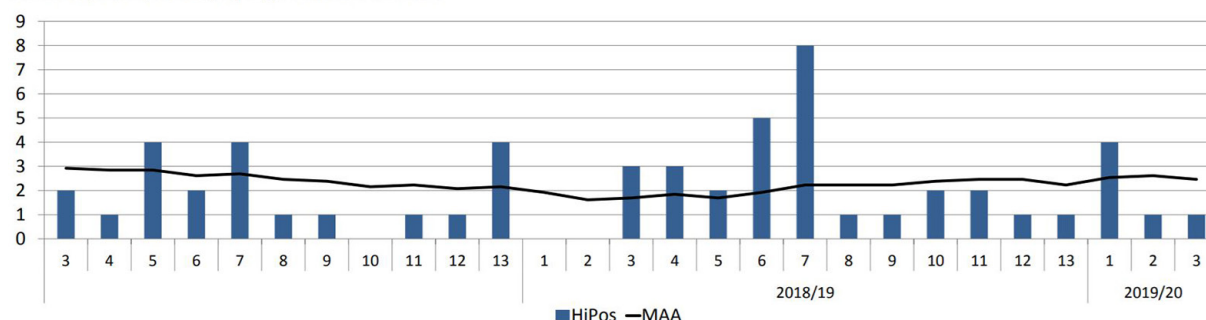
Figure 11: The number of workforce safety high potential incidents over the two years before the Margam accident (extracted from Network Rail's Safety, Health and Environment Performance Report, Period 3, 2019/20)

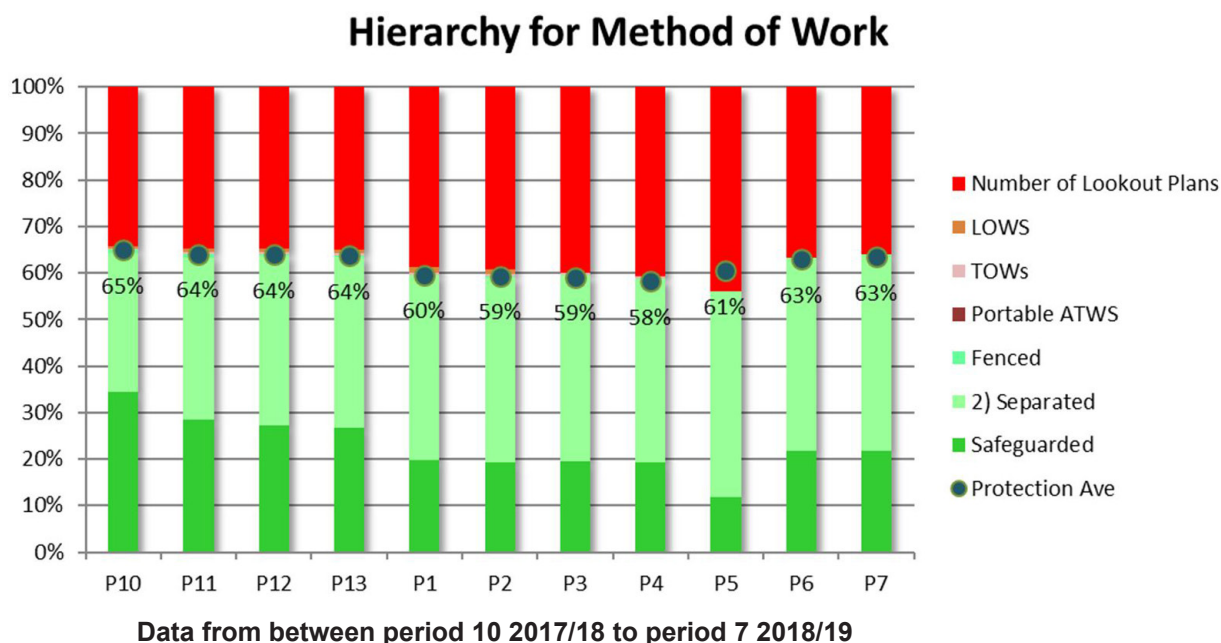
Figure 12: Proportion of work planned to take place with different forms of 'protection' (green columns in figure above) and 'warning' systems (red columns in figure above) (extract from Network Rail paper 31/18 submitted to the Safety, Health and Environment Committee, November 2018)

191 These figures indicate that the programmes for separating people from trains which have been implemented by Network Rail in recent years have yet to achieve a sustained reduction in the exposure of track workers to the risk of being struck by moving trains.

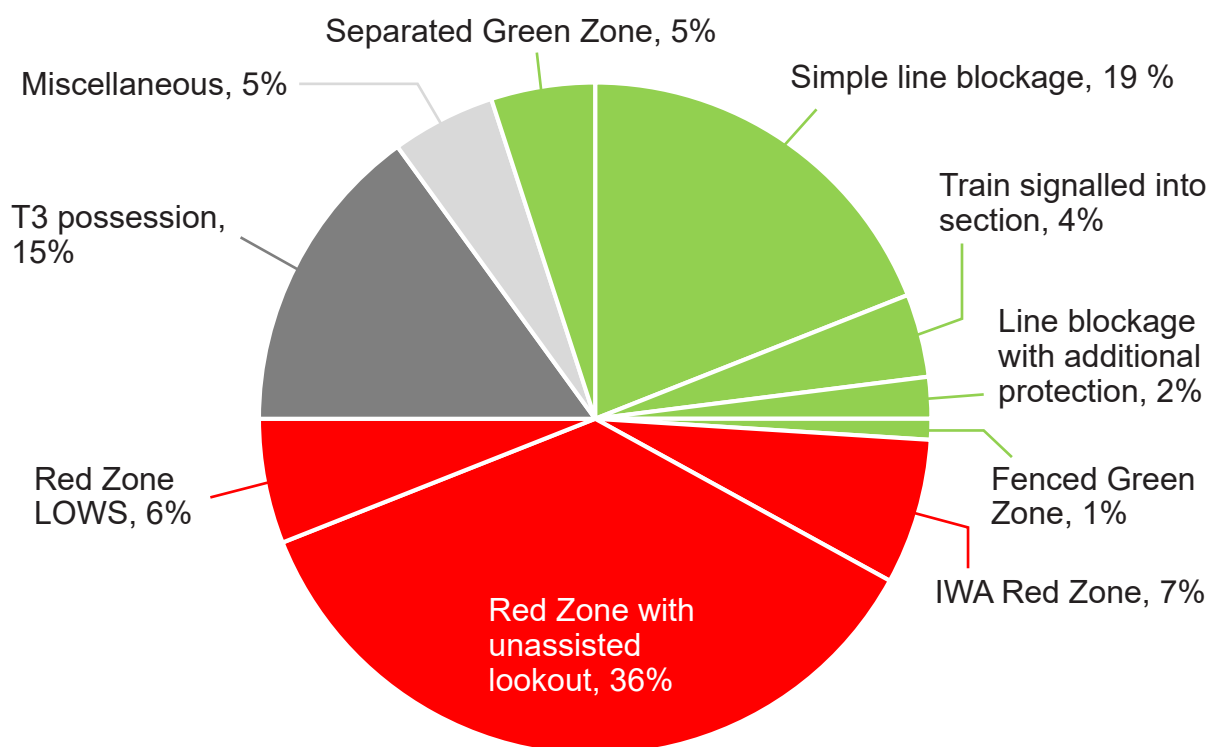
Figure 13: Near misses recorded for work planned using different Safe System of Work types; two years 2014/15- 2015/16 (source: Network Rail). The red coloured sectors show the proportion occurring under the 'warning' safe system of work

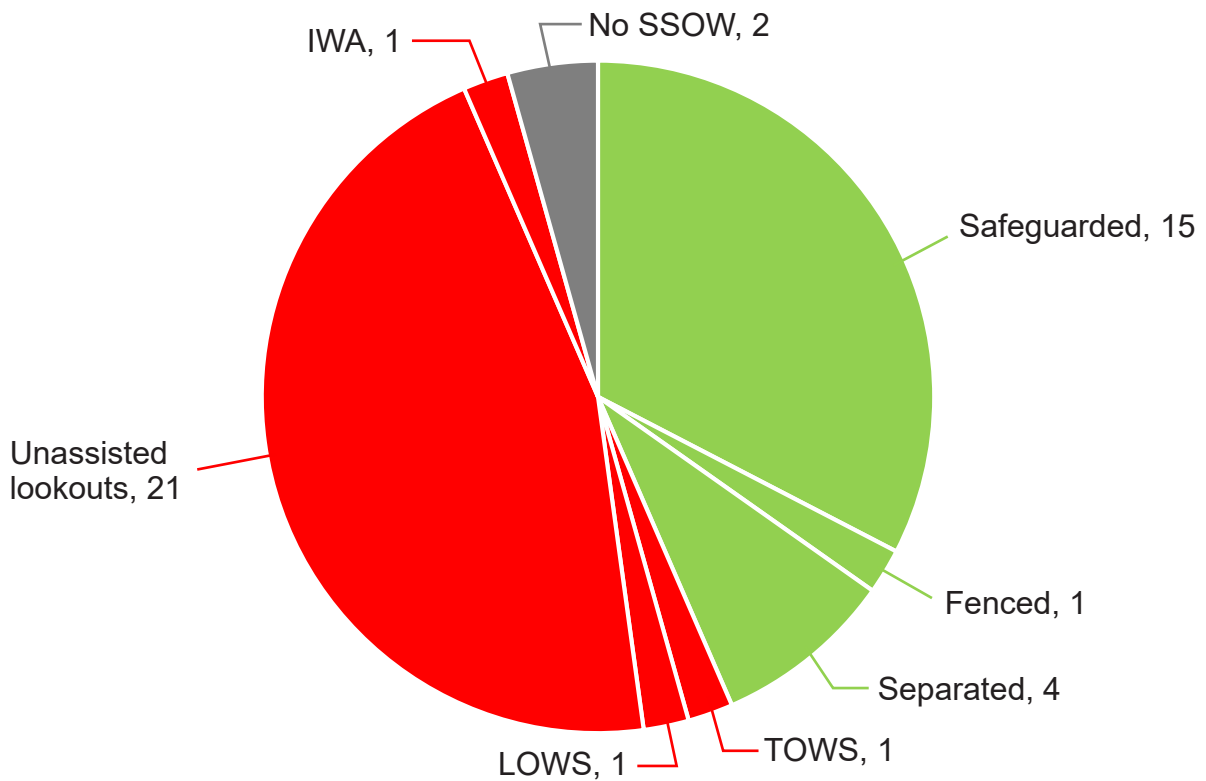
242 The analysis showed that almost half the accidents and incidents occurred while staff were working under an unassisted lookout warning system (figure 14). In standard 019 this method of work is considered to carry the highest risk, and should only be used as a last resort, being vulnerable to variability in human performance. However, this method of work is often preferred by track worker teams because it offers them greater flexibility and autonomy than using protection arrangements (paragraph 185).

Figure 14: Chart showing the planned Safe Systems of Work of the 45 track worker accidents and incidents for which RAIB has published an investigation, bulletin or safety digest (Note: The data set totals 46 data points. The Heathrow Tunnel investigation is included twice, as it covered two separate events)

243 The chart shows that 43% of accidents and incidents occurred when staff should have been protected from train movements (they were working in what was formerly called 'green' zone). Some of these incidents were due to signallers or site safety leaders making errors when establishing line blockages, but many involved staff working beyond the planned limits of their safe system of work, often due to a lack of local knowledge. In the incidents using line blockages, none utilised 'additional protection' in which the COSS, signaller or signalling technician uses a secondary engineered safeguard to minimise the risk from a signaller error.

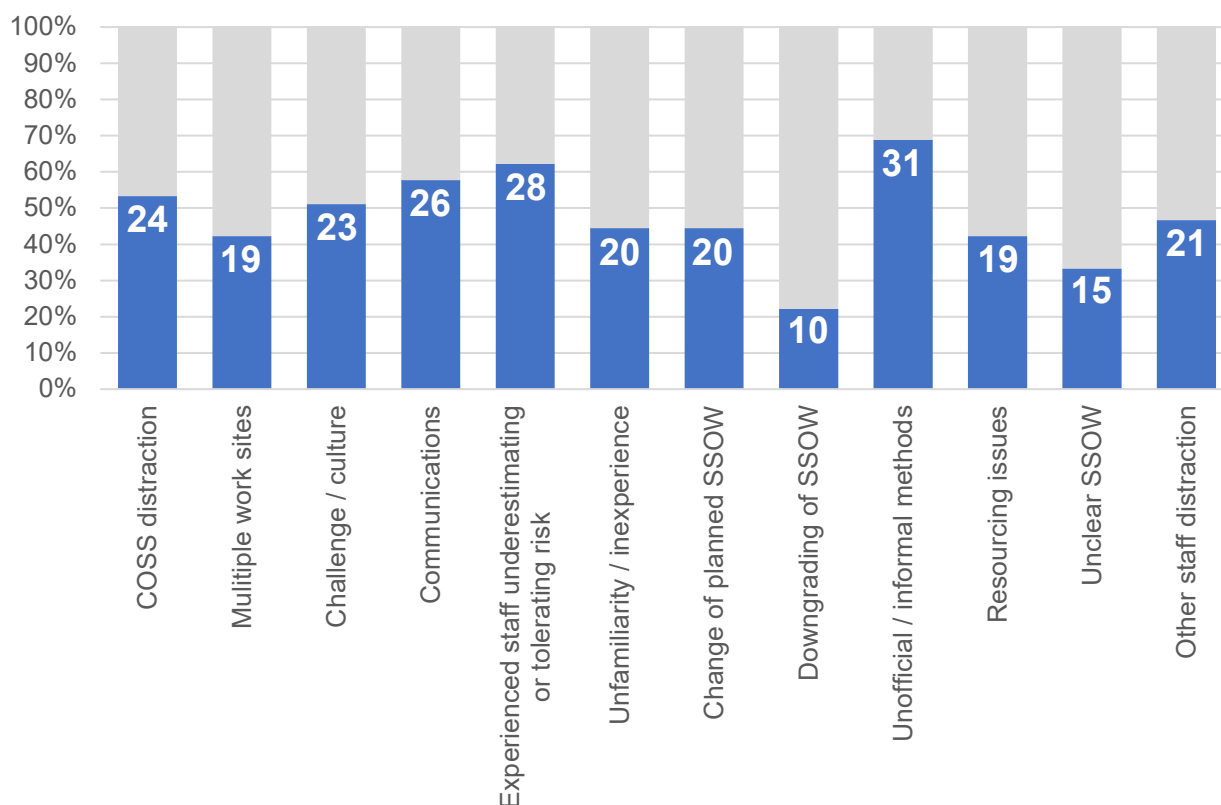
Figure 15: Occurrence of common causal factors in 45 RAIB published track worker reports

244 RAIB's review of the 45 reports listed in Appendix D revealed that there is no dominant cause of track worker accidents and near miss incidents (figure 15). Instead, there is a range of overlapping factors that are found to recur frequently. These include:

- use of unofficial working practices
- perception of risks by experienced staff
- poor safety critical communications
- COSS distraction
- unwillingness to challenge unsafe working or cultural issues.

245 RAIB's overall conclusion from its analysis of this data is that reliance on compliance with procedures alone is unlikely to achieve the required levels of safety unless steps are taken to separate people from moving trains. However, until this separation is routinely achieved there will continue to be a need to address the quality of procedures, the quality of leadership, and underlying behaviours and attitudes. RAIB also observes that the introduction of new technology to protect track workers, or to warn of approaching trains, will not overcome the need for willing compliance with effective procedures, continued risk awareness by everybody on site, good quality safety leadership and positive working relationships within teams.

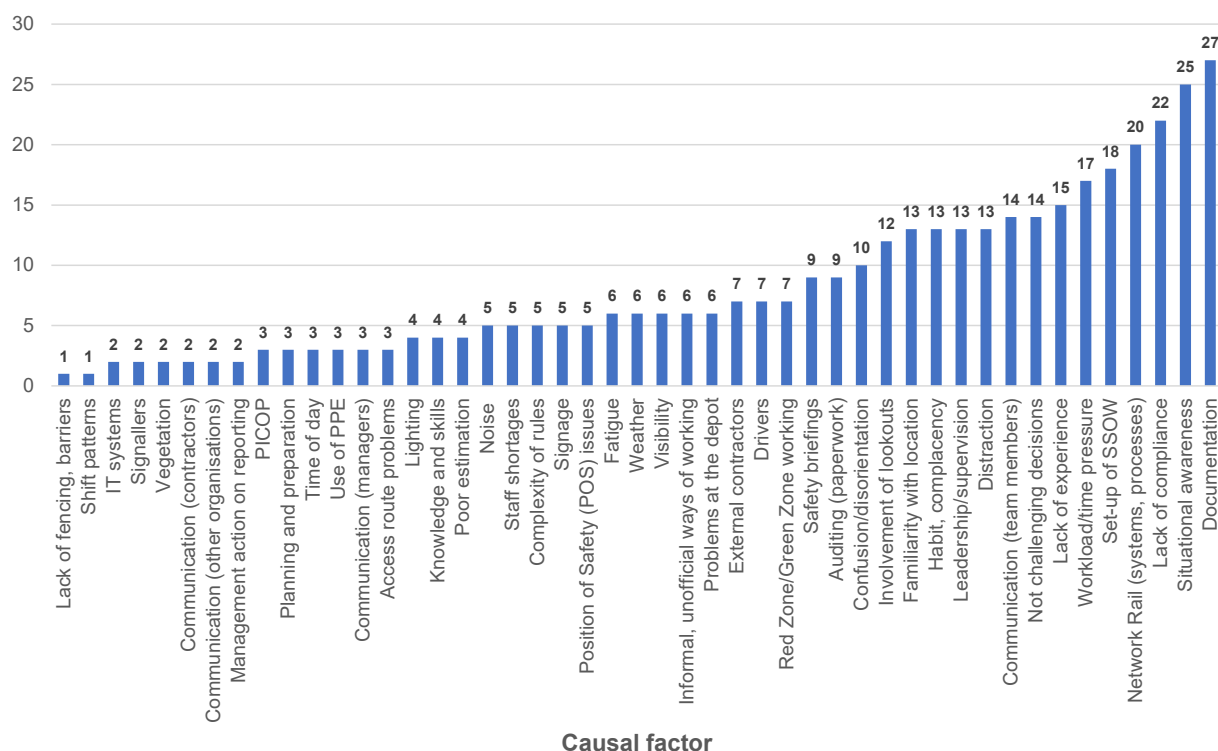
Figure 16: Aggregated causal factors and frequency of occurrence in RAIB reports

255 The list of factors from RAIB reports is shown in figure 16, ordered by frequency of occurrence. The most frequently occurring factor was 'documentation', and there was also evidence from the COSS focus groups that the increasing volume and complexity of site safety paperwork is becoming overwhelming. Part of this is associated with the experience and capabilities of the planners who produce the paperwork, which can vary between depots. COSSs saw value in planners having experience of being a COSS themselves, as well as knowledge of the location, to produce appropriate and usable paperwork.

256 When the COSSs rated these factors for frequency and severity, three factors stood out as being considered both high frequency and high severity: fatigue, workload/time pressure, and distraction. Comparing these with the findings from previous RAIB reports, fatigue was ranked 25th of 47 in terms of frequency (appearing in six of the 47 reports). In the focus group discussions, COSSs raised concerns about the amount of rest rostered between shifts, as well as variations in shift patterns. Meanwhile, workload/time pressure and distraction ranked sixth and tenth respectively for frequency in RAIB reports (appearing 17 and 13 times, respectively, in the 47 reports).

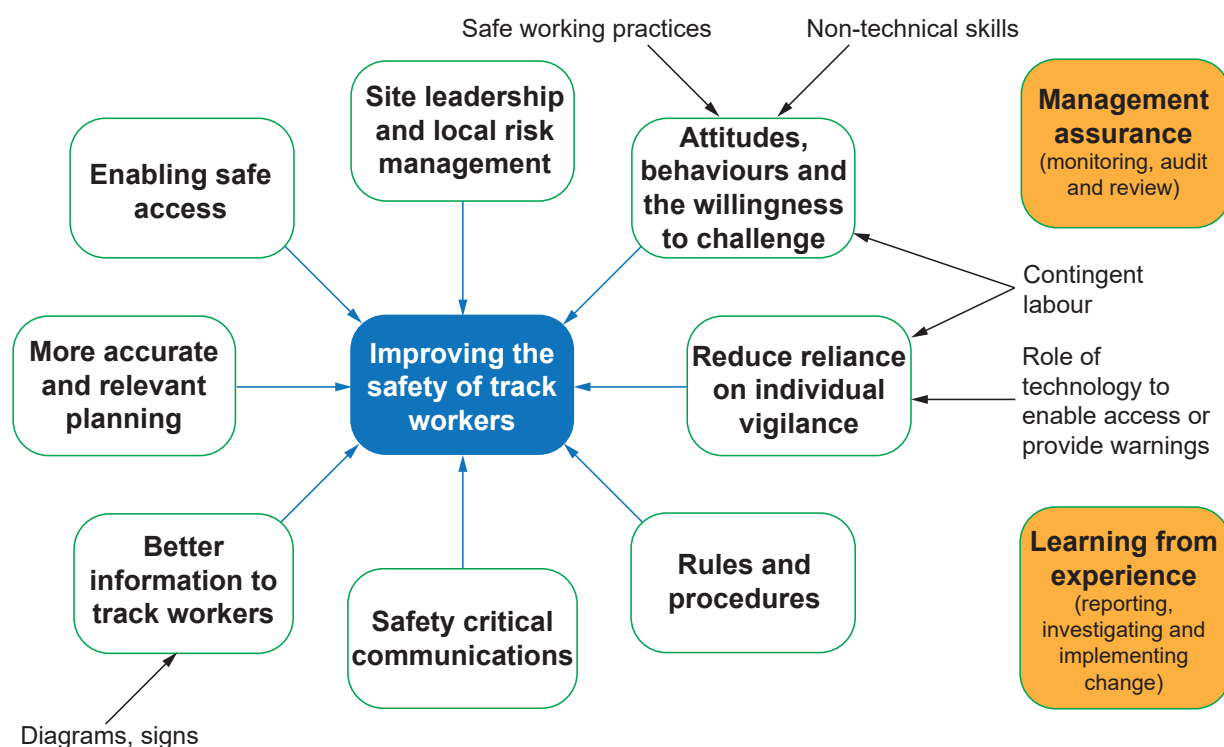
Figure 17: Key track worker safety themes identified by RAIB 2005-20

354 Between October 2005 and the accident at Margam in July 2019, RAIB had published 31 investigation reports, two class investigation reports and 14 safety bulletins/digests relating to track worker safety. Taken together, these evidence a range of the factors that have contributed to track worker accidents and near misses over this period. RAIB's own analysis of the findings of factors has enabled it to map the key themes that need to be addressed if track worker safety is to be improved, as shown in figure 17.

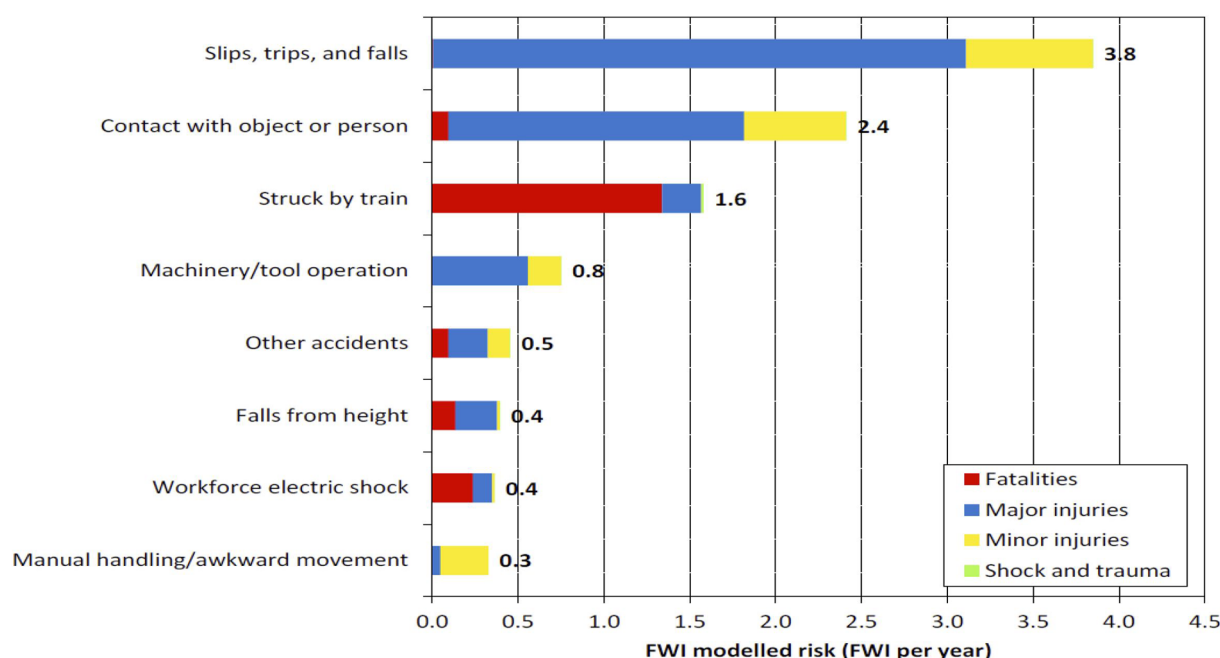
- H7 In September 2017, the chart shown in figure H1 was presented in a paper to the SHE committee. It showed that the biggest risk of harm to track workers was ‘slips, trips and falls’, with an FWI²⁶ of 3.8 per year, followed by ‘contact with an object or person’ with an FWI of 2.4 per year. The FWI for ‘struck by train’ was 1.6 per year. However, the chart also showed that the biggest risk of fatal accidents involving track workers on or about the line was being struck by a train (the data excluded road traffic accidents).

Figure H1: Chart presented in a paper to the SHE committee on 6 September 2017 (based on data in the RSSB Safety Risk Model)
