Rail Accident Report

Collision and derailment at Neville Hill 13 November 2019

Report 13/2020
November 2020

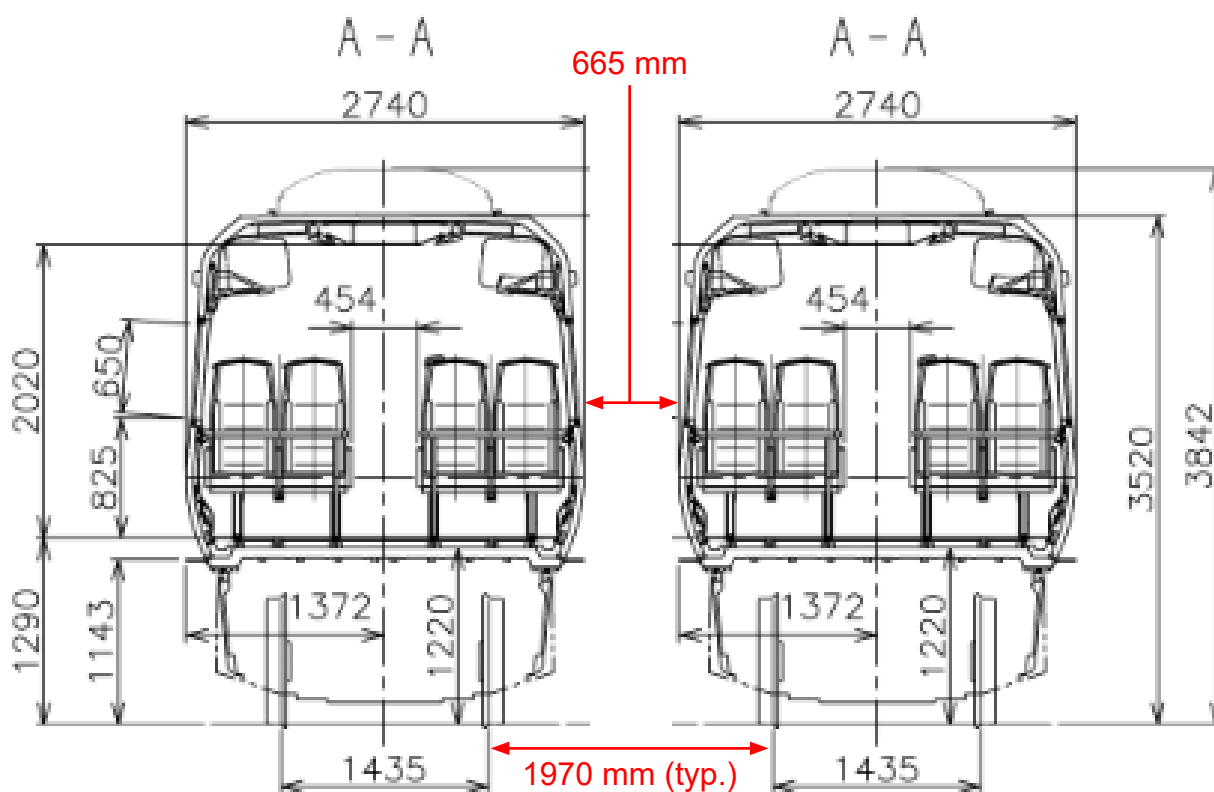
Figure 10: Typical passing clearance between two IETs on adjacent tracks

- 89 The trailing bogie of the second and third vehicles and the trailing wheelset of the fourth vehicle on the IET, derailed to the right in the direction of travel as a result of the collision. Figure 9 shows the lateral movement of the vehicles during the collision as witnessed by the marks left by the couplers on the vehicle structures. The extent of the derailment (up to 1.25 metre of lateral displacement on the second vehicle) would have been sufficient to significantly infringe the swept path of a vehicle travelling on an adjacent line, assuming a typical gap between adjacent running lines (known as the 'six-foot'), as shown in figure 10.

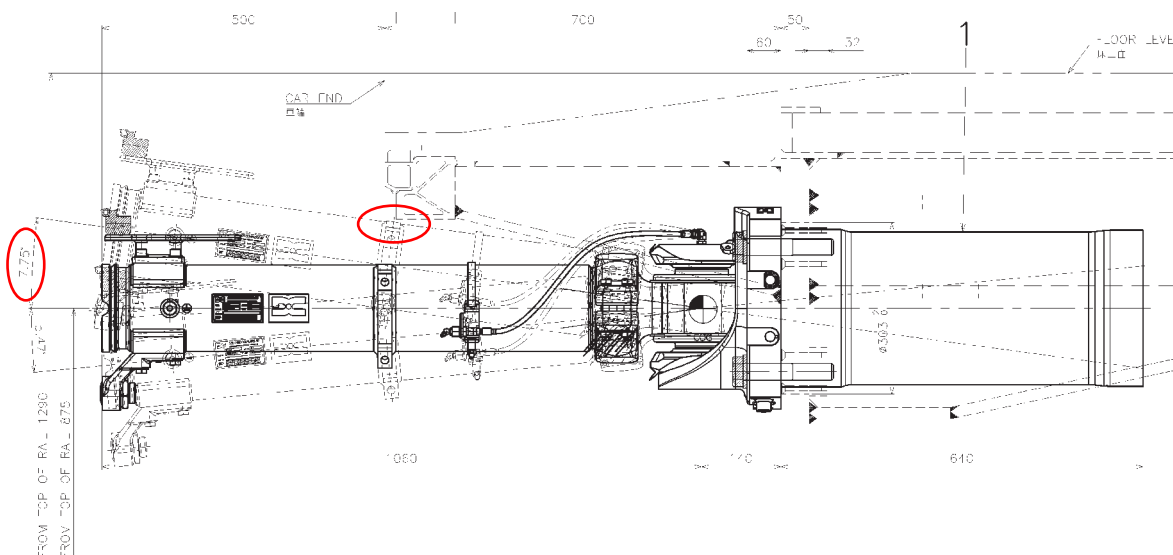
- An inter-vehicle coupler on an IET can pitch unrestrained until either of the following occurs: the coupler shank contacts the vehicle structure (figure 11), or contact between parts of the coupler itself prevents further movement. However, when a coupler starts to collapse, internal contact reduces the freedom of movement in pitch (figure 16). The representation of the inter-vehicle couplers was improved to model this variable restraint (figure 12).

Figure 11: Coupler pitch up movement and limit due to coupler contacting the carbody (courtesy of Hitachi)

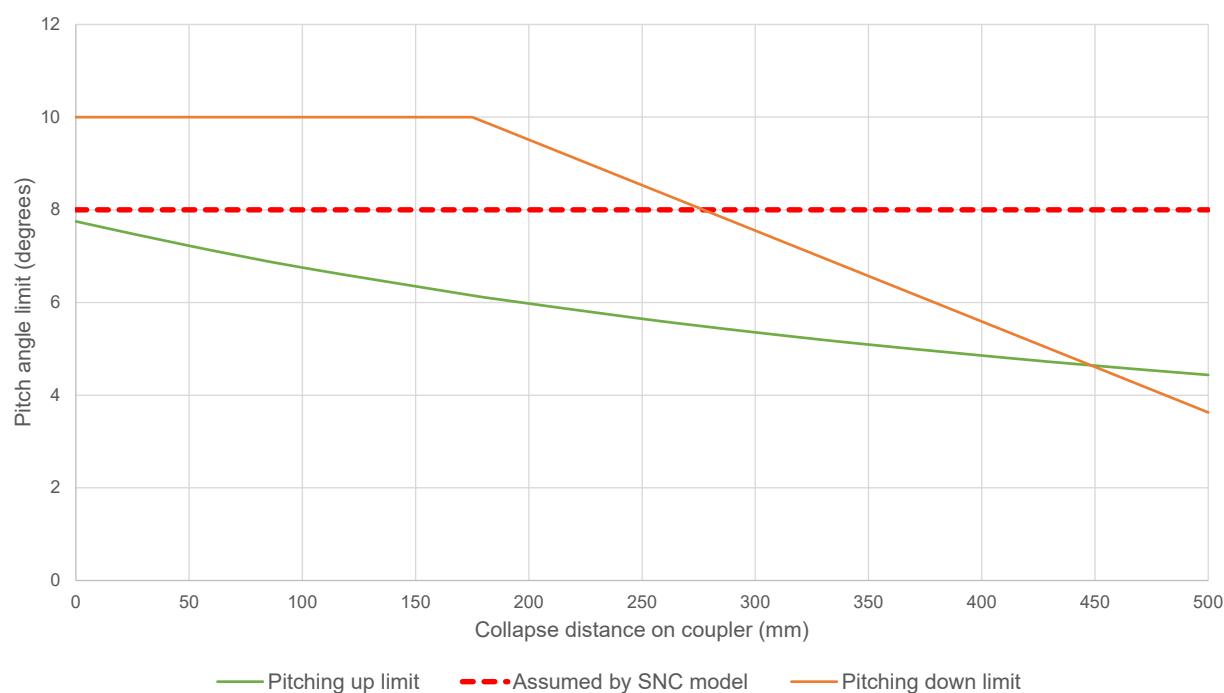
Figure 12: Graph showing how the pitch limits change as the inter-vehicle coupler collapses¹²

¹² Each coupler half can collapse by up to 500 mm. The inter-vehicle gap is 1000 mm.

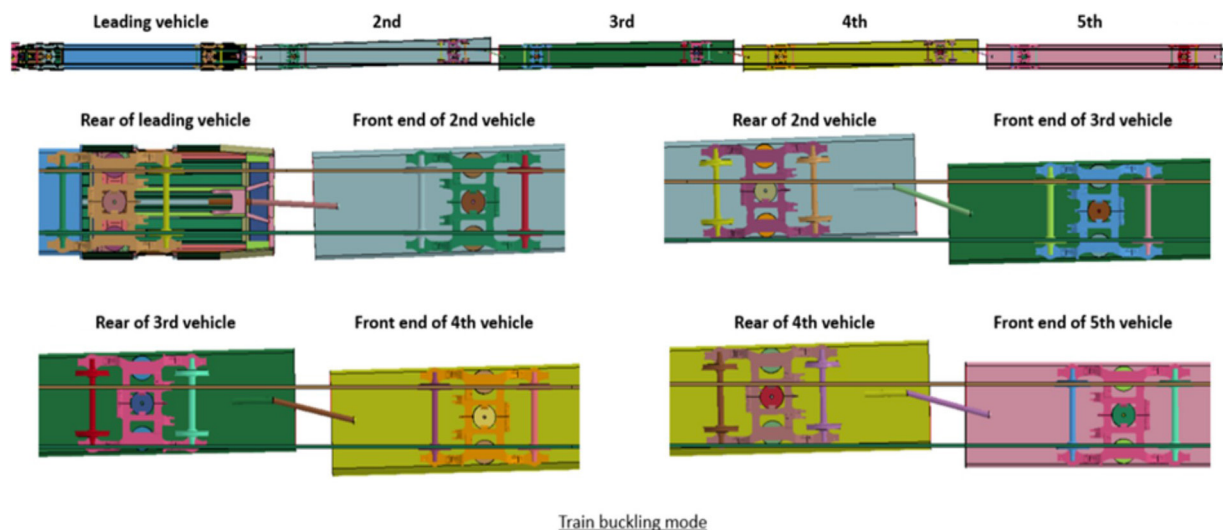
Figure 14: Output from collision and derailment simulation – bird's eye view (courtesy of Hitachi)

100 The Hitachi 3D model predicted that the leading couplers of the HST and IET would deflect each other sideways during the collision. This generated yaw movement on the leading vehicle which was then transferred to the other vehicles. Overall, the Hitachi 3D model predicted vertical and lateral displacements on all vehicles which were consistent in magnitude and direction with the observations on site.
