**Accident**

| <b>Aircraft Type and Registration:</b> | Piper PA-18-150, G-CUBX | |
| <b>Location:</b> | Croft Farm Airstrip (Defford Airfield), Worcester | |

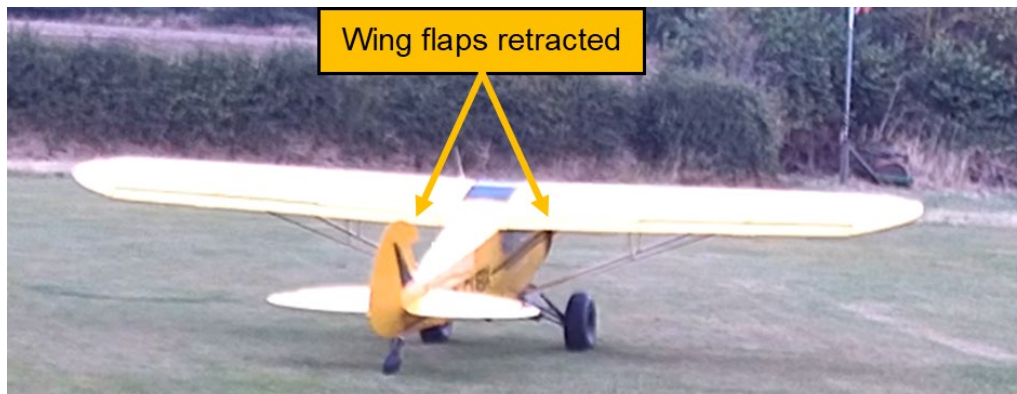
**Figure 1**

On the morning of the accident, the pilot used a remote-controlled aircraft tug to manoeuvre G-CUBX out of its hangar before completing his pre-flight checks. After initially having trouble starting the engine, he taxied out for departure from Runway 28. As the aircraft entered the runway to backtrack, its wing flaps were retracted (Figure 1).

CCTV snapshot showing G-CUBX entering Runway 28 to backtrack for departure
