Report on the investigation of  
the fatal contact between the dive workboat

***Karin***

and a recreational diver  
in Scapa Flow, Orkney Islands, Scotland  
on 28 September 2023

REPORT NO 16/2025

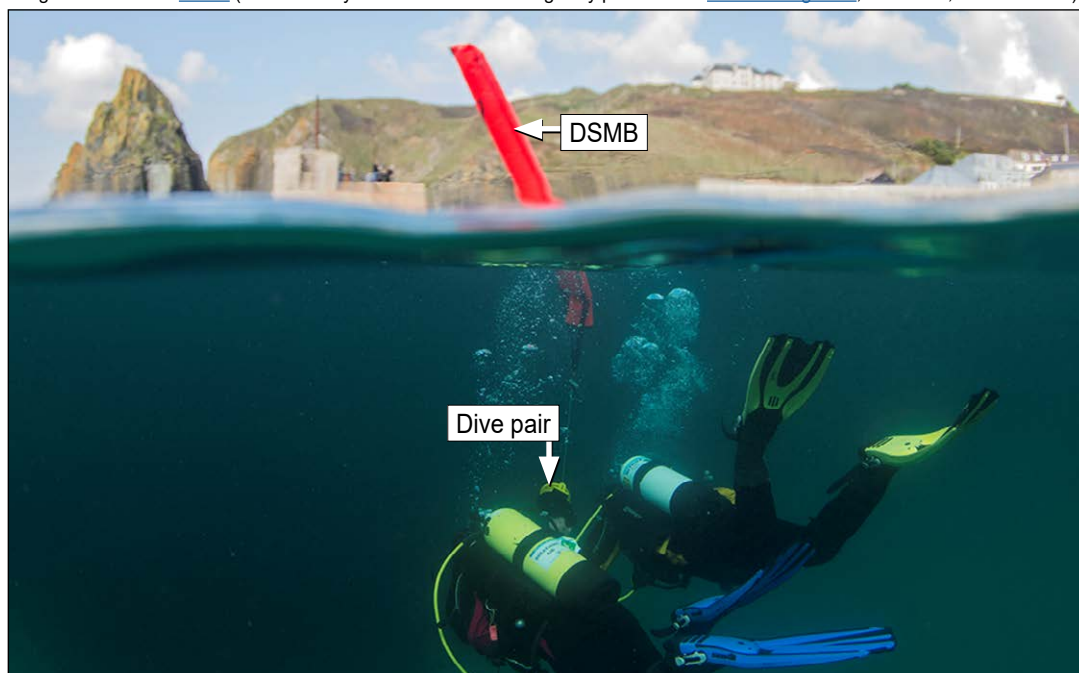
**Figure 7: A typical DSMB in use**

A DSMB is an inflatable tube or buoy about 1.4m in length with a 20cm circumference and typically orange in colour. DSMBs are deployed by ascending divers towards the end of a dive and inflated using the diver's air supply (**Figure 7**). DSMBs are typically connected to a hand reel to enable the user to control the length of line being payed out or reeled in and keep it taut in line with the depth of water (**Figure 8**). DSMBs assist support craft to locate and monitor divers' locations, and in doing so reduce the risk of contact and injury.

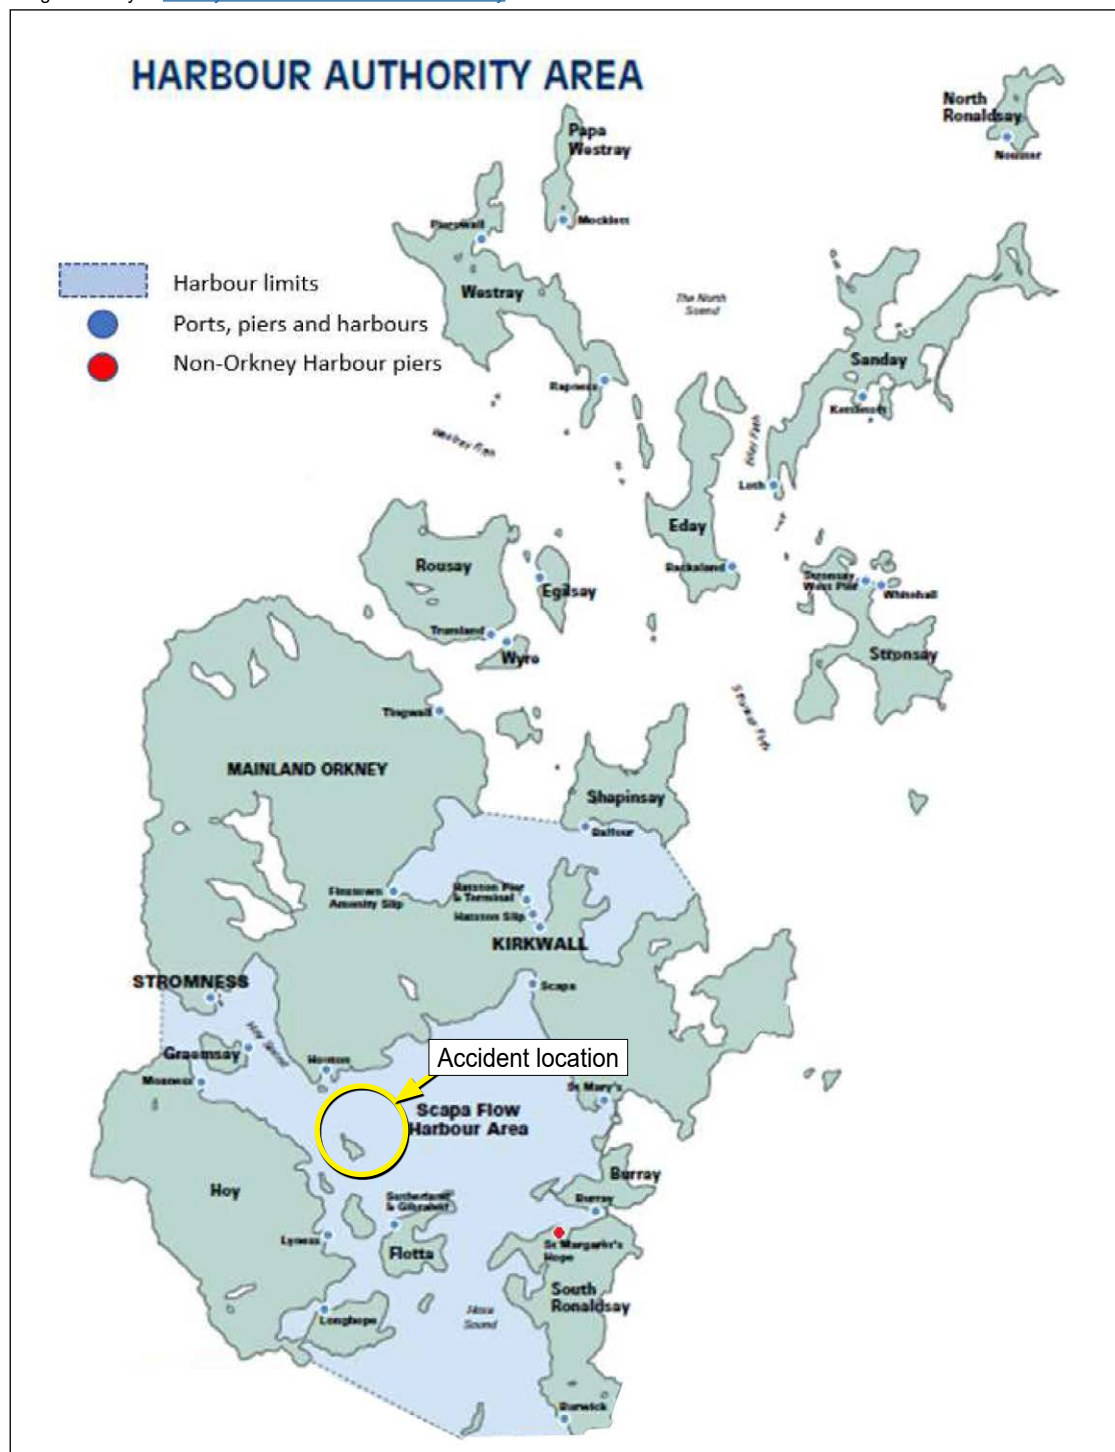
**Figure 9:** Accident location in the Orkney Islands Council Harbour Authority sea area

The Orkney Islands Council Harbour Authority (the harbour authority) was the Statutory Harbour Authority (SHA) responsible for the safe and efficient operation of 29 piers and harbours throughout the Orkney Islands, including Scapa Flow (**Figure 9**). The harbour authority operated under the principles set out in the Port Marine Safety Code (PMSC)<sup>8</sup>. The harbourmaster managed the safe navigational operation of the harbour area by using Orkney vessel traffic services (VTS) to monitor marine traffic.
