Report on the investigation of the grounding  
and recovery of the container feeder vessel

***Thea II***

***Svitzer Josephine***

in the approaches to the Humber Estuary

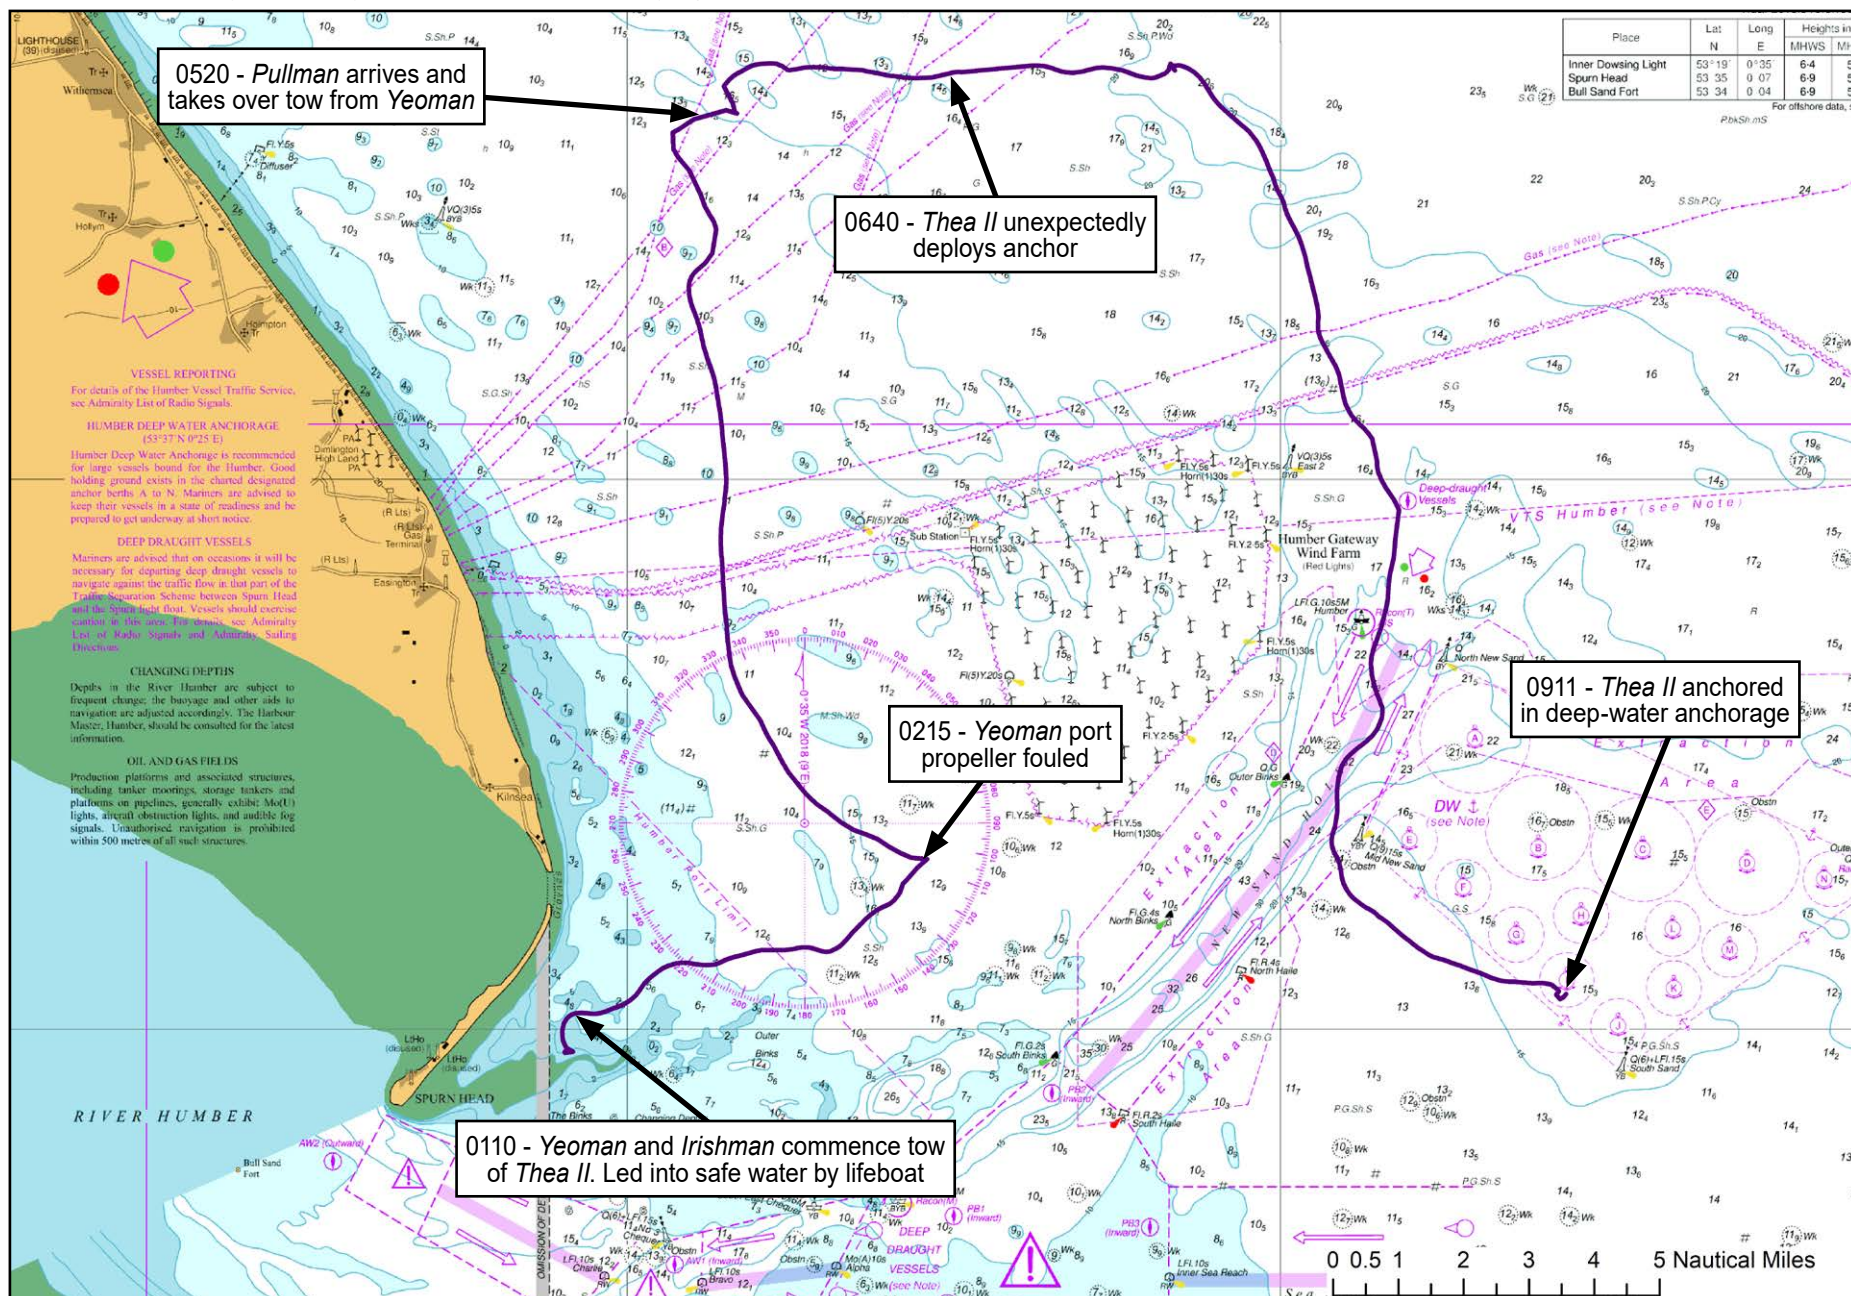
Figure 6: Thea II's passage, under tow, from the Binks shoal to the deep water anchorage

The tugs towed *Thea II* to the north following a passage plan agreed with the harbourmaster (**Figure 6**). This took the vessel down sea, between the mainland and the Humber Gateway windfarm. From there, the plan took *Thea II* east of the windfarm, before taking it south to the port's deep water anchorage. Thereafter, the plan was that *Thea II* would remain at anchor until the weather moderated and the vessel could be safely towed into harbour.

Shortly after 0200 the forward tug, *Yeoman*, unexpectedly lost the use of its starboard azimuth unit. This was quickly followed by the failure of its port azimuth unit at 0215. The remaining tug, *Irishman*, was able to control the tow as the three vessels ran down sea at slow speed. VTS Humber was informed and SMS Towage

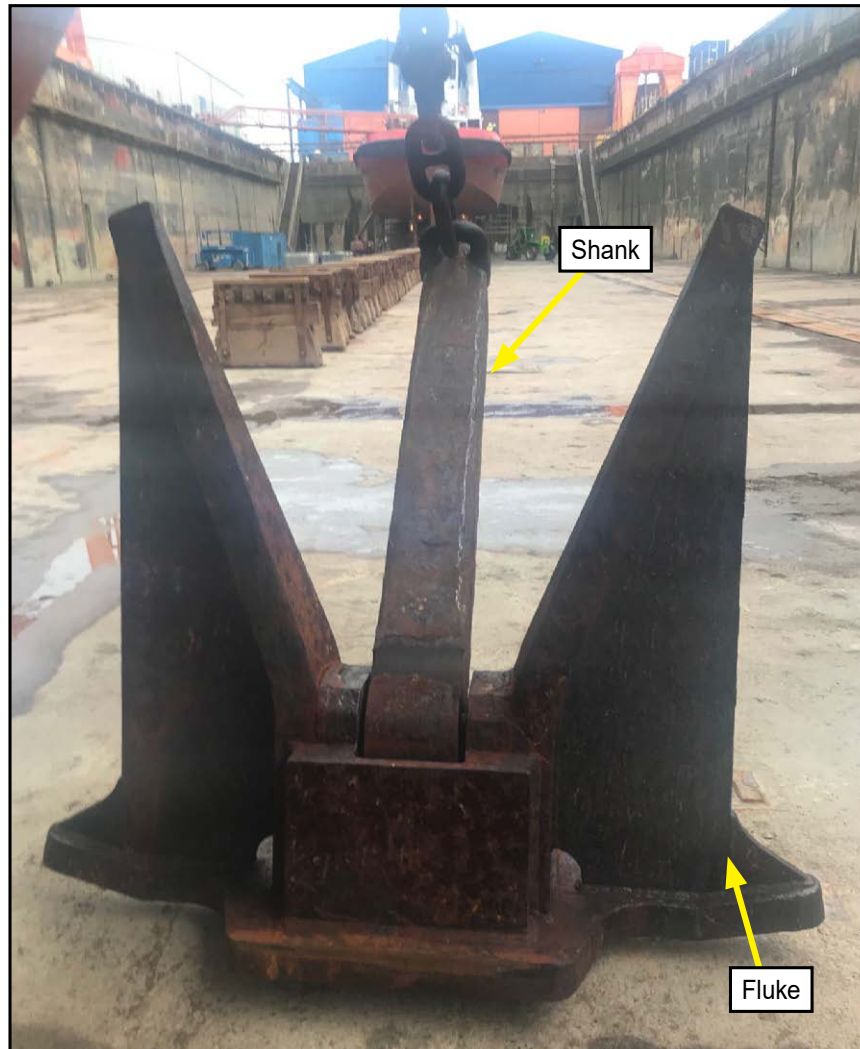
**Figure 8:** *Thea II*'s D'Hone, high holding power anchor

*Thea II*'s anchor arrangements comprised a forecastle windlass and two 1998kg, high holding power, D'Hone anchors (**Figure 8**). The port anchor was attached to 12 shackles and the starboard anchor to 9 shackles of 40mm hardened steel cable.
