Rail Accident Investigation Branch

Rail Accident Report

**Track worker near miss at Chiltern Green,
between Harpenden and Luton
23 April 2024**

Report 06/2025
April 2025

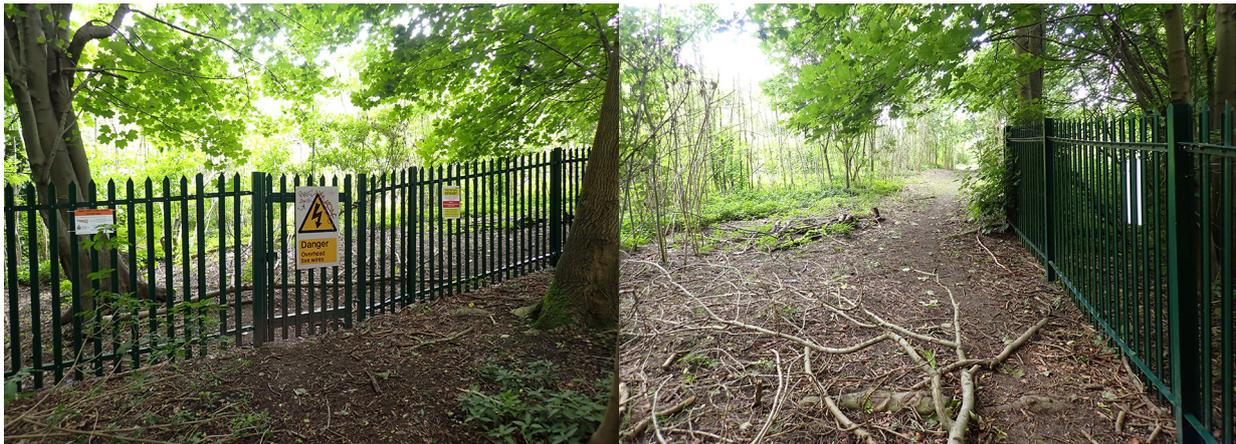
- 73 Users of the Luton Hoo and Cycleway South access point need to park their vehicle on Copt Hall Road, then walk a short distance along a path to a gate in the boundary fence (figure 15). After passing through the gate, users follow another path that leads to the various location cases and equipment buildings associated with the Chiltern Green hot axle box detectors.

Figure 15: The gate for the Luton Hoo and Cycleway South access point and path leading from it.

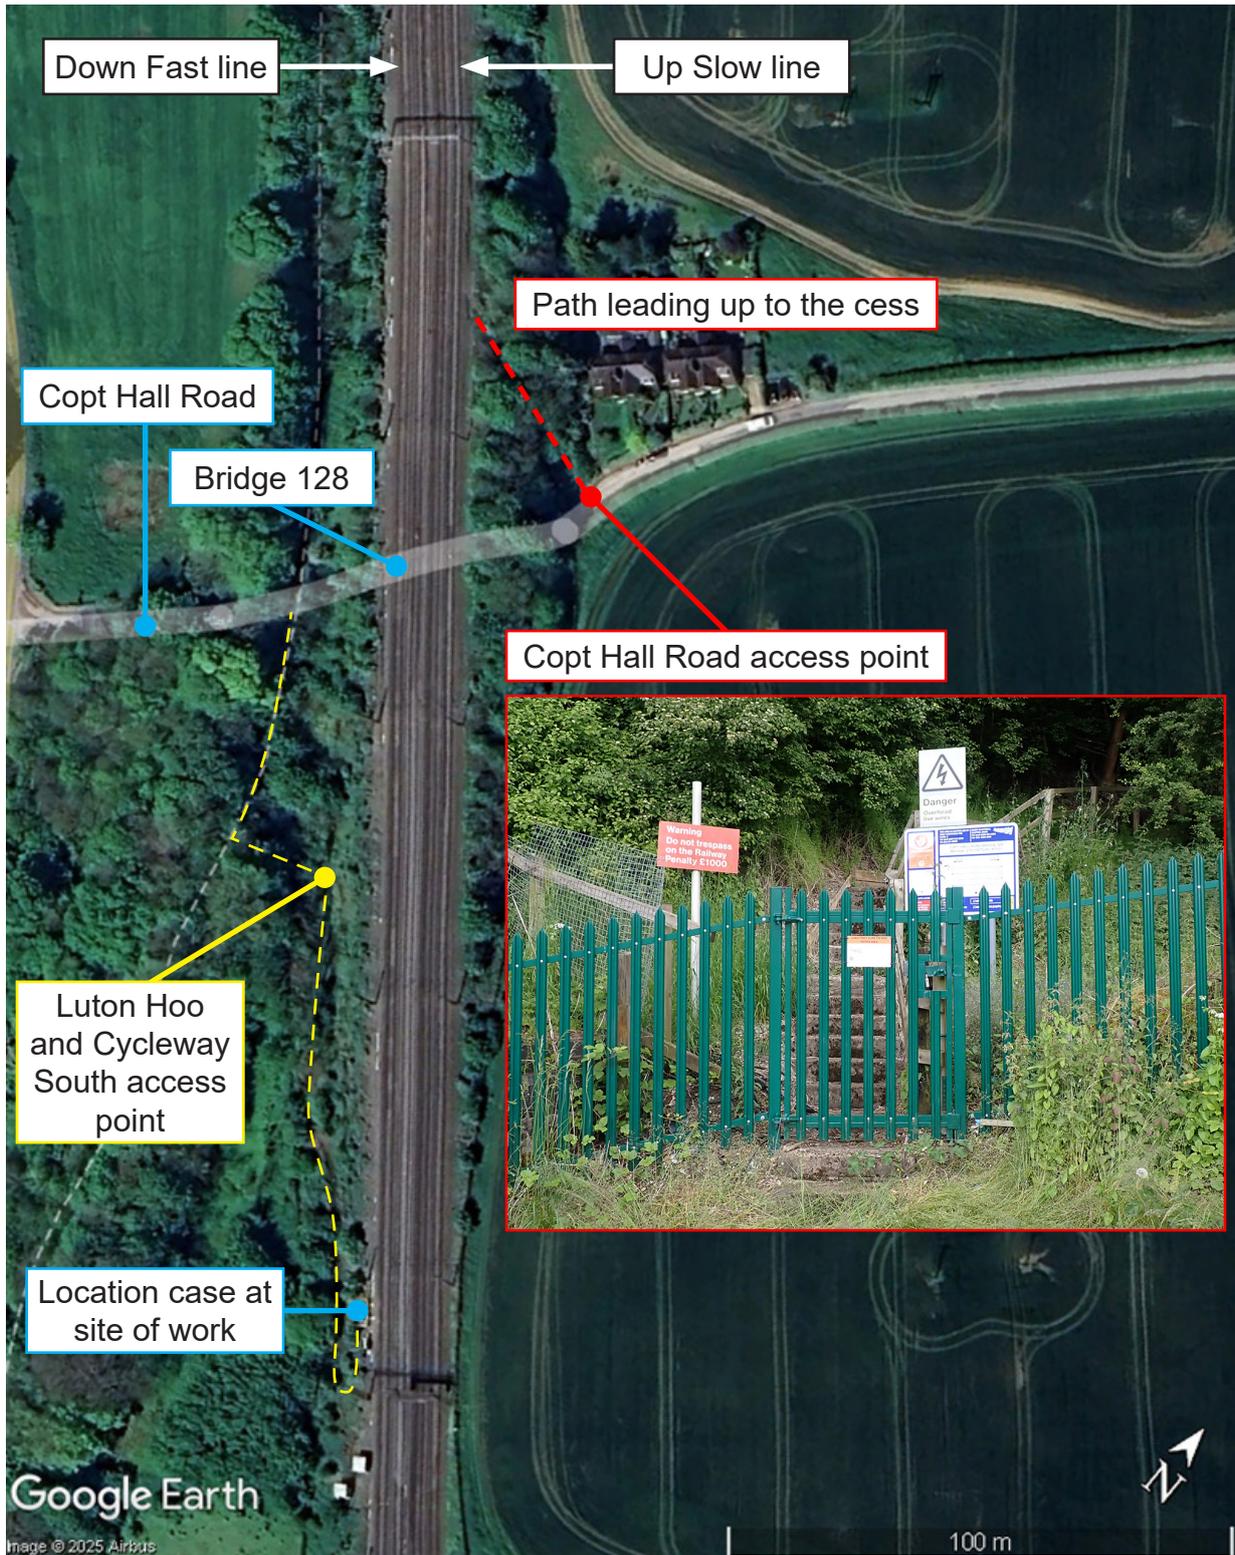
- 76 In the past, both the PIC and tester had been to another access point, which was also located off Copt Hall Road. On these occasions, they had gone to a pedestrian access point located next to bridge 128, where the railway passes over Copt Hall Road (figure 16). This access point is used to get to the Up Slow side of the railway. Both the PIC and tester knew this access point was on the opposite side of the tracks to where they needed to be working on the day of the incident.

Figure 16: The Copt Hall Road access point (courtesy of Google with RAIB annotations).

- 111 The site works plan described the access point the PIC, tester and observer needed to go to as 'Cophthall Road UB128'. The mileage given for this access point was 27 miles 1477 yards (67 chains), which matched the mileage of the Copt Hall Road access point on the Up Slow side of the railway at bridge 128 (figure 4). The plan also listed two what-3-words references for this access point, whereas all the other entries only had one. The first matched the Copt Hall Road access point on the Up Slow side of the railway. The second tallied with the location of the gate in the boundary fence for the Luton Hoo and Cycleway South access point on the Down Fast side (figure 15). This plan also provided the correct mileage and what-3-words reference for the location case that the group needed to go to.

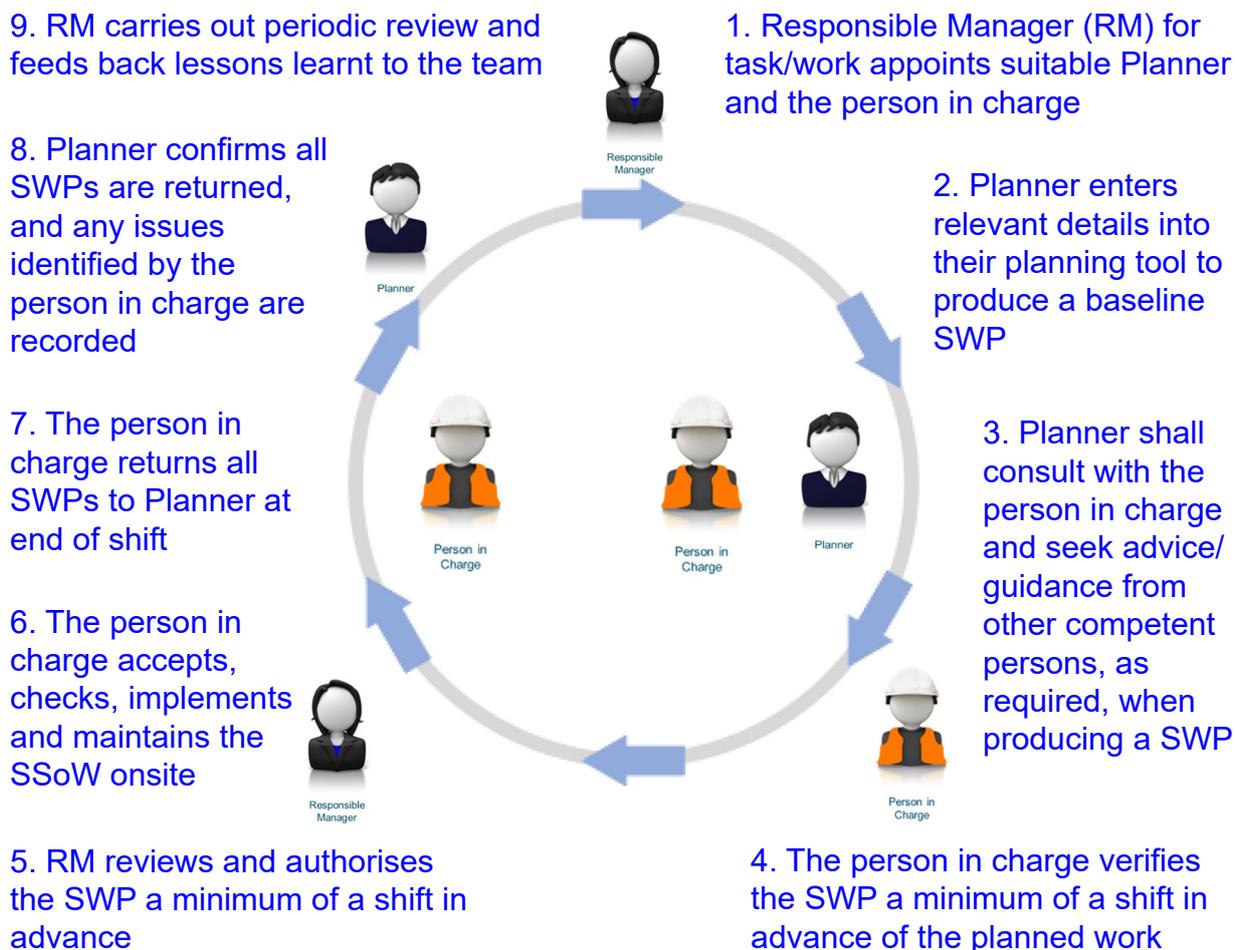
81 Network Rail company standard NR/L2/OHS/019, 'Safety of people at work on or near the line', issue 12 dated 3 June 2023, defines the process that should be followed for planning work that is to take place on Network Rail infrastructure (figure 17). In step 3 (as shown in figure 17), the process requires the planner to consult with the PIC when producing the SWP. It also references that it is good practice for the planner and PIC to collaborate and create the plan for the work together. In this case, neither the project engineer nor the planner consulted with the PIC when the SWP was produced.

Figure 17: The planning process as defined in NR/L2/OHS/019 (courtesy of Network Rail).

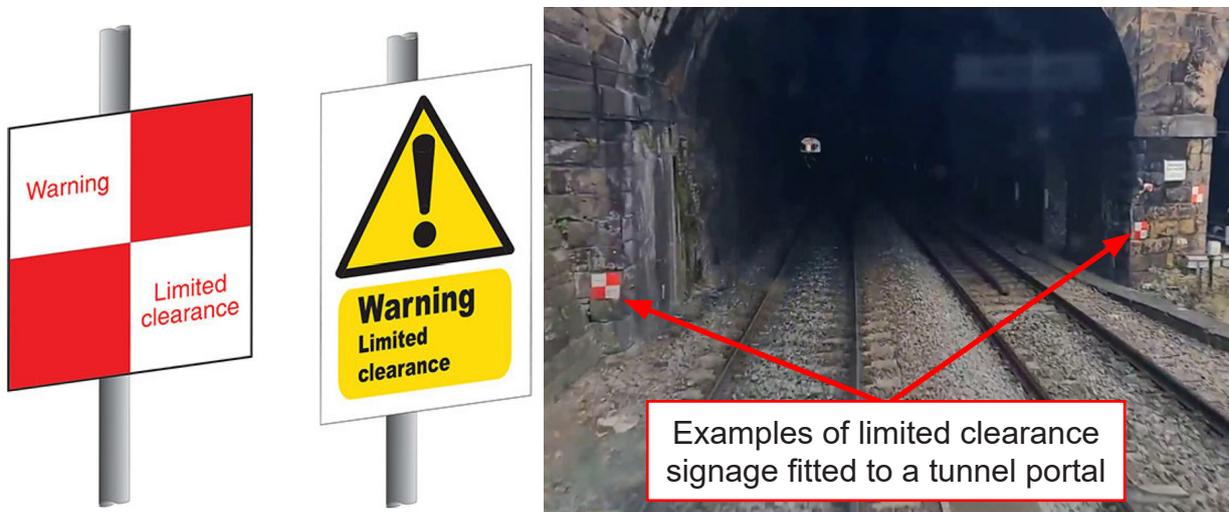
- 115 When the group set off from the Chiltern Green Cottages access point, it was possible for them to maintain 2 metres of separation from the nearest running rail while walking in the cess. However, as they reached bridge 127, the PIC (as COSS) and tester (as site warden) could both see that the amount of separation to the nearest running rail was reduced to less than 2 metres (figure 12), even though there were no limited clearance signs displayed on the bridge (figure 20).

Figure 20: Limited clearance signage as defined in GERT8000-HB1 and example of this signage fitted to a tunnel portal (left image courtesy of RSSB).

137 RIS-3413-TOM requires Network Rail to provide limited clearance signage where a position of safety is interrupted for more than 2 metres, and the criteria for no refuges or prohibition warning signage are not applicable. The type of sign that should have been provided at bridge 127 is dependent on how these criteria are interpreted (see paragraph 154). However, no signage was fitted to the bridge.

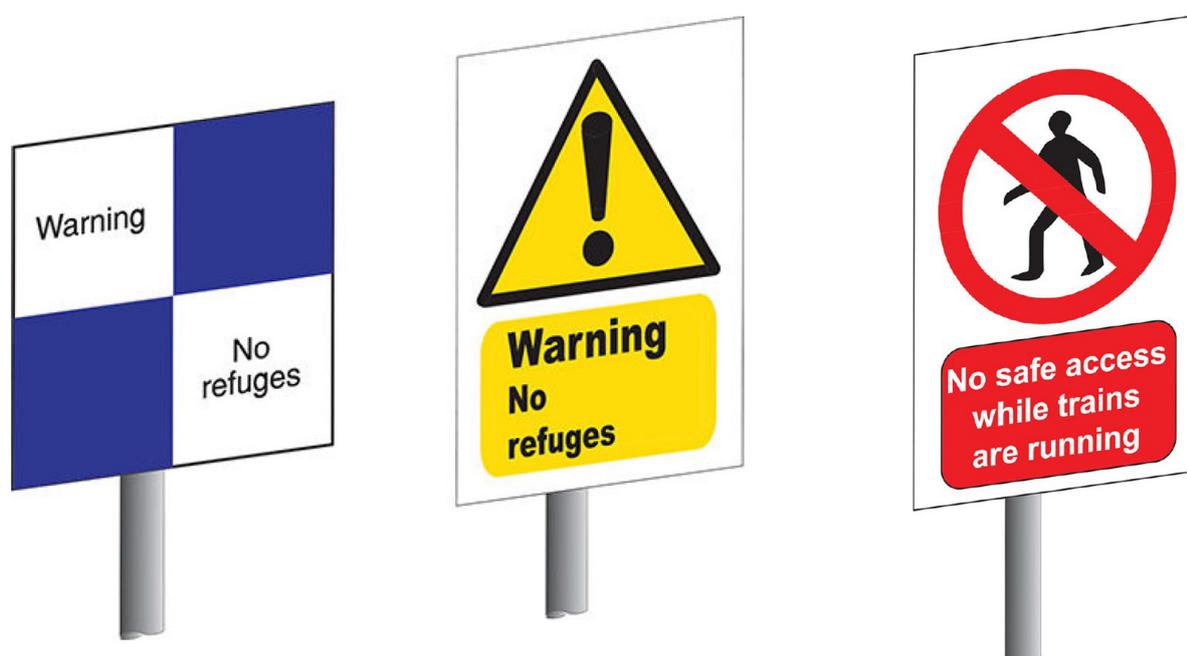
Figure 22: No refuge and prohibition signage as defined in GERT8000-HB1 (courtesy of RSSB).

- 155 RIS-3413-TOM states that where there is not adequate time to reach a position of safety or refuge because of sighting distances or other reasons, infrastructure managers should provide a prohibition sign (figure 22) on a structure with restricted clearance. The fitment of prohibition signage means that no other type of warning sign, such as one for limited clearance, can be fitted to the structure.
