MAIB Safety Flyer to the Fishing Industry

SAFETY FLYER TO THE FISHING INDUSTRY

Fatal accident to a crewman on board the scallop dredger *Olivia Jean* (TN35), north-east of Aberdeen, Scotland on 28 June 2019

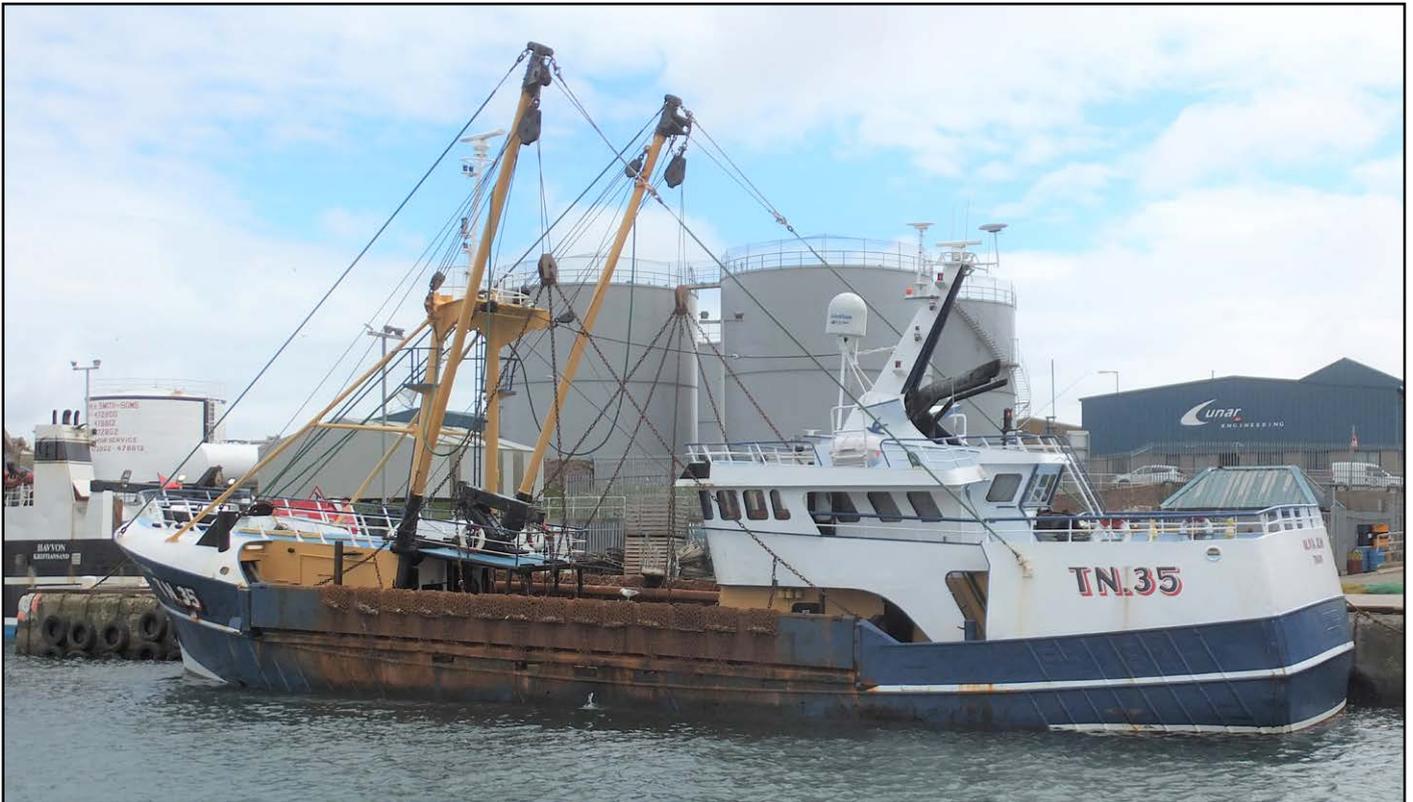
Olivia Jean

At about 2200 on 28 June 2019, an Indonesian crewman on board the scallop dredger *Olivia Jean* was fatally injured after being struck on the head by one of the vessel's scallop dredge towing bars while working on deck.

The crewman had replaced two worn dredges on the towing bar and stood clear as the skipper used the winches and derrick to lift and realign the gear against the vessel's tipping door. Unfortunately, one of the towing bar's securing chains had not been released and the dredge gear became snagged. Although the skipper shouted instructions to the crewman to remain clear as he attempted to free the gear, the crewman stepped between the snagged bar and the accommodation superstructure just as the snagged bar released and swung inboard.

1. The shooting, hauling, and moving of dredge gear are extremely hazardous activities that need to be tightly controlled. No matter how experienced the crew on deck might be, they need to be properly supervised and their safety closely monitored.
2. The crew on deck may not be visible to the winch or machinery operator, so clear, explicit and easily understood communications are vital to the avoidance of dangerous situations from developing. This is particularly the case where the crew do not share the same first language.
3. Learning lessons from previous accidents can prevent injuries and save lives. In this case, the lessons learned and corrective action implemented did not prevent a near identical accident from occurring to the crew on board in August 2020. It was very fortunate that it did not result in another fatality.
